***Inspection of brick tunnels and covered ways
SSL (Circle, Hammersmith & City and District Lines)***

LONDON UNDERGROUND LIMITED

Inspection date: July 6th 2014

Report date: September 22nd 2014

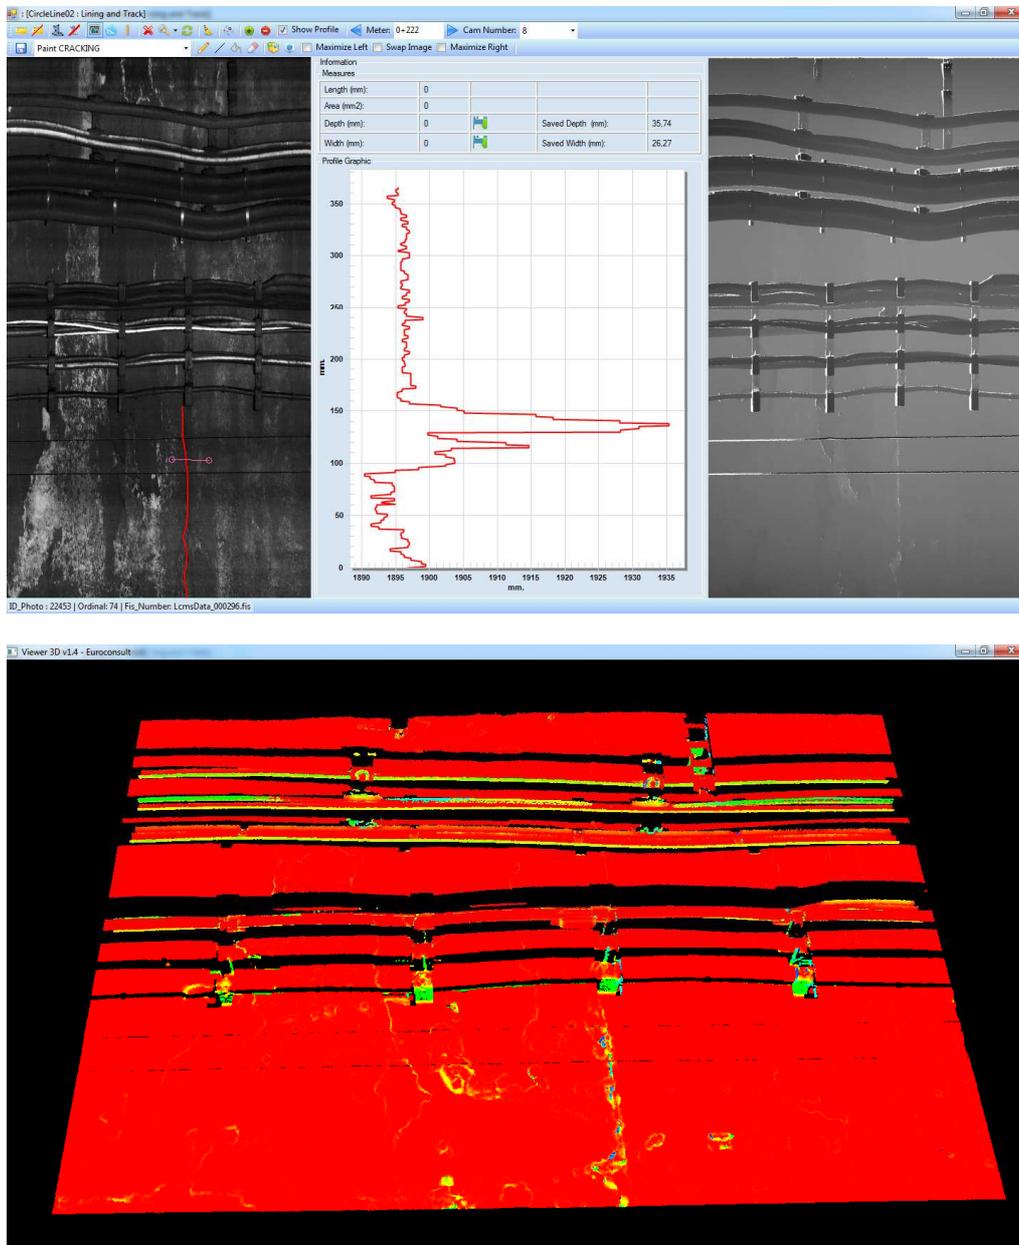
This category deals with cracking, showing an obvious opening between its edges. It has been both in the intensity and depth images (3D).

Figure 11. Cracking example. Tower Hill – Monumet (TL32)

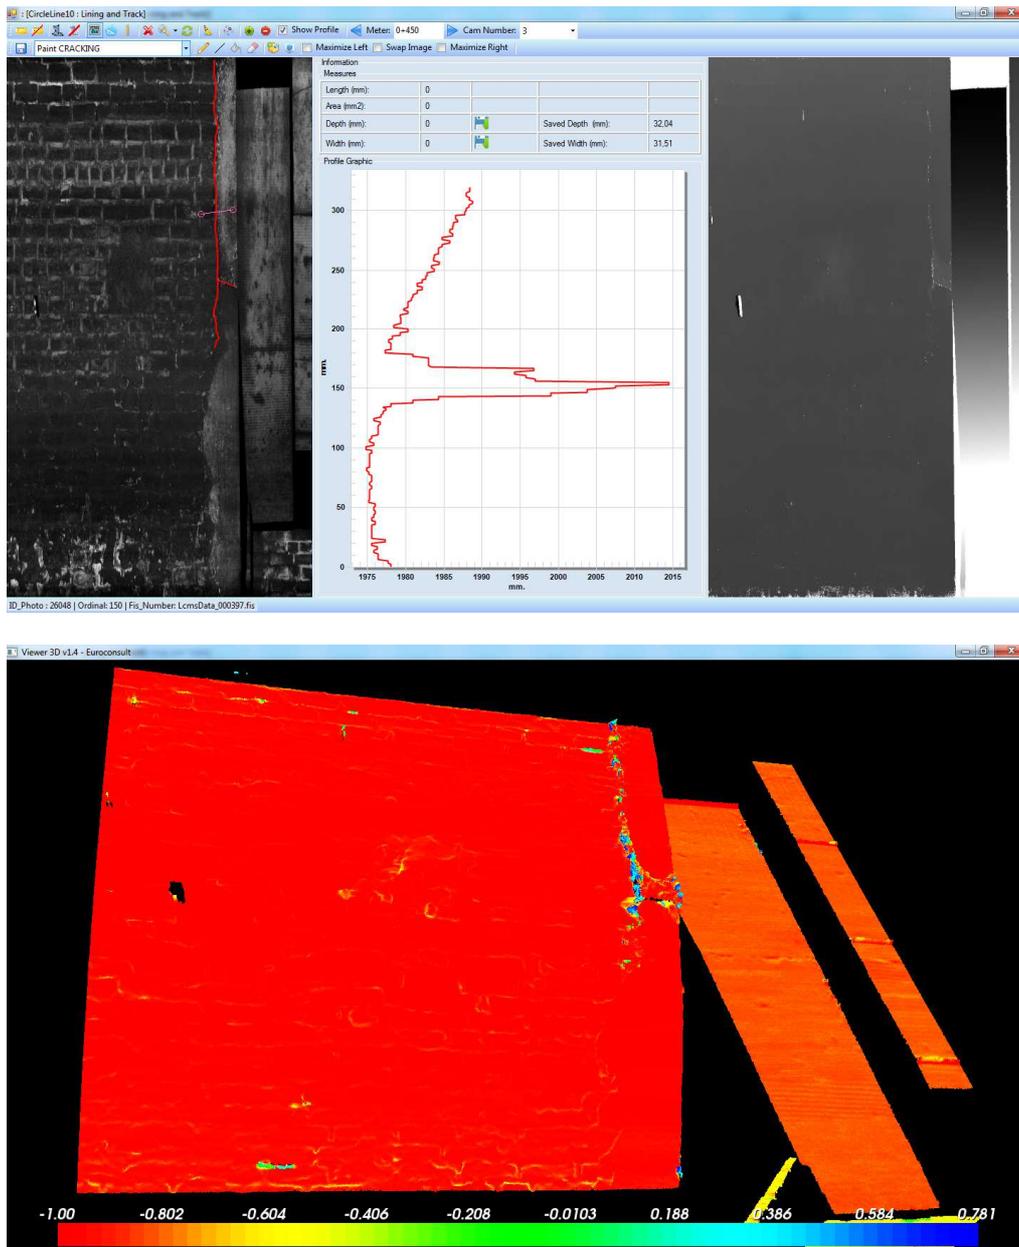
Figure 12. Cracking example. St James's Park – Victoria (TL17)

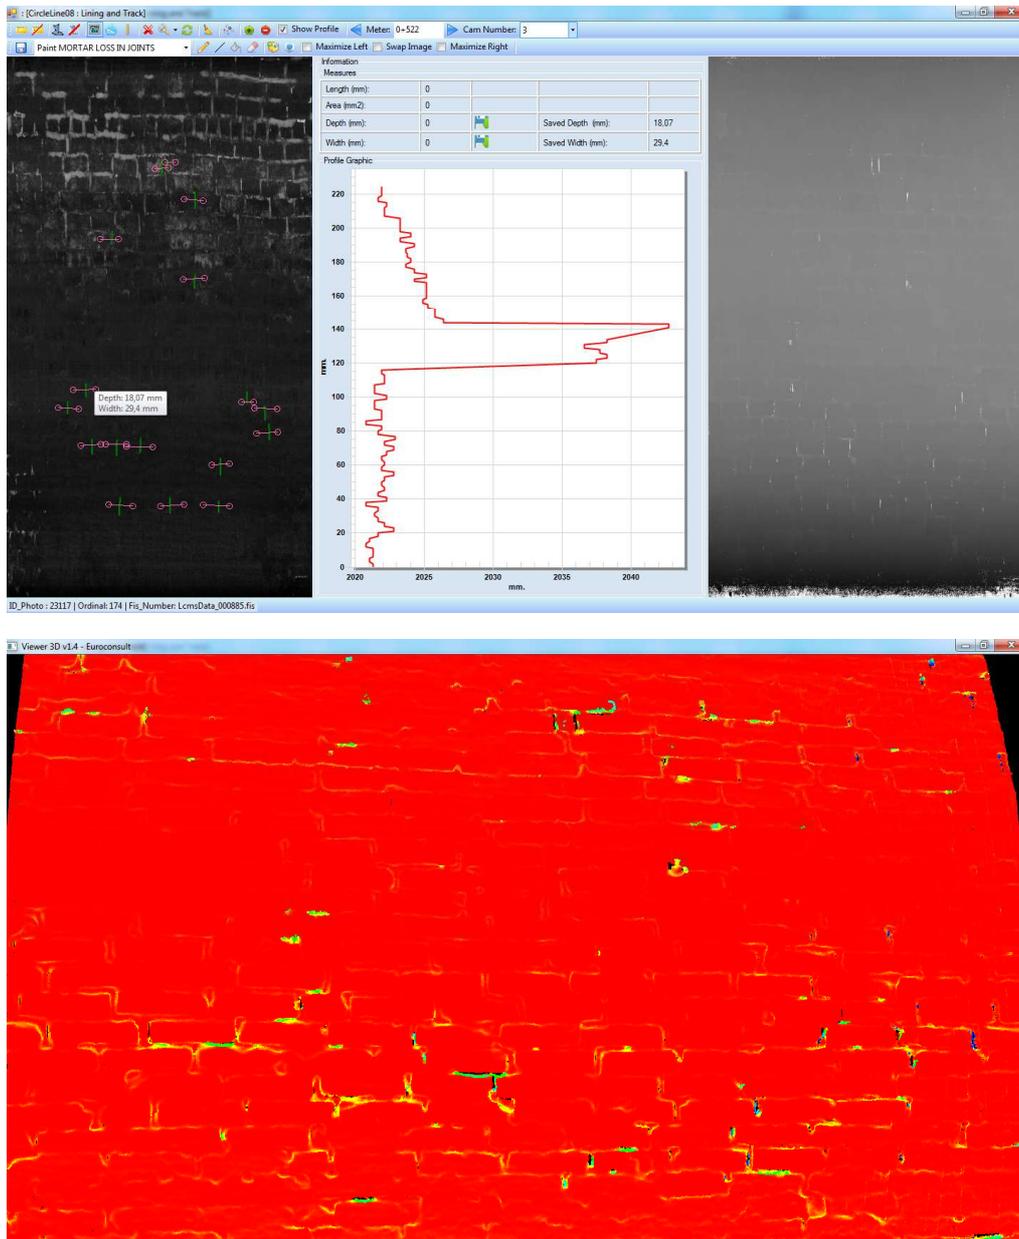
This category presents the bricks' joints that have been detected on the lining. Thanks to the 3D image, both their width and depth can be clearly assessed. The lack of material in these joints has not been treated yet. In addition to this, they do not reveal any previous presence of water.

Figure 13. Mortar loss in joints example. Embankment – Westminster (TL21)

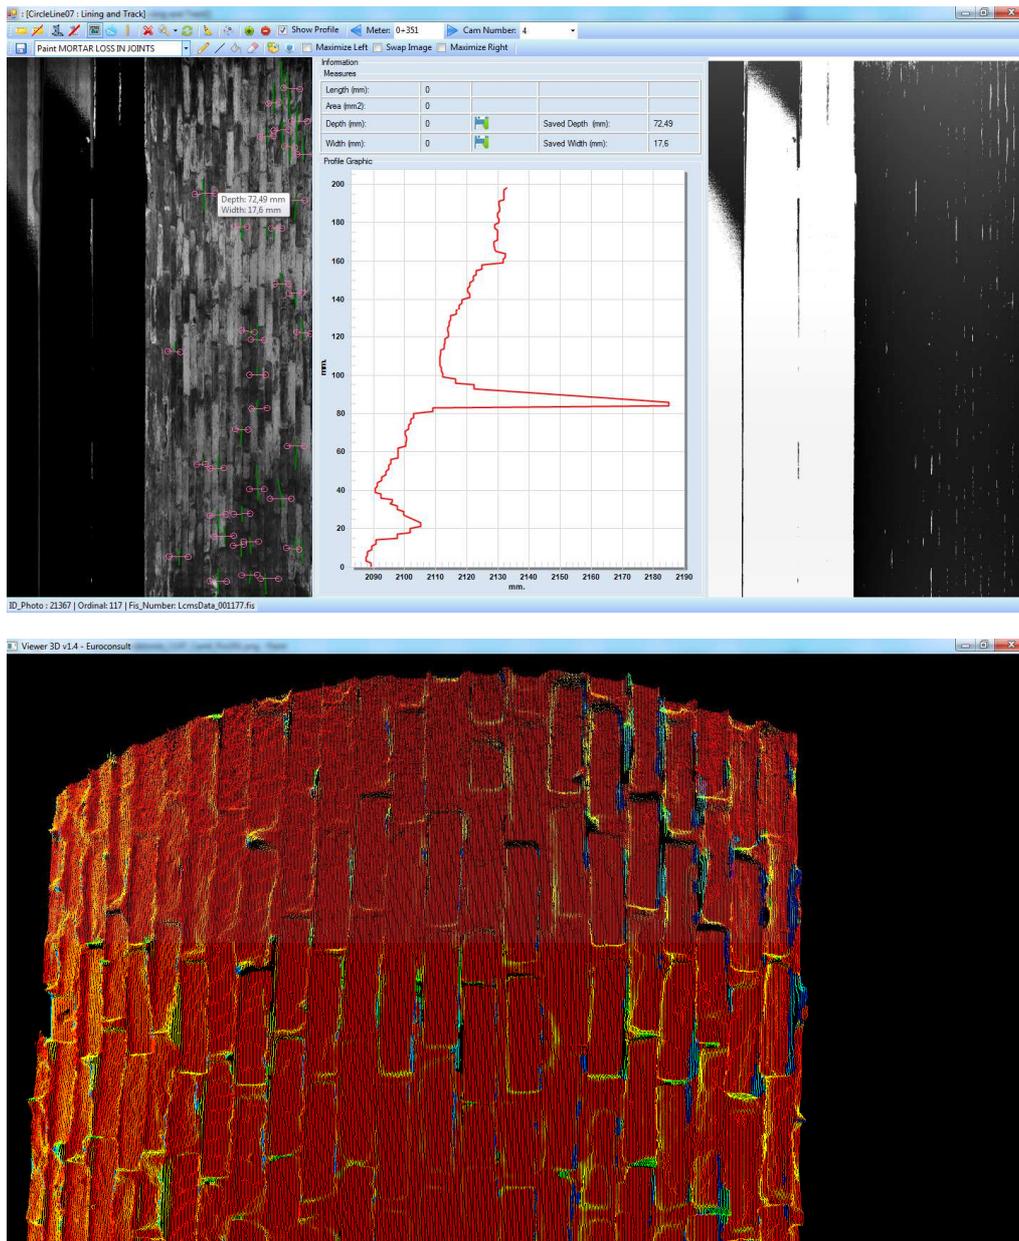
Figure X. Mortar loss in joints example. Temple – Embankment (CW19)

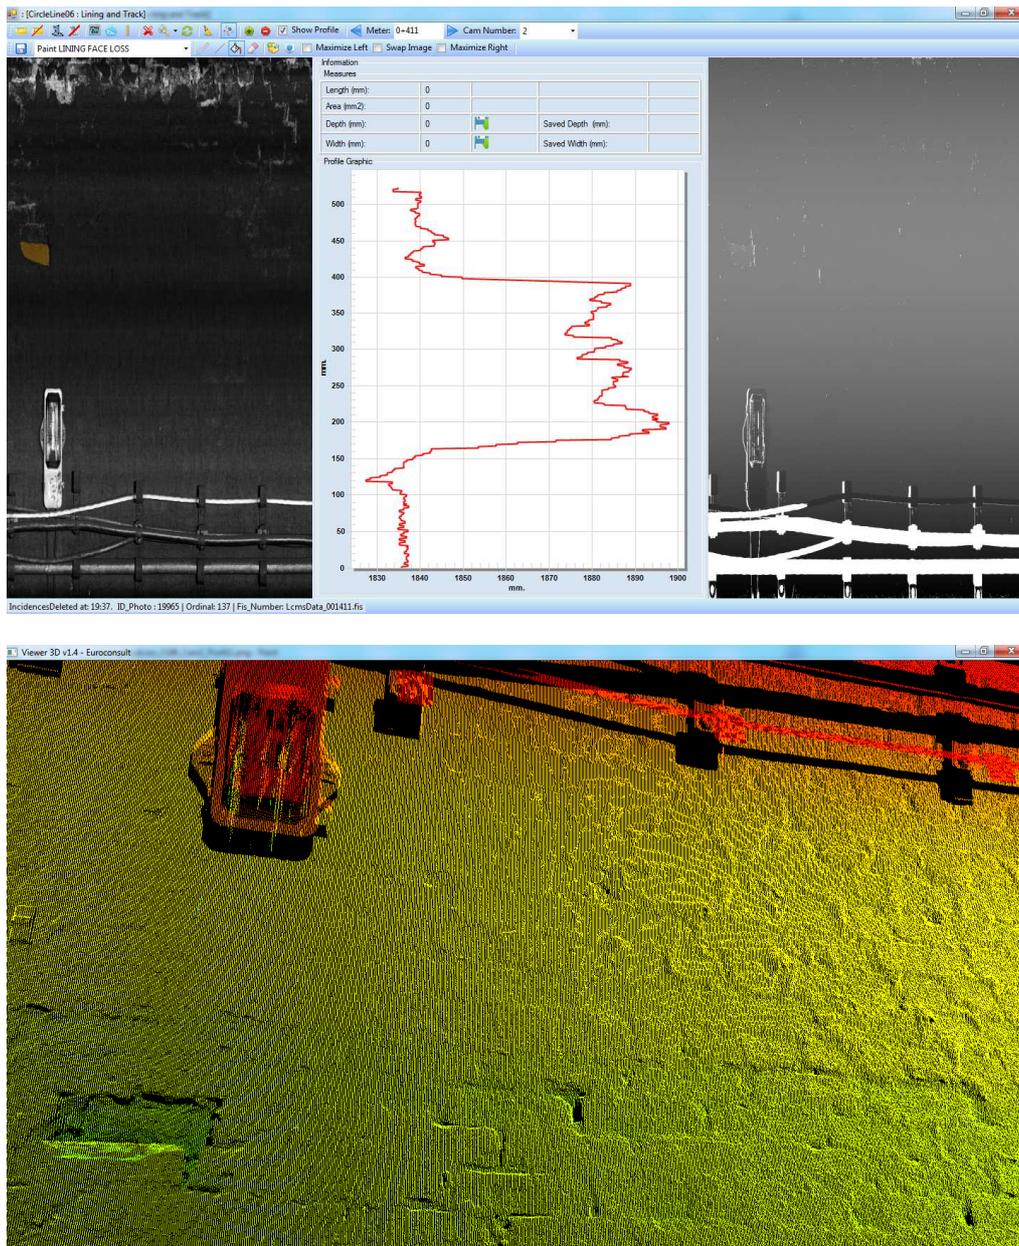
The areas on the bricks that show significant lining face breaking, missing parts and major material loss have been here stressed. These areas are automatically detected thanks to the 3D image and have been clearly marked on the surface as irregularities distorting the theoretical profile of the tunnel.

Figure 15. Lining face loss example. Blackfriars – Temple (TL22)

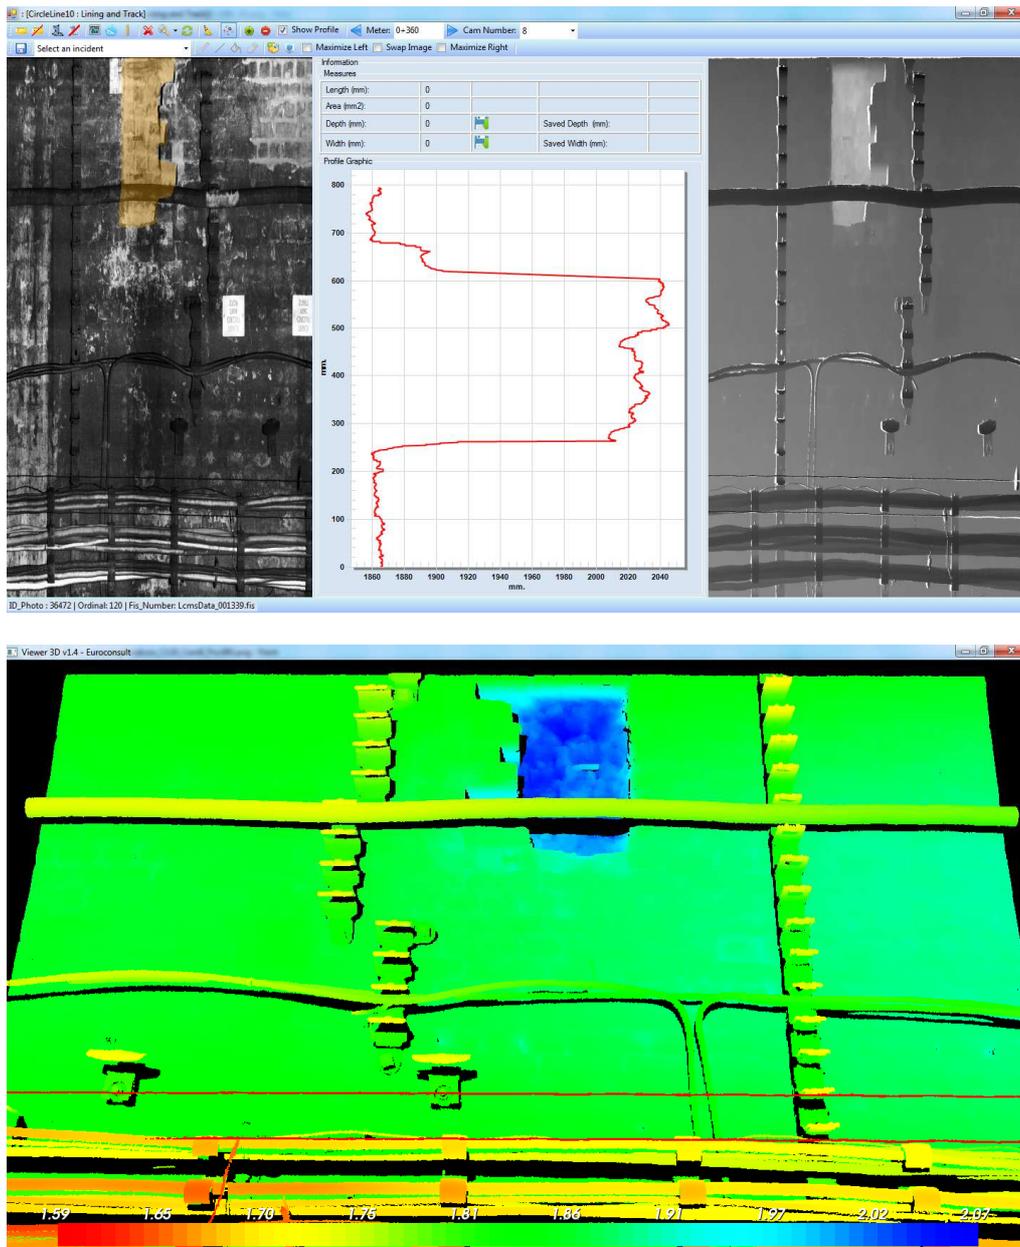
Figure 16. Lining face loss example. St James's Park – Victoria (TL17)

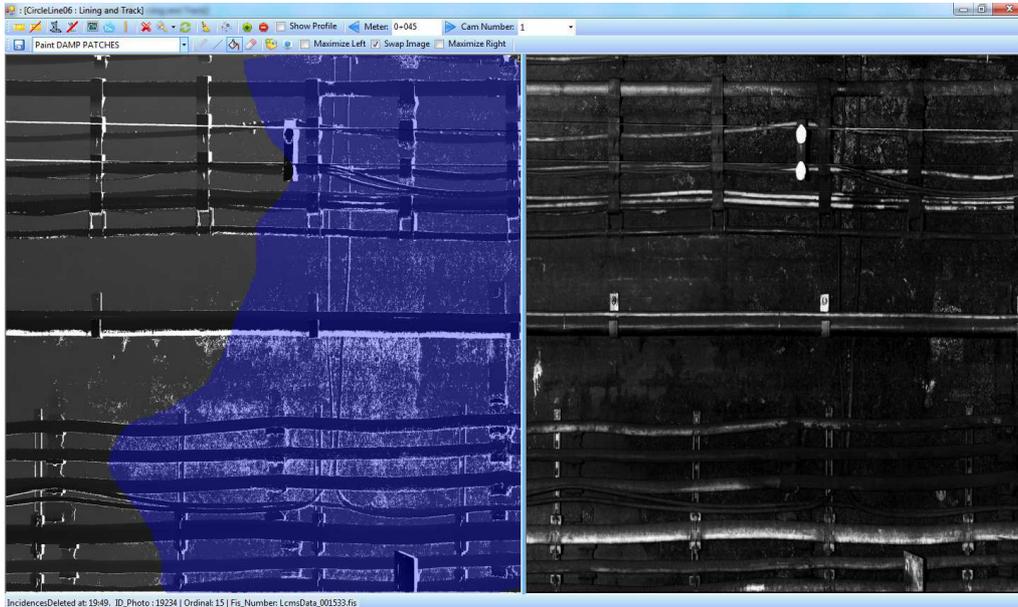
Figure 17. Blackfriars – Temple (TL23)

For the purpose of analysing any dampness in the tunnel, areas in which a surface run-off has been detected and areas which show dampness coating have been detected as damp patches.
