REHABILITATION AND MONITORING OF SAWTELLS INLET BRIDGE – 12 YEARS LATER

Fred Andrews-Phaedonos, GeoPave, VicRoads
Ahmad Shayan, ARRB Transport Research Pty Ltd
Aimin Xu, ARRB Transport Research Pty Ltd

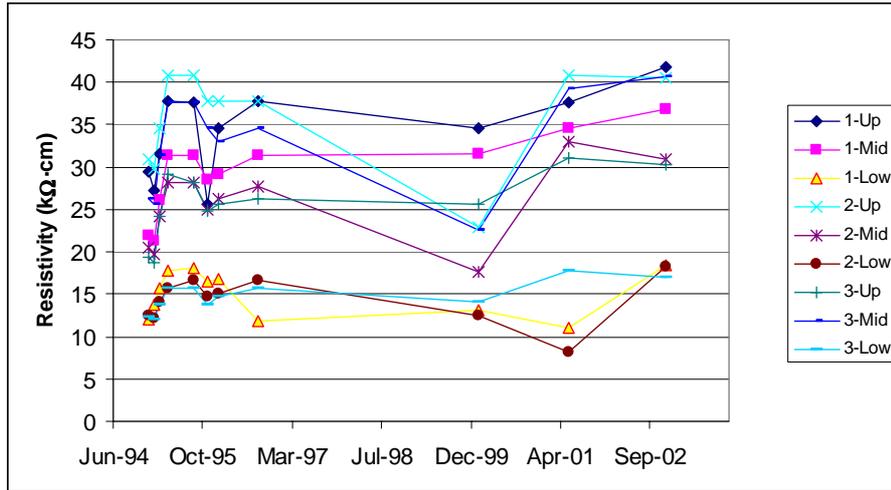
Figure 2 : Resistivity of concrete for Melbourne Pier columns

Figures 1 and 2 clearly show that the resistivities of the upper parts of the columns for both piers range between 20,000 ohm cm to 40,000 ohm cm, which would indicate that the vulnerability of these areas of the columns to corrosion or the rate of corrosion supported would be low to very low. Resistivity measurements at "tidal zone", i.e. at 0.3 m above the pile-cap top surface are between 10,000 ohm cm to 20,000 ohm cm which are likely to support low to moderate corrosion rates. The lower resistivity measurements are consistent with more negative electropotential measurements and the low to moderate corrosion current densities recorded.

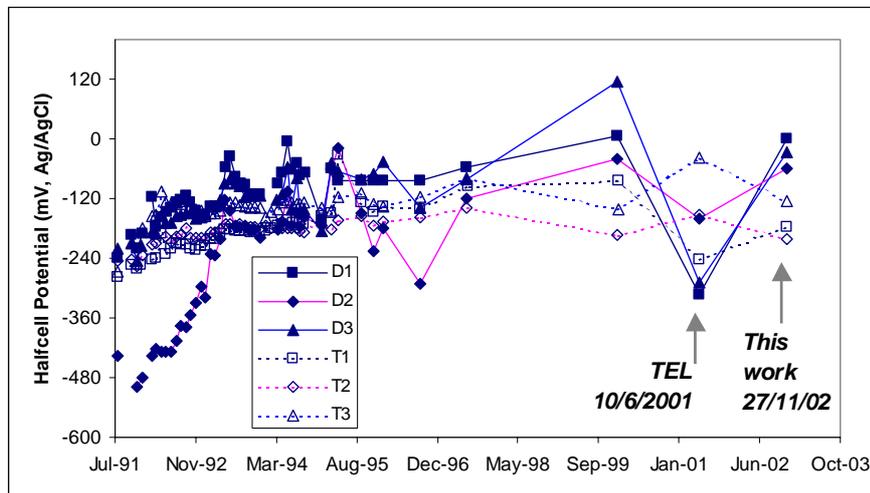
Figure 5 : Half-cell potential of the internal sensors. “D” = Melbourne Pier (Pier 1); “T”= Tooradin Pier (Pier 2)

The values obtained in this investigation (Ref.2) and those that have been estimated from the 2001 investigation (Ref. 3) are summarised in Figure 5. It can be seen that the half-cell potential determined in June 2001 was substantially different compared to those determined before and after. It is thus concluded that the potential measurement results of 2001 may not be stable due to seasonal variations, or faulty connections.

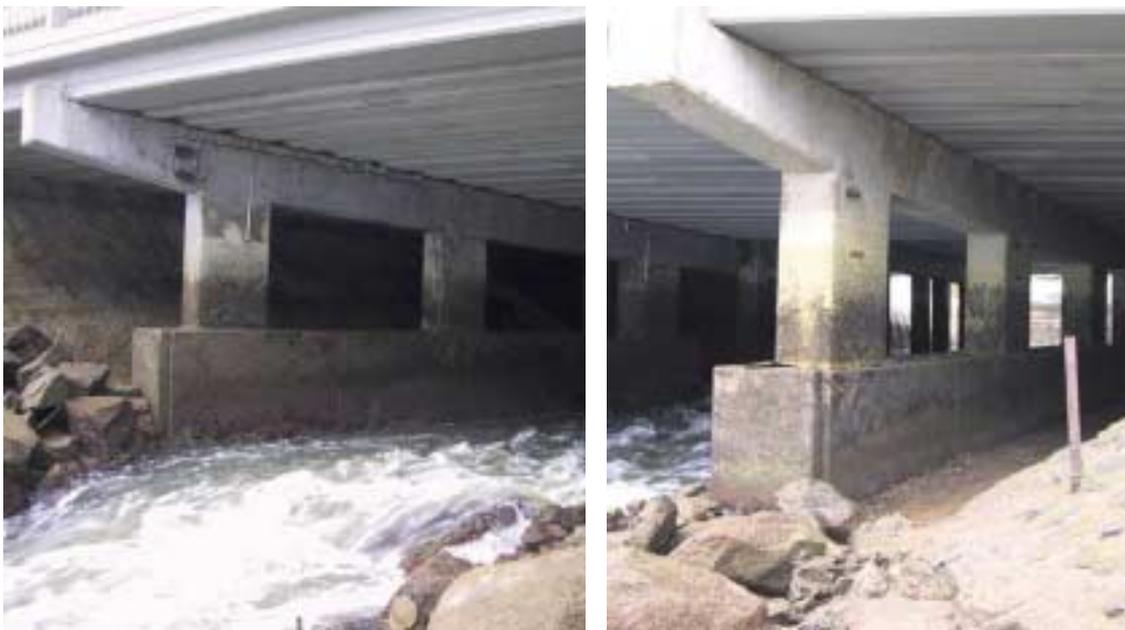
Figure7: The investigated piers (left: Melbourne Pier; right: Tooradin Pier) at low tide, Nov' 02

The epoxy coating on Column 3 of the Tooradin Pier (Pier 2) has bulged and separated from the base concrete, which was also reported previously (Ref.3). The epoxy layer on the pilecap has disintegrated (Figure 7). This system, which does not allow moisture to escape, appears to be unsuitable for this bridge, because the columns are constantly immersed in water. Pressure build up behind the epoxy layer finally leads to its separation from the concrete surface.

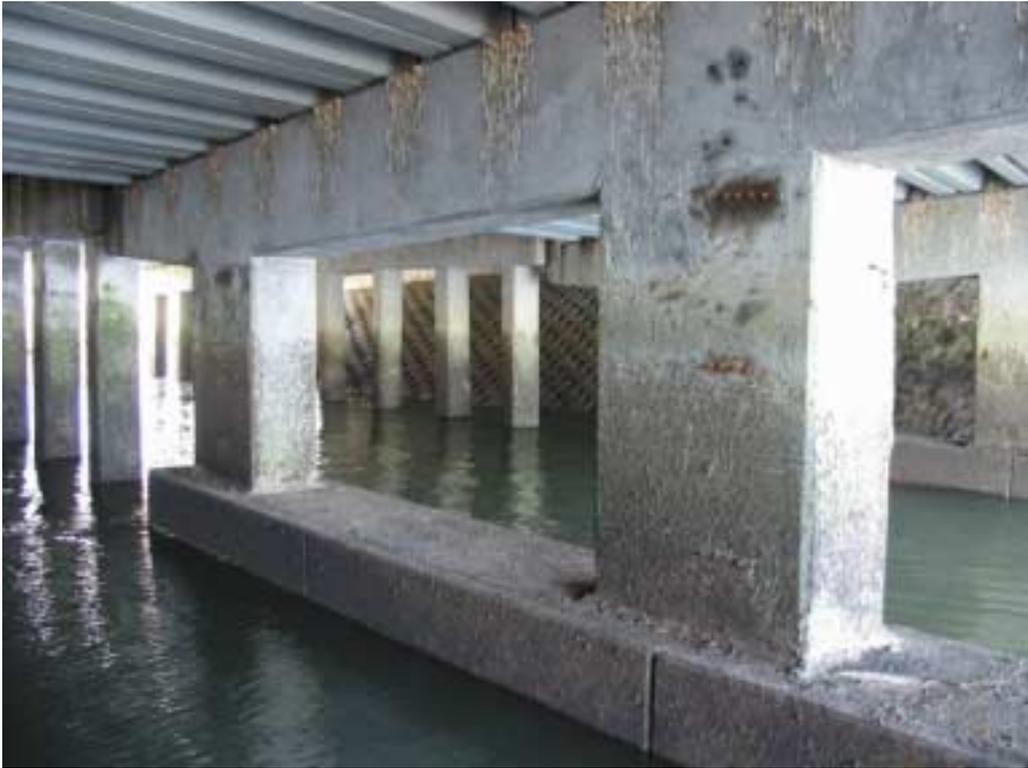
Figure 8 : Columns 1 and 2 of Melbourne Pier (Pier 1), Melbourne face

Resistivity measurements pins at the lower rows have severely corroded, and some of the pins have totally disintegrated (Figure 8). It would be difficult to perform the test on those pins in the future.

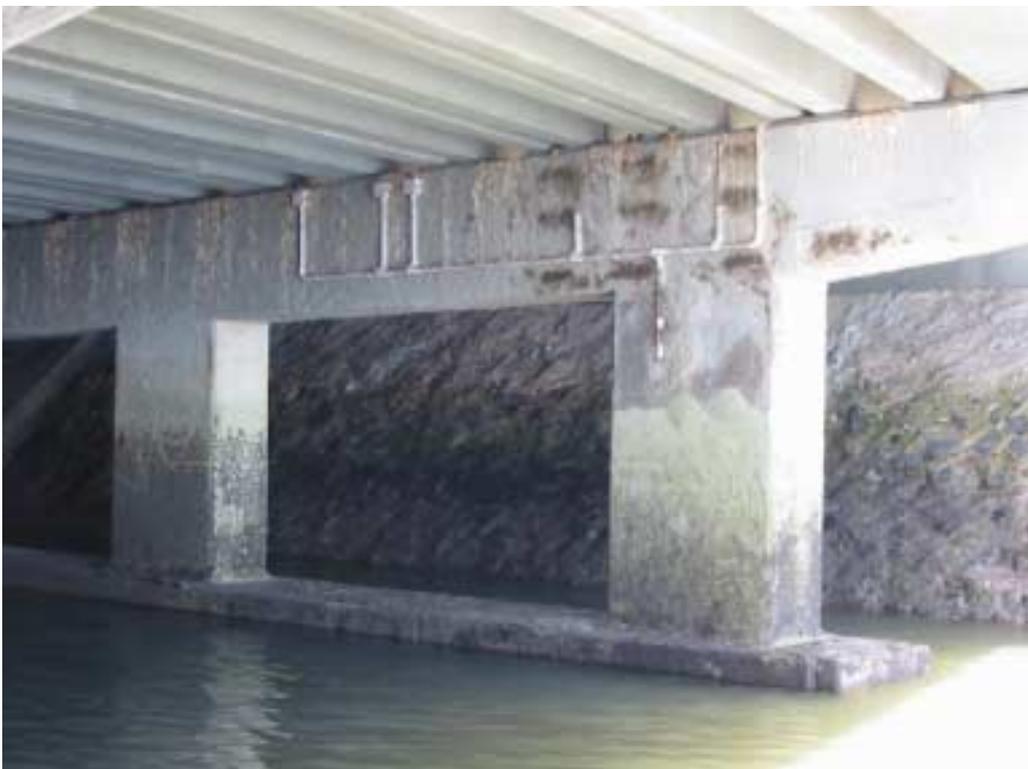
Figure 9 : Columns 2 and 3 of Tooradin Pier (Pier 2), Melbourne face

The epoxy coating on the downstream column of the Tooradin pier has deteriorated and has peeled off from the pilecap, and has bulged at the lower part of the column. It would appear that vapour pressure build up behind the coating could have caused it to separate from the concrete substrate. Some peeling of the cementitious coating has also been noted in some areas, particularly at the lower sections of columns and the top of the pilecap.
