# **Bridge Over Cooks River at Tempe – Sydney NSW**

## **Emergency Underpinning of Piers**

*R.Oates (RTA), L. Prasad (RTA), W.Stalder (RTA)*

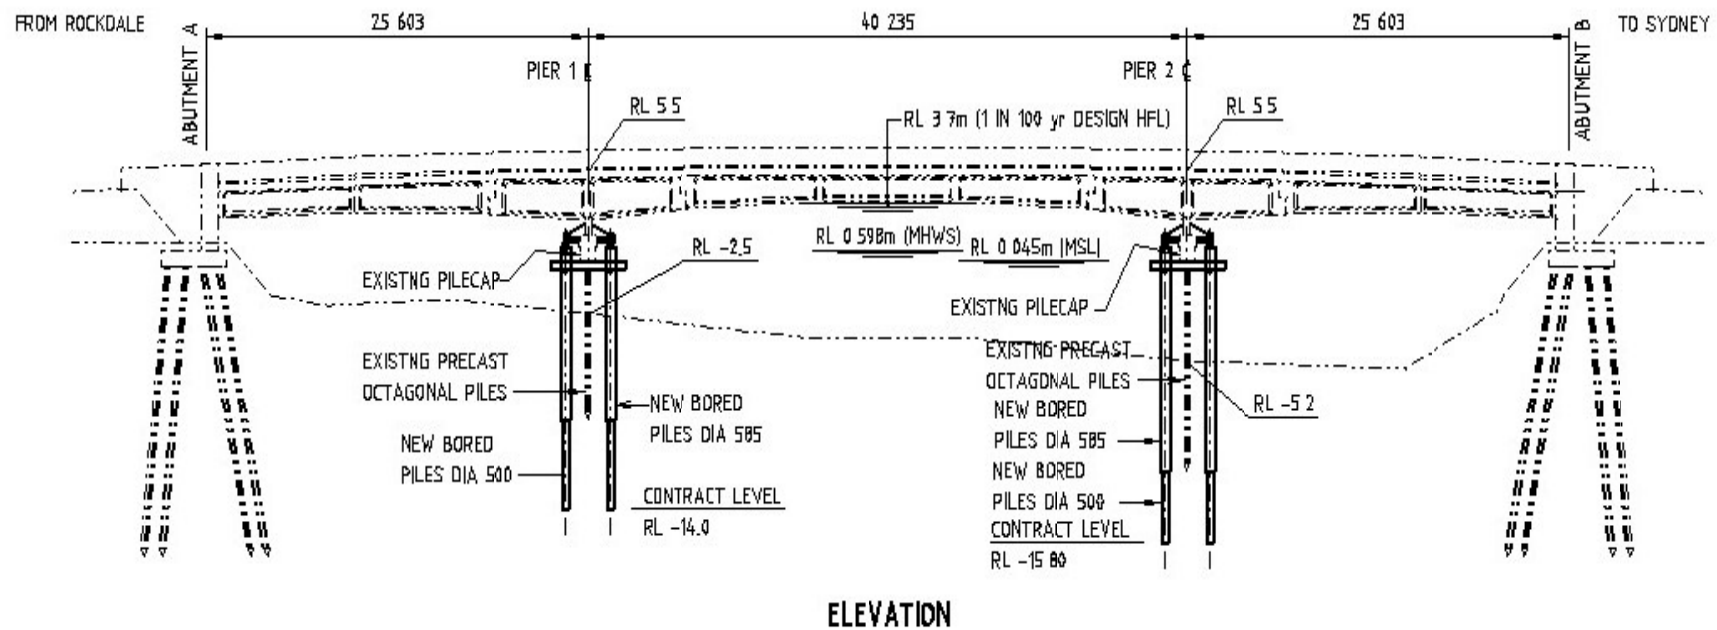
**Figure 1: Elevation of the Bridge over Cooks River at Tempe showing the existing piles and the rehabilitation scheme.**

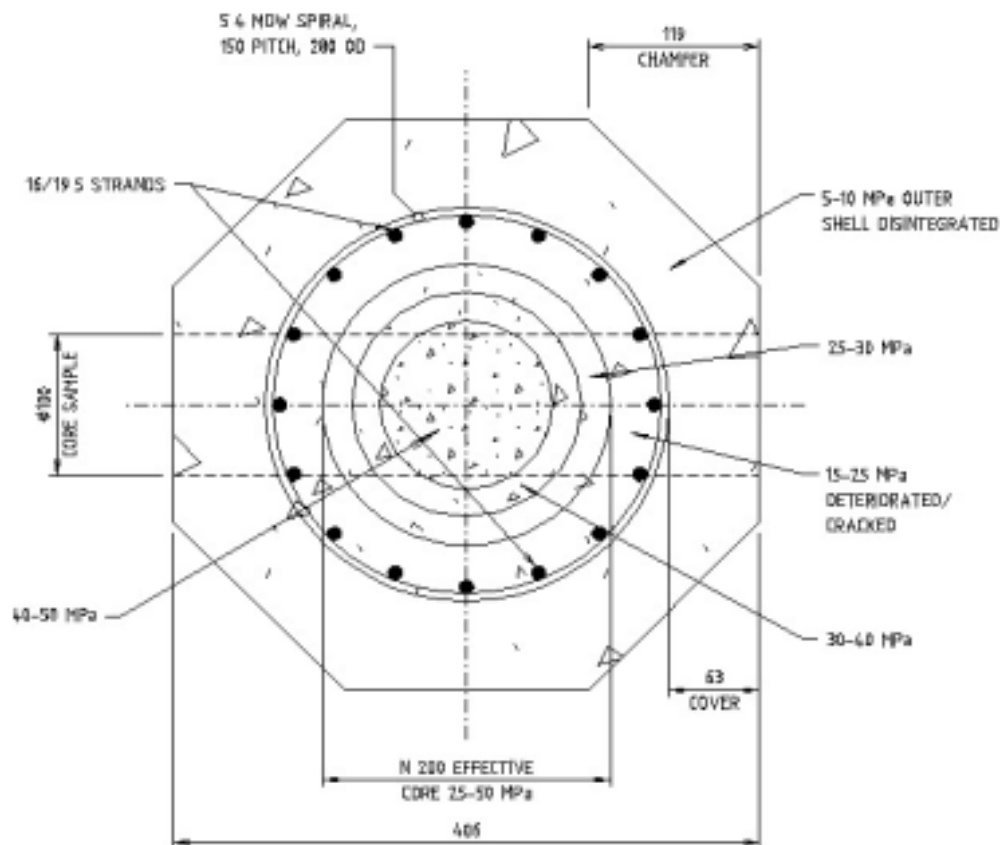
Figure 2 shows the typical extent of deterioration in the pre-cast concrete piles and the estimated strength of the concrete in the different zones within the cross section.

**Fig 2: Estimated strengths of extensive zones of damage within the cross section of existing piles**

The reason for such extensive damage was attributed to a phenomenon known as Delayed Ettringite Formation (DEF). Microscopic examination of the cores extracted from Pile 76 at Pier 2, indicated that the deterioration mechanism was initially caused by DEF followed by attack of the cement

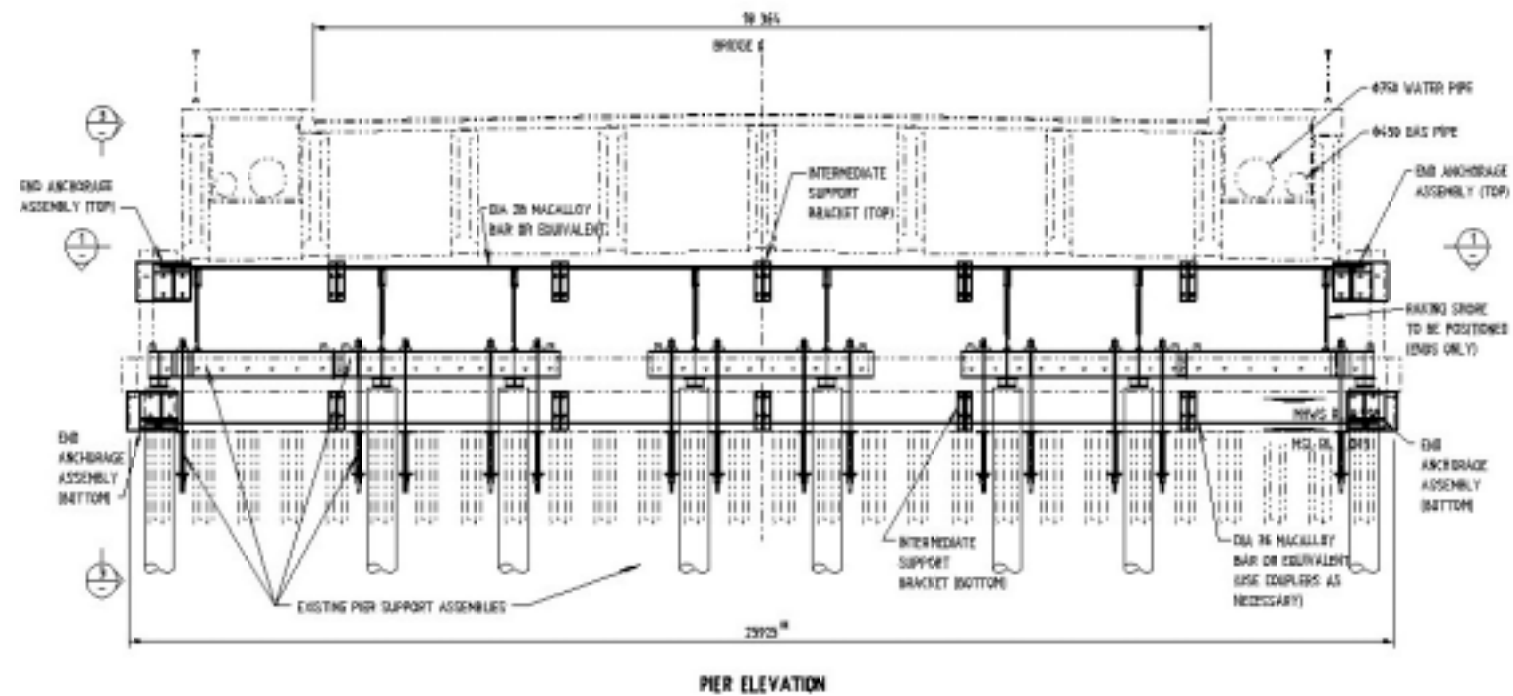
*Figure 3: Elevation of the pier and the supporting arrangement*

The support beams were installed in the transverse direction to the axis of the bridge and supported on stools sitting on the new piles. The yoke beams, installed in the longitudinal direction to the bridge were pulled up under the pile caps to transfer the loads to the new piles using 50mm VSL stress bars. Groups of stress bars were linked together to counterbalance loading on the piles and were stressed simultaneously to a level equivalent to 80% of self-weight of the bridge.

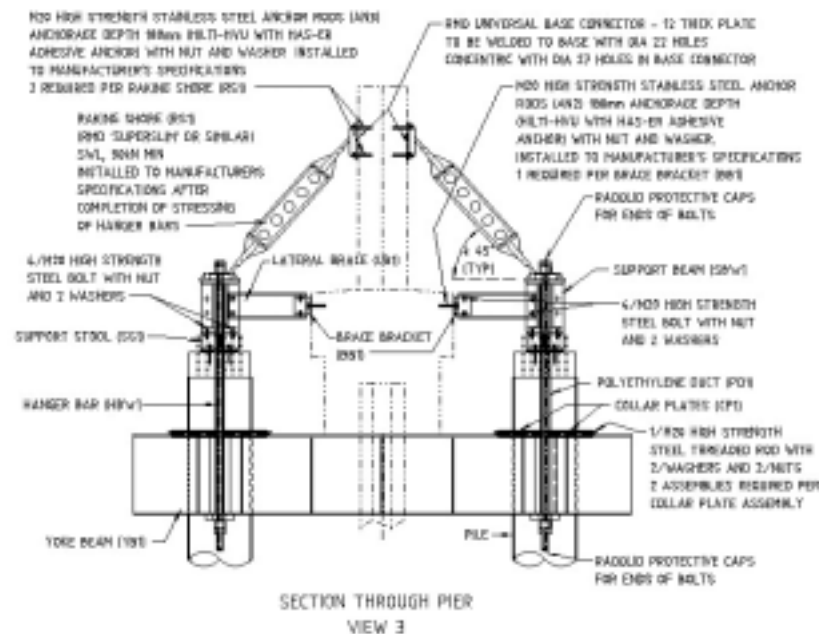
**Figure 4: Section through pier showing arrangement of supporting system**

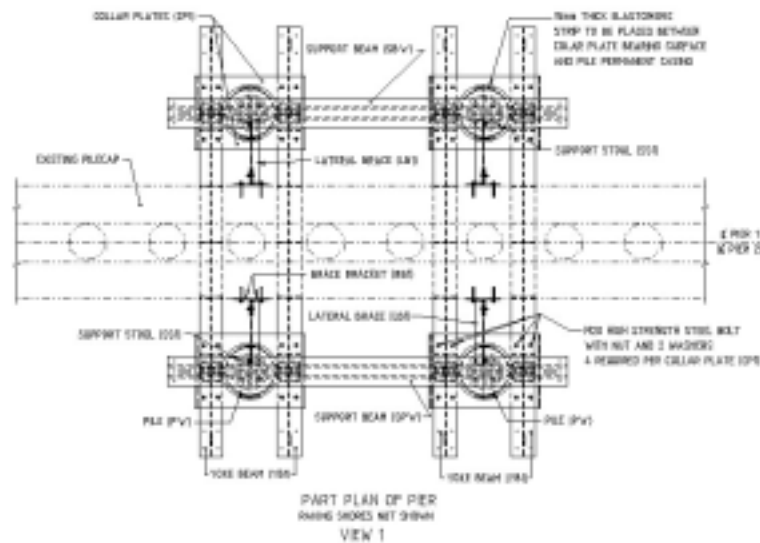
**Figure 5: Part plan of the supporting system for the pier**

The structural system for underpinning the piers consists of 8 pairs of new piles alongside each pier and a system of structural steel support and yoke beams. The location of existing piles was surveyed and the layout for the new piles chosen so that the yoke beams could be easily installed in the gaps between the existing octagonal piles. A pile configuration to suit readily available steel casing (610 mm outside diameter) was selected and each pile casing was driven to rock through access holes created in the deck. Rock sockets under each pile were then excavated and after cleaning, reinforcement cages were installed and concrete poured to required levels.
