# **Suitable Intervention Strategies for Structures Affected by Alkali-Silica Reaction (ASR)**

*Alan Carse*  
**Structures Division**  
**Queensland Main Roads**

## **SYNOPSIS**

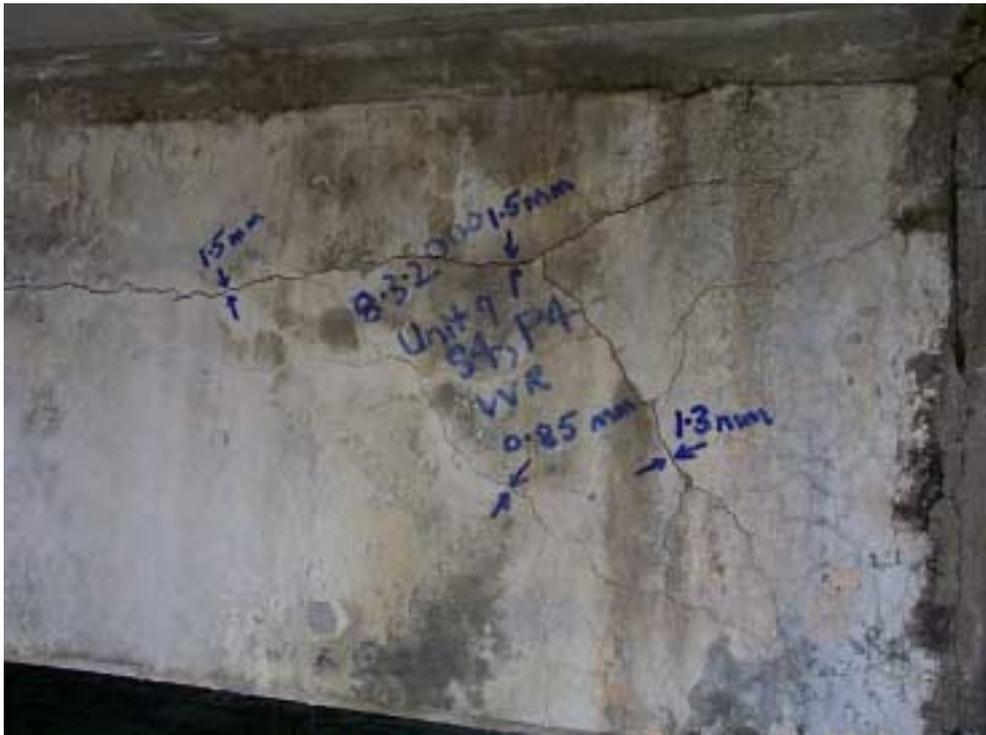
Inspection of the deck units indicated cracking was severe at each pier location and generally for 1500 mm each side of the piers (see Fig's 1 and 2). This is presumably due to the flow of water through the footpath and leakage at the pier joints. Subsequently the water will travel along the unit soffits and discharge from the units into the creek over the measured distribution length. Table 1 summarises my broad assessment of the crack widths along the Western and Eastern sides.

Examination of the data in Table 1 shows the maximum crack width on the vertical faces of the units increases away from the central pier in each direction. The largest cracks were identified in the vicinity of the Pier 1 at the Southern end of the bridge. This structure runs in a North - South direction. The type of cracking observed was map cracking at the ends of the units and longitudinal away from the transmission length of the tendons ( approx. 600 mm). This type of cracking is typical of alkali-silica cracking however the size of the maximum crack width of 2.5 mm is very severe in this case.

**Figure 1: View of severe ASR cracking in deck units**

- (i)** Alkali-Silica Reaction (ASR) is the primary mechanism causing the observed cracking in the prestressed deck units used in the widening of this bridge in 1990.

The large cracks in the deck units (0.5 mm and above) should be sealed with a flexible silicone sealant prior to coating with Silane as defined in (c) below. The sealant should be gunned into the cracks and pressed home with a spatula etc. The object is not to fill all of the depth of the crack but provide a surface barrier to the macro- penetration of chloride ions. Note this crack filling should not be done until after item (a) sealing of the footpaths.

The deck units should be coated with Silane Cream product recently made available in the market place to act as a desiccator and as a chloride ion barrier. I believe the Cream is more appropriate due to environmental concerns with the close proximity of the Creek. Note the structure should not be cleaned by any water blasting methods as this will act to accelerate the ASR expansion.

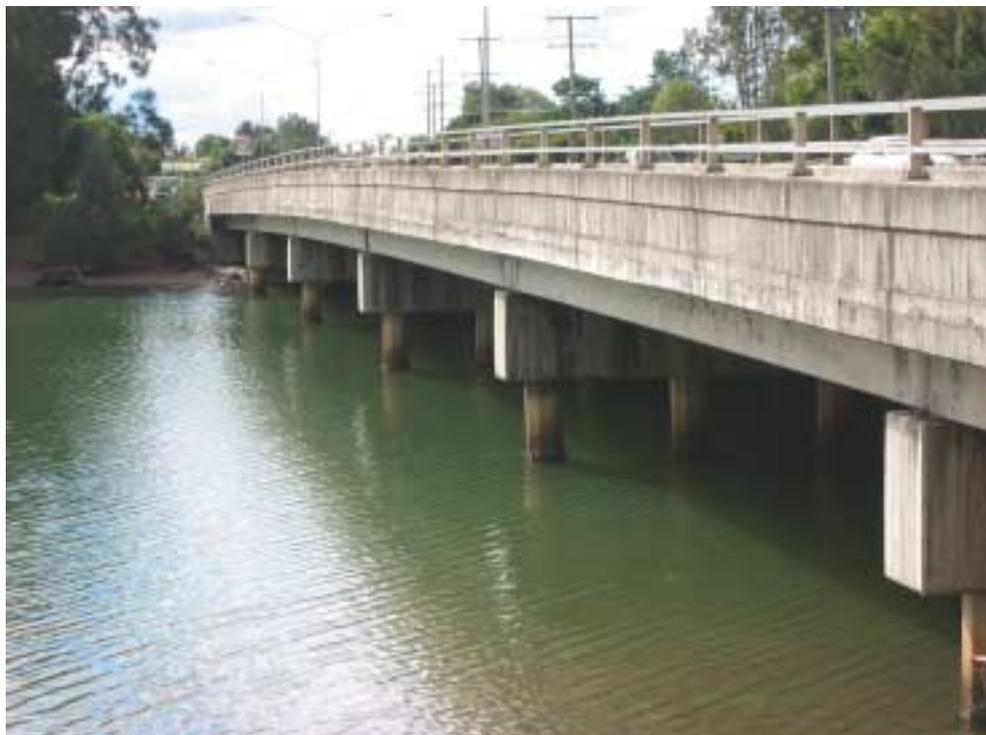
units is very close to the high water mark in the tidal creek (approx. 1000 mm clearance). This means that the deck units reside in a very aggressive environment in relation to concrete durability and hence I would classify the environment Type C in relation to the Code requirements.

**Figure 2: General view of structure and proximity to salt water**

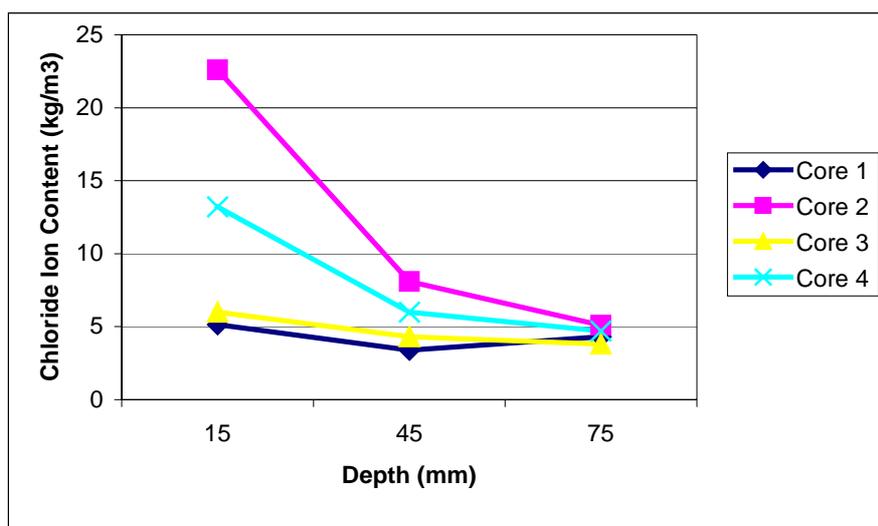
The allowable level of chloride ions in concrete is 0.8 kg/m<sup>3</sup> at the time of construction (see AS 2758.1). The threshold value for corrosion in this type of concrete is approximately 2.0 kg/m<sup>3</sup>. At the level of the prestressing steel which is close to the 45 mm depth level given in Table 4 it can be seen that the concentration of chloride ions is 2 to 4 times the threshold value for corrosion to initiate. Hence the penetration of chloride ions into this structure has been significant over the last 10 years and their concentration at the level of the prestressing strands is now critical. Examination of Fig. 3 shows the chloride ion concentration is highest on the vertical faces of the deck units, which is consistent with the associated large crack widths.

**Figure 3: Deck Unit Chloride Ion Profiles**

- (iii)** A high level of chloride ions was detected at the level of the prestressing strands. This level is between 2 to 4 times the level required to initiate corrosion. The concentration of chloride ions is highest on the vertical exterior faces of the deck units.

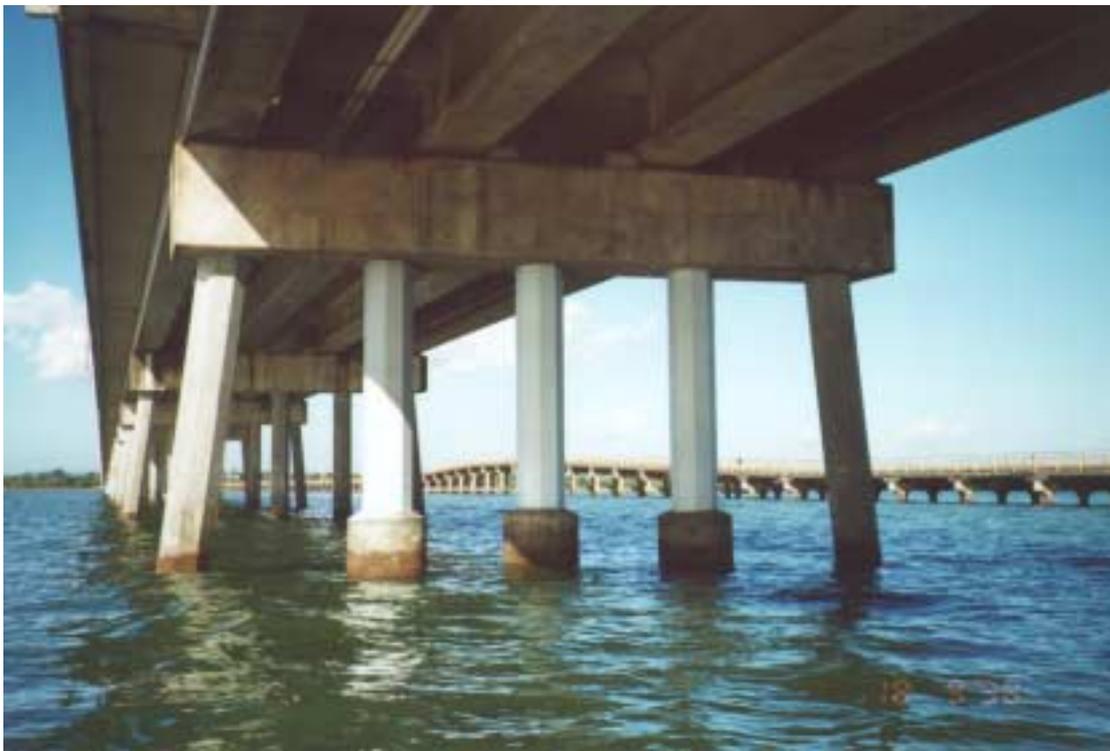
The main purpose of the wrapping carried out in (a) and (b) above was to provide a durability wrap rather than additional structural capacity. The concrete encasement was chosen for the section underwater as it would stay continuously wet and not be prone to excessive restrained shrinkage cracking. The composite fibre wrap was chosen for the section above the high water mark as it would be in a wind tunnel environment and needed to remain crack free. In addition, the appearance of the repair would be enhanced by having a slender top section leading into a thicker concrete repair in the water. Figures 4 and 5 show views of the repair system and final product where the desired affect has been achieved.

*Figure 4: View of Concrete and Fibre Composite Encasement of Piles*

- (a) Concrete encase all piles below water and to 500 mm above high water level
- (b) Composite fibre encase all piles to the underside of the headstocks
- (c) Insert linear polarization probes in selected piles under the composite fibre encasements for monitoring of corrosion currents

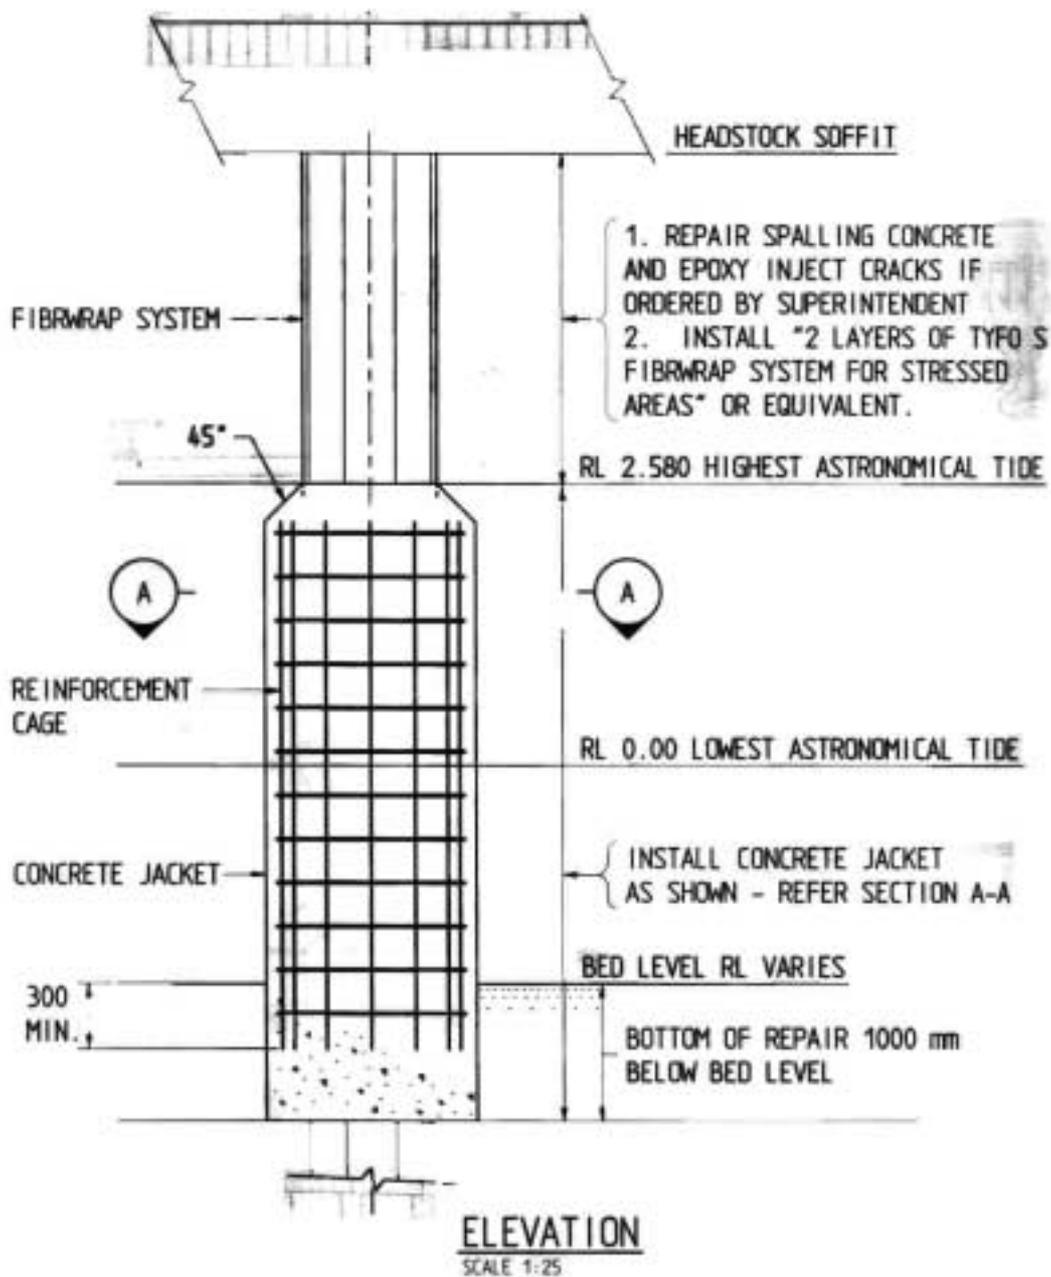
*Figure 5: View of Concrete and Fibre Composite Encasement System*
