# **Feasibility study of the life extension of a 100-year old timber truss rail bridge over the Grey River, New Zealand.**

**Rudolph Kotze, MIPENZ, Reg. Eng., AStructE**

**Walter Rushbrook**

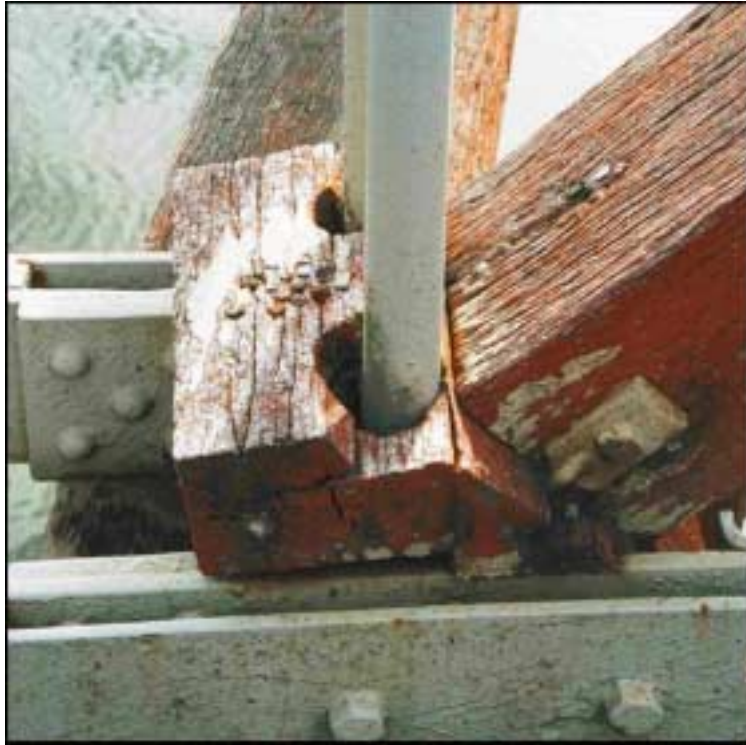
The combination of qualitative inspection and detailed structural analysis confirmed that the most critical members were transom beams, rail beams and thrust blocks. Theoretically most of these members are under-strength and have to be strengthened or replaced. Figure 5 shows the condition of a typical thrust block.

*Figure 5: Deterioration of a Typical Thrust Block*

- Strengthening of transom beams by adding steel flitch beams (Figure 8)
- Strengthening of the rail beams.
- Replacement and/or strengthening of timber thrust blocks.
- Strengthening of steel bottom cords where deterioration is becoming advanced.

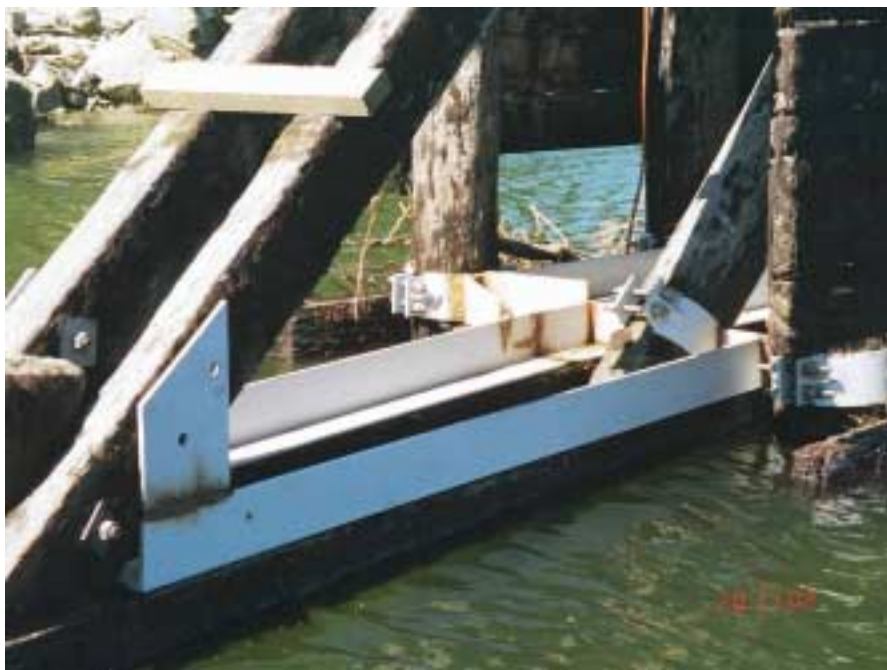
**Figure 7: Pier & Pile Bracing to increase Lateral Pier Stiffness**

- Removal of debris between piles to reduce the risk of damage during flood conditions.
- Renewal of horizontal- and knee bracing on spans to reduce the overall flexibility of the bridge superstructure.
- Removal and replacement of pier shrouding members to increase the protection of the piles under flood conditions as well as increase the lateral stiffness of the pier bracing. (Refer to Figure 7)
- Strengthening of approximately 6 piers by installing external steel cross bracing. (Refer to Figure 1)
- Strapping of piles where driven spikes have resulted in damage to piles though steel clamps in order to prevent further potential vertical splitting of the piles.

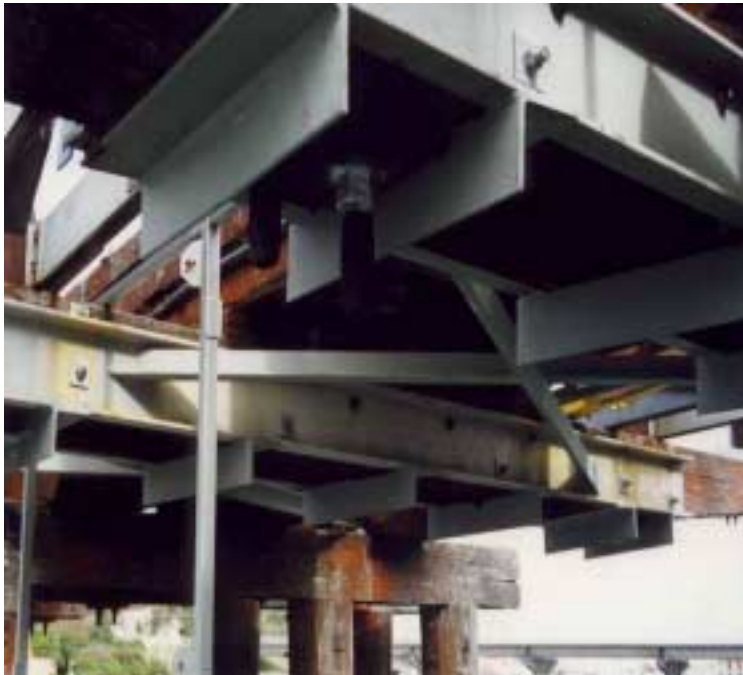
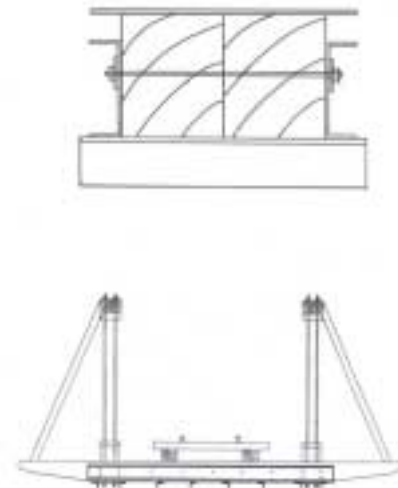
***Figure 8: Transom Beam Strengthening***
