Plank Lane Bridge

Counterweight Failure

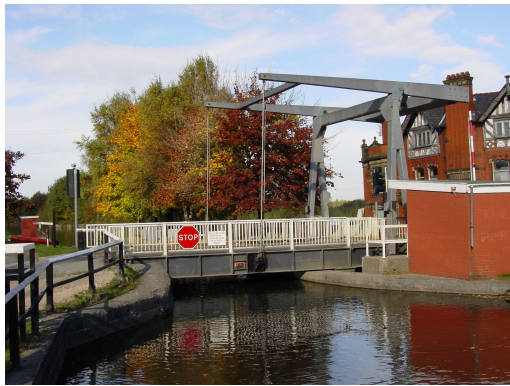
Bridge before failure

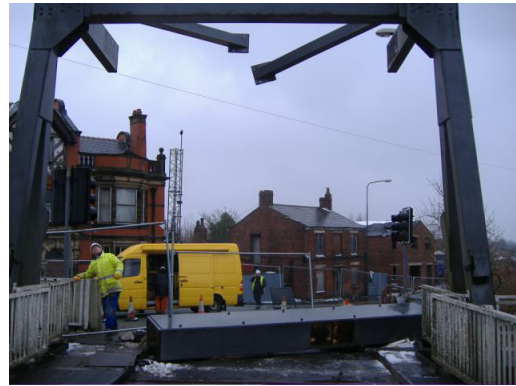
After failure with counterweight across carriageway

One of the principal connections failed as the bridge deck was going through its normal closing cycle. Initial investigations indicate that the bolts in this connection yielded in shear. The actual cause of the failure is yet to be confirmed but sequential shear failure due to uneven distribution of load between bolts, fatigue due to cyclic loading and even accidental or dynamic impact loading are all possibilities.

Once this connection gave up the other principal connection followed suit in a twisting manner with a number of its bolts yielding in tension. The secondary cross bracing connections failed at the same time and the counterweight fell to the ground.

British Waterways subsequent actions were to close all of its structures of a similar type and check them for hidden and inaccessible connections. Where these were found further investigations followed to ascertain the condition of the connections. In a couple of cases, where connections could not be immediately exposed, the bridges were kept out of service or alternative supports provided until the condition of the structures was assured.

A full review of the maintenance and inspection regime for these structures will be undertaken in due course.
