Inspection guidance for bridge expansion joints

Part 2 – Inspector's Practical Guide

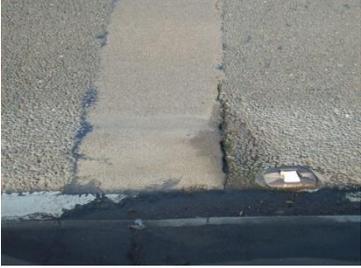
<i>(Courtesy of Transport Scotland)</i>	The outlets to the drainage are slightly blocked, but there are only very minor signs of ponding on the carriageway by the expansion joint.
3

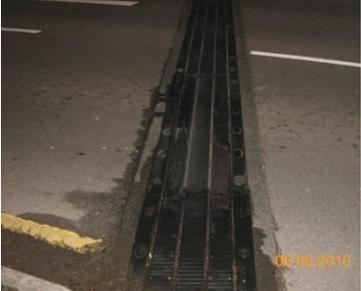
Surface water on the carriageway is significant. The drainage outlets are almost fully blocked (>75%).
5			Joint drainage is completely non-functional. Ponding is severe. The drainage outlets appear blocked.

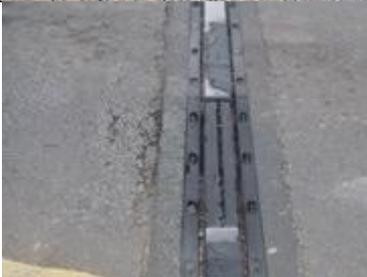
There is some cracking or break-up, but it is not affecting ride quality, or exposing any part of the joint. Cracks are narrow and shallow (maximum depth 25mm).
3	Moderate break up of road surface adjacent to joint

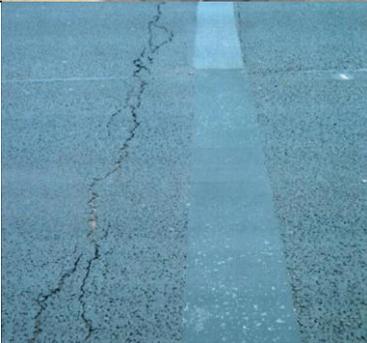
The road surface is significantly cracked, but there are no pot-holes, nor is any part of the joint exposed. Crack depth is not deeper than 50mm.
4	Major break up of road surface adjacent to joint

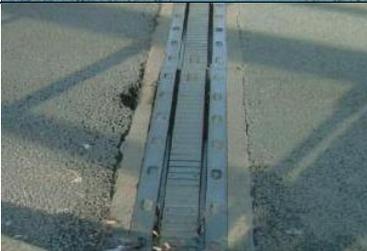
The cracking is such that pot-holes are expected to form shortly. The joint or nosing is becoming exposed. The depth of the cracking is less than the depth of the surfacing.
5	Joint failure due to deteriorated condition of adjacent road surface

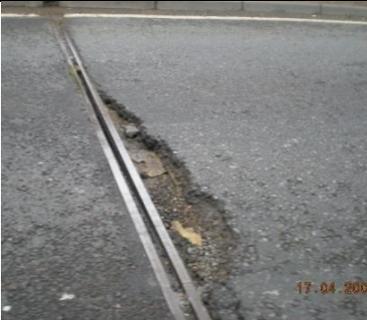
The surfacing has disintegrated, exposing the nosing or joint component. There may be leakage. The disintegration is to the full depth of the surfacing.

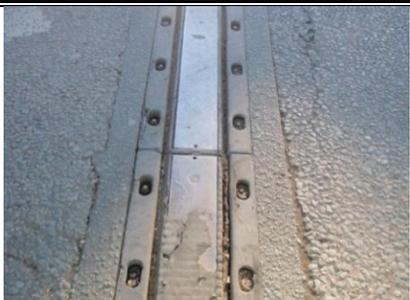
The elastomeric caps on the bolts protect them from corrosion and vehicle impact, but they regularly come free. The extent rating should be used to indicate proportion missing.
3	Fixings loose

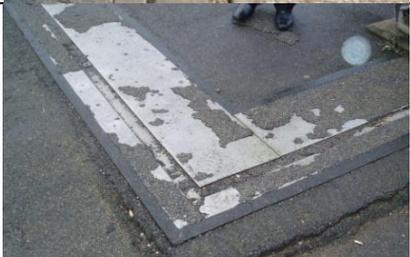
Fixtures are all still attached, but there is at least one example of a loose fixing, but this is not causing a failure or danger to road users.
4	Fixings missing, plates and angles loose

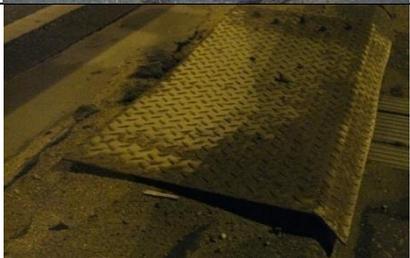
Fixtures are missing or loose, but are not causing failure of the joint or a danger to road users/pedestrians. In this example, the plate is bent, leaving a trip hazard at the edges.
5	Failure due to missing fixtures

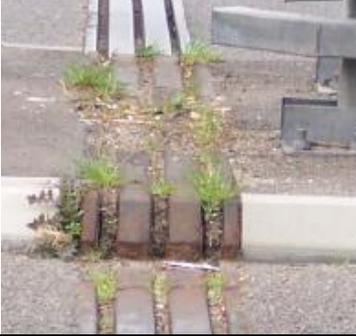
Vegetation is growing from the joint, and accelerating deterioration of the joint.
4			It is considered that vegetation will not cause a defect of severity four or five.
5

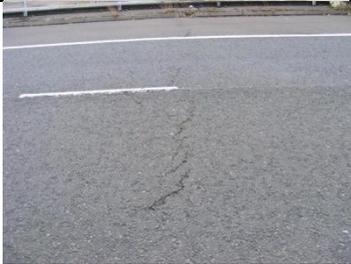
<i>(Courtesy of Transport Scotland)</i>	There are some cracks in the surfacing over the joint, but these cracks are very narrow and shallow (maximum depth 25mm).
3	Moderate surface cracking

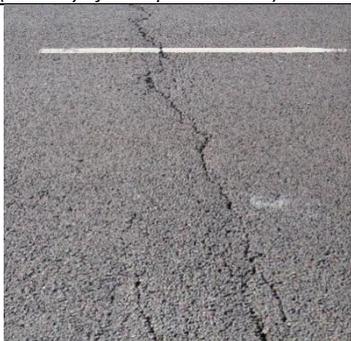
Cracks are clearly visible, up to 5mm in width at the extreme. The depth of the cracks is less than 50mm.
4	Major surface cracking

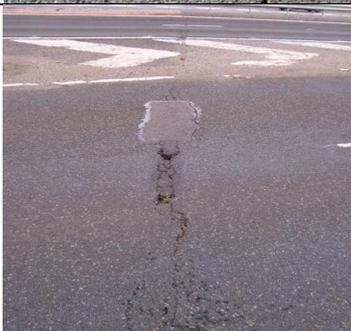
<i>(Courtesy of Transport Scotland)</i>	Cracks are developing, up to 25mm in width at the extreme. The depth of the crack is less than the depth of the surfacing.

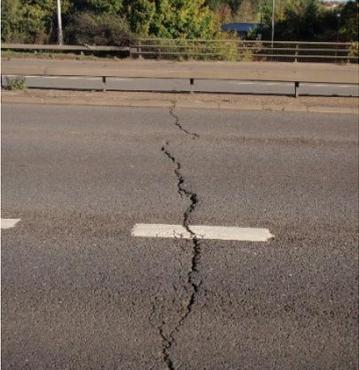
5	Failure

<p>The width of the crack is greater than 25mm and the depth is similar to the depth of the surfacing. The surfacing around the crack is breaking up. There is evidence of leakage.</p>

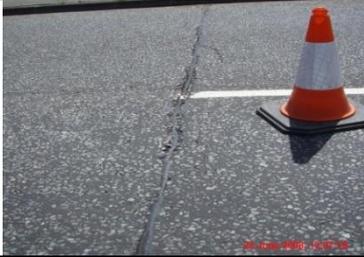
The seal has some cracks, which are narrow and short and do not affect the integrity of the seal. The seal has not been pushed upwards to any noticeable degree.
3	Moderate cracking or break up of sealant for induced crack		The cracks are clearly visible, or some of the seal is unbonded. It is still generally functional. There is no evidence of leaking.
4	Major cracking or break up of sealant for induced crack

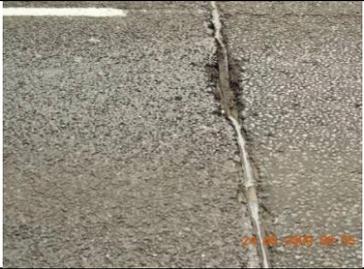
There is major cracking or break up of sealant, so it can no longer be considered fully functional.
5	Disintegrated or missing sealant for induced crack

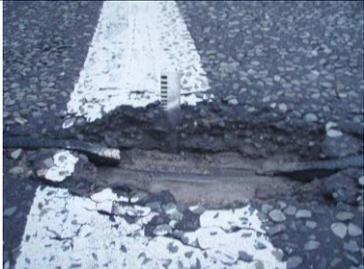
The seal is completely missing at some point causing break up of the adjacent but unsupported surfacing. There is evidence of water leakage.

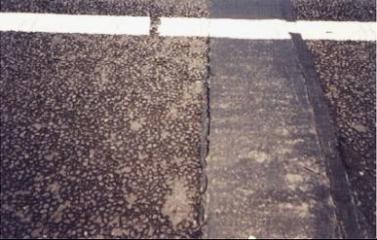
The plug has debonded from the surfacing at some point across the carriageway, but the gap is still fairly narrow (1-2mm). The depth of the debonded area is maximum 25mm. The adjacent road surface remains in good condition.
3	Moderate debonding between plug and road

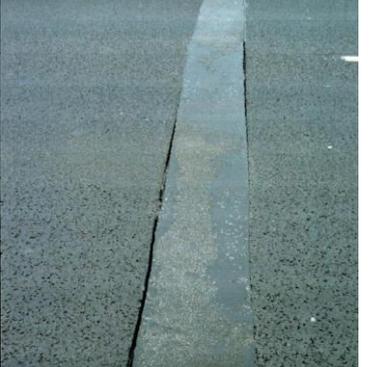
The debonded gap is now greater, and there are visible signs of the adjacent surface breaking up because it is now clearly unsupported. The gap is greater than 5mm wide but the depth is less than that of the surfacing. There is some leakage evident.

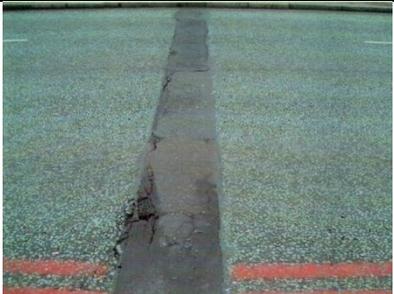
There is significant loss of material, with penetration up to 50mm. Ride quality is affected, and noise is produced.
4	Loss of material from joint (causing holes >50mm deep)

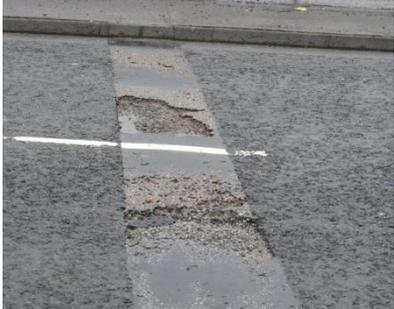
<i>(Courtesy of Transport Scotland)</i>	There is serious loss of material, with holes greater than 50mm in depth. There is some leakage evident.
5	Missing		Some of the joint is missing to the full depth of the plug, or the plug is broken up as a result of missing material. The joint is leaking.

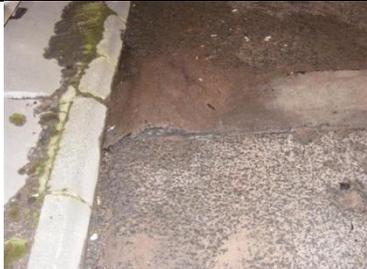
<i>(Courtesy of Transport Scotland)</i>	Slight depressions in the plug are visible on inspection, but are not significant, or some plug material has flowed beyond the boundary. The effect is purely aesthetic.
3	Moderate tracking and flow of binder

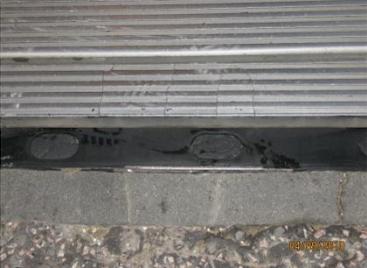
Cracks in the transition strip are visible on close inspection, but are having no effect on joint functionality.
3	Moderate cracking along nosing, some break-up

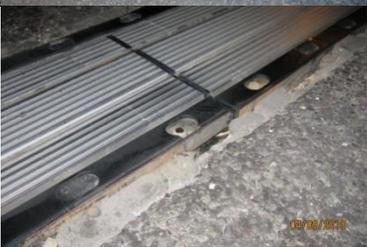
Cracking has developed sufficiently that the transition strip has broken up; with some material missing from the strip. The joint component is becoming exposed.
5	Disintegrated

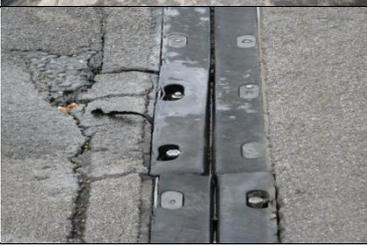
The nosing material is beyond isolated areas of break-up; it has disintegrated, leaving other elements of the joint exposed. The joint is leaking.

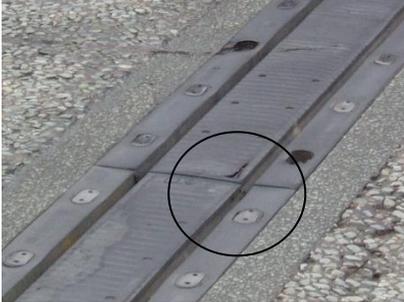
Cracks or tears are visible. They are hairline and will require careful inspection to detect.
3	Crack/tear <20% of width of component

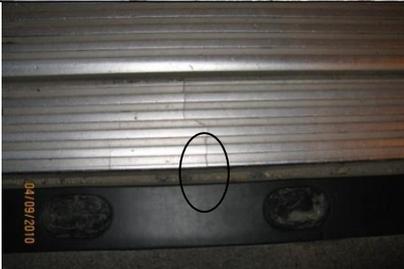
Cracks and tears are easily visible but the joint is still able to function.
4	Crack/tear >20% by <50% of width of component

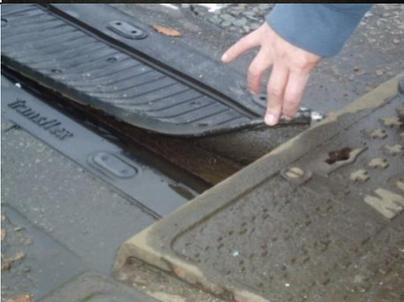
Cracks and tears are significant, but there remains some limited functionality. The steel in the plates is exposed. Complete failure can be expected shortly.
5	Failure of expansion joint component

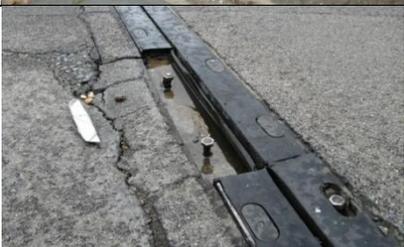
A component of the joint has completely failed. Part of it has detached or is missing. A steel plate is loose or missing.

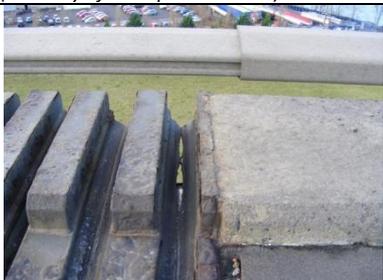
<i>(Courtesy of Transport Scotland)</i>	The seal has some cracks, or very minor tears or breaches but is still able to function to a large extent. The defects require close attention to see. There is a small amount of debris in the seal.
3	Sealant breached, strip sealant breached

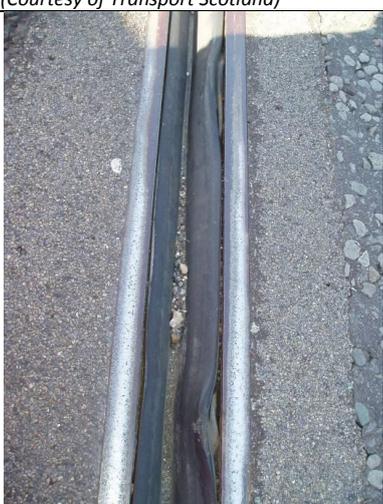
The seal is visibly breached, allowing some water through the joint. There is a small amount of debris in the seal.
4	Sealant missing, strip sealant missing/out

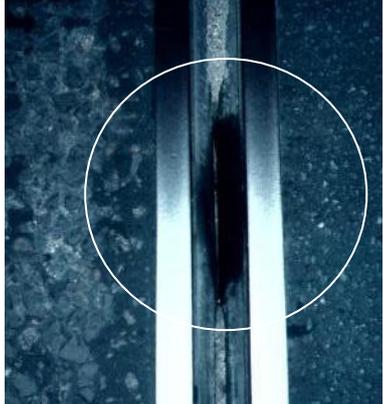
The seal is missing or significantly breached at least at some point across the joint. It does retain some limited functionality but there is evidence of water leakage. The seal is holding a significant amount of debris.

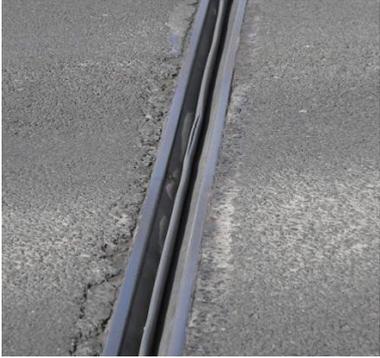
5	Failure

<p><i>(Courtesy of Transport Scotland)</i></p>	<p>The seal is missing or sufficiently disintegrated to allow large amounts of water to flow through the joint. The seal is full of debris.</p> <p>(In the example to the left, the seal is completed detached from the metal rail on the right-hand side)</p>

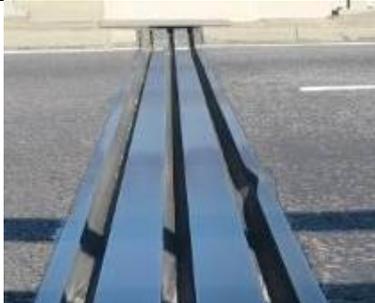
A rail is clearly deformed, but is still able to function safely. There is no vertical deflection of the rail.
4	Crack/tear >20% but <50% of width of component

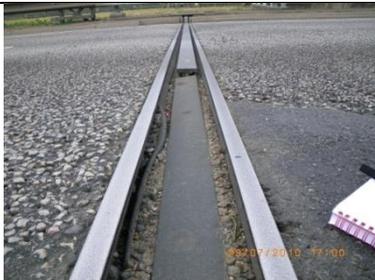
A rail has completely cracked, is missing, has dropped due to failure of the supporting mechanism below or there has been significant upward deflection of the rail, which is now likely to be pulled up by passing vehicles.

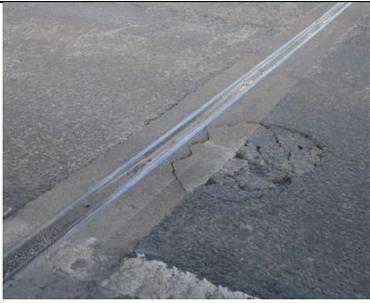
<i>(Courtesy of Transport Scotland)</i>	Isolated areas of the resin have broken up, leaving parts of the rails unprotected and some of the adjacent surfacing unprotected.
5	Disintegrated

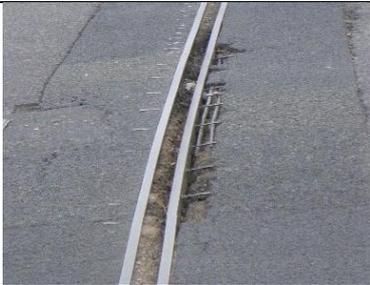
The resin has disintegrated sufficiently to expose the reinforcement embedded in the resin, as well as leaving the rails unprotected. The joint is leaking.

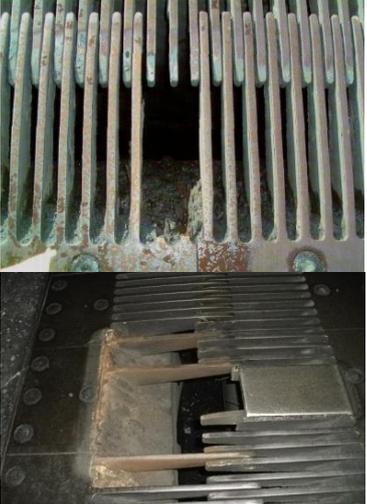
At least one tooth has fractured, or the teeth are sufficiently misaligned so that movement will cause interference, or there is a crack in the metalwork. Corrosion has caused a serious loss of section of a tooth (>20%).
