# THE REPAIR OF TADCASTER BRIDGE DAMAGED BY FLOOD WATER BOXING DAY 2015

**On 29 December 2015, Tadcaster Bridge collapsed during flooding caused by Storm Eva.**

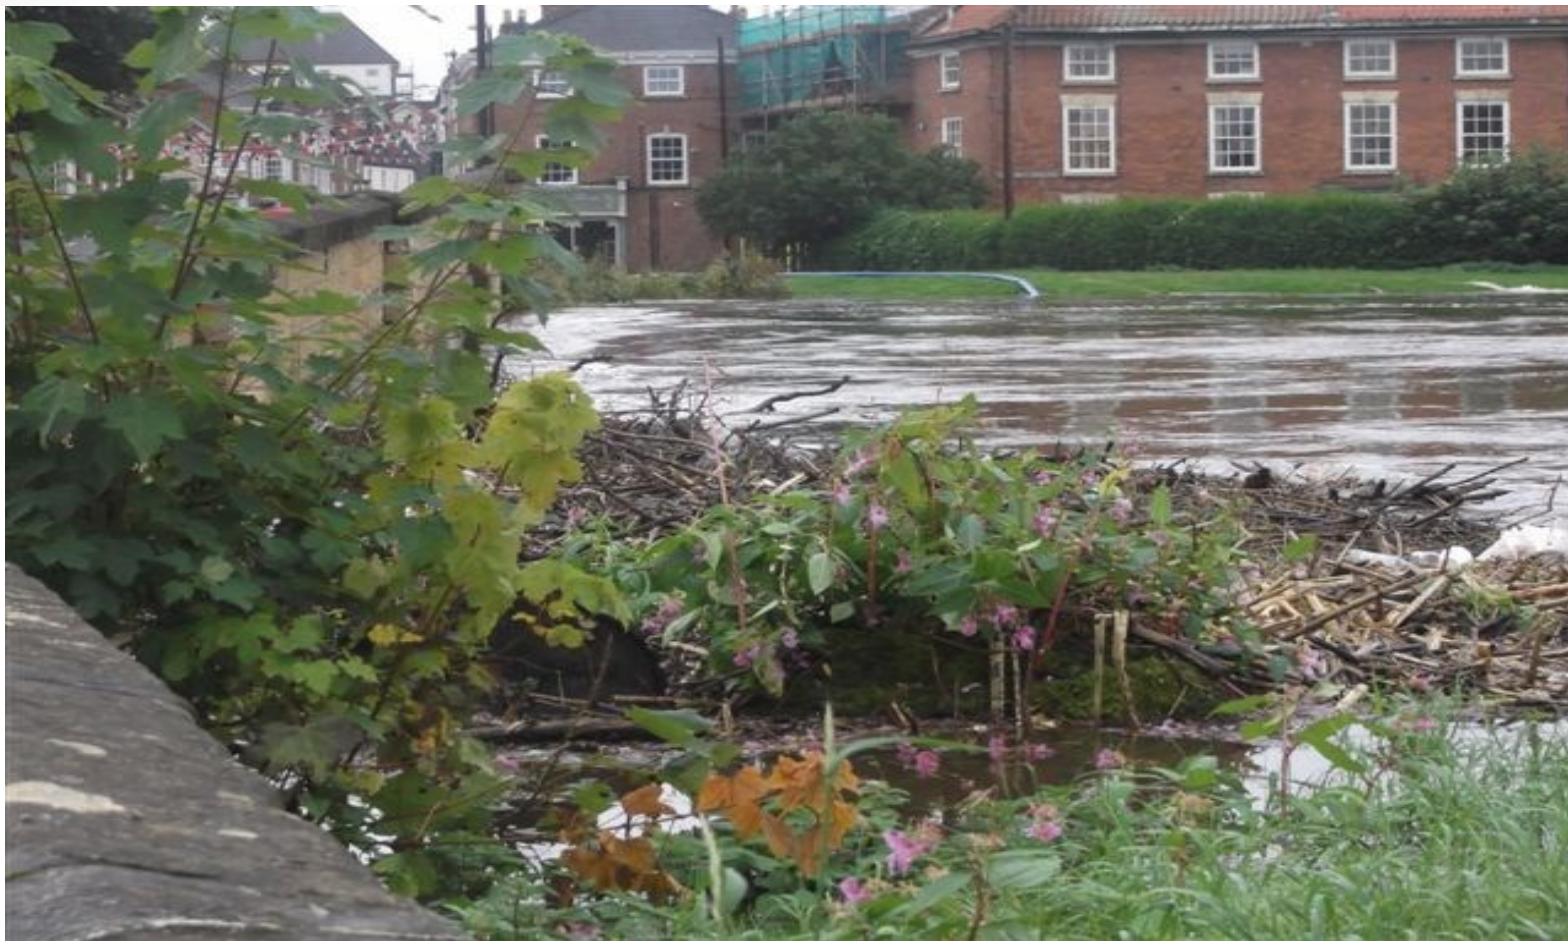
The River Wharfe had been swollen since  
September this photograph is dated 29/09/2015

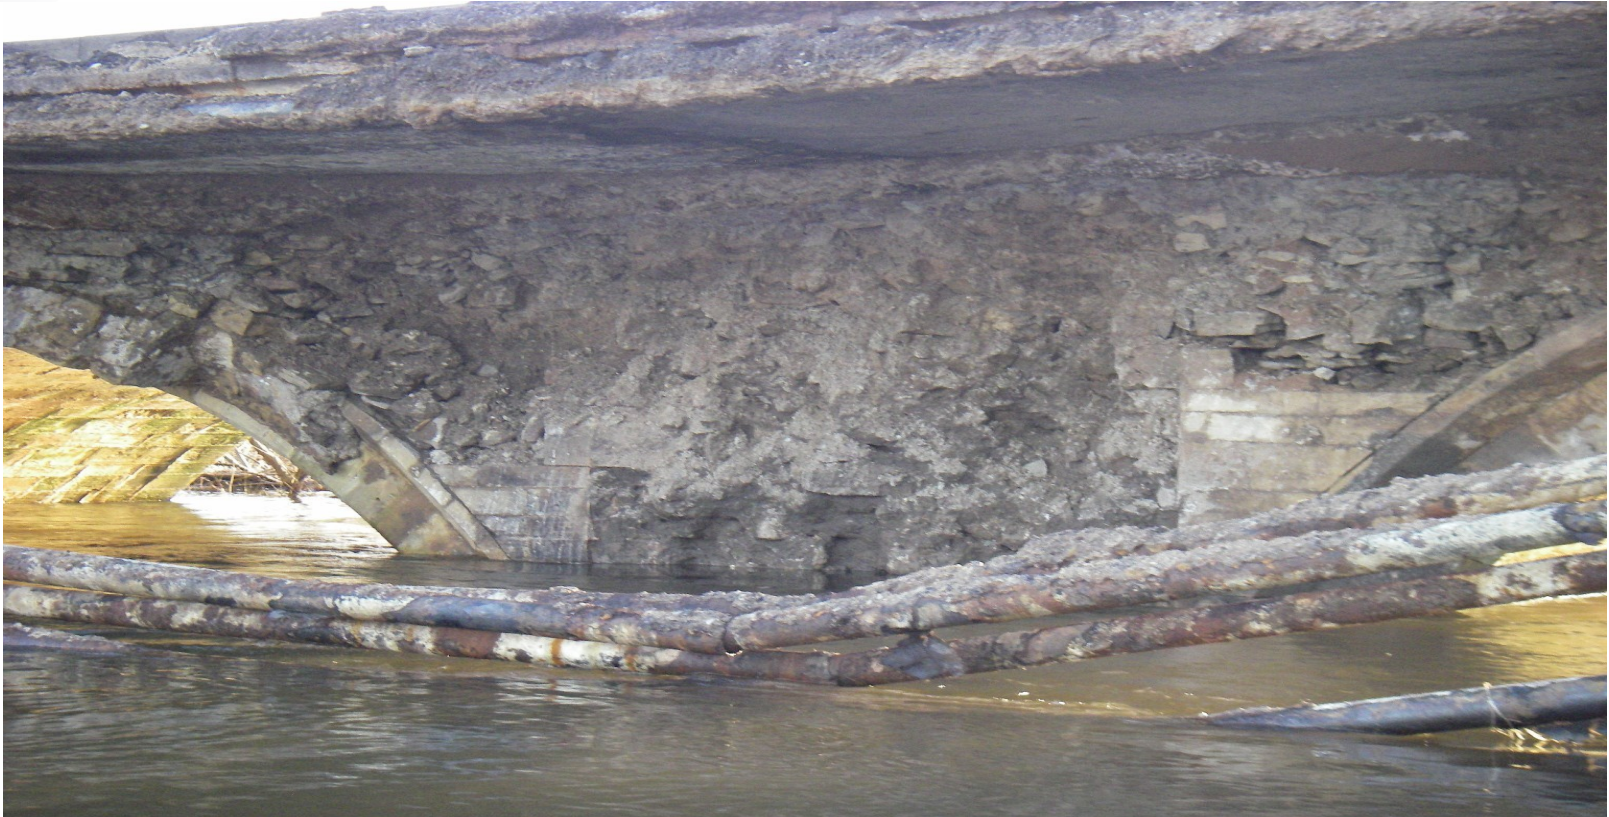
- It rained quite heavily throughout November and December and on Boxing Day 2015 the bridge partially collapsed due to the scour of pier number 3 in the main river flow.

- The collapse of the pier stripped the support of the two arches back to the downstream side of the bridge which remained intact, but we did not know if the pier in the photo was undermined. So we sent in the divers when the water levels dropped to carry out an inspection

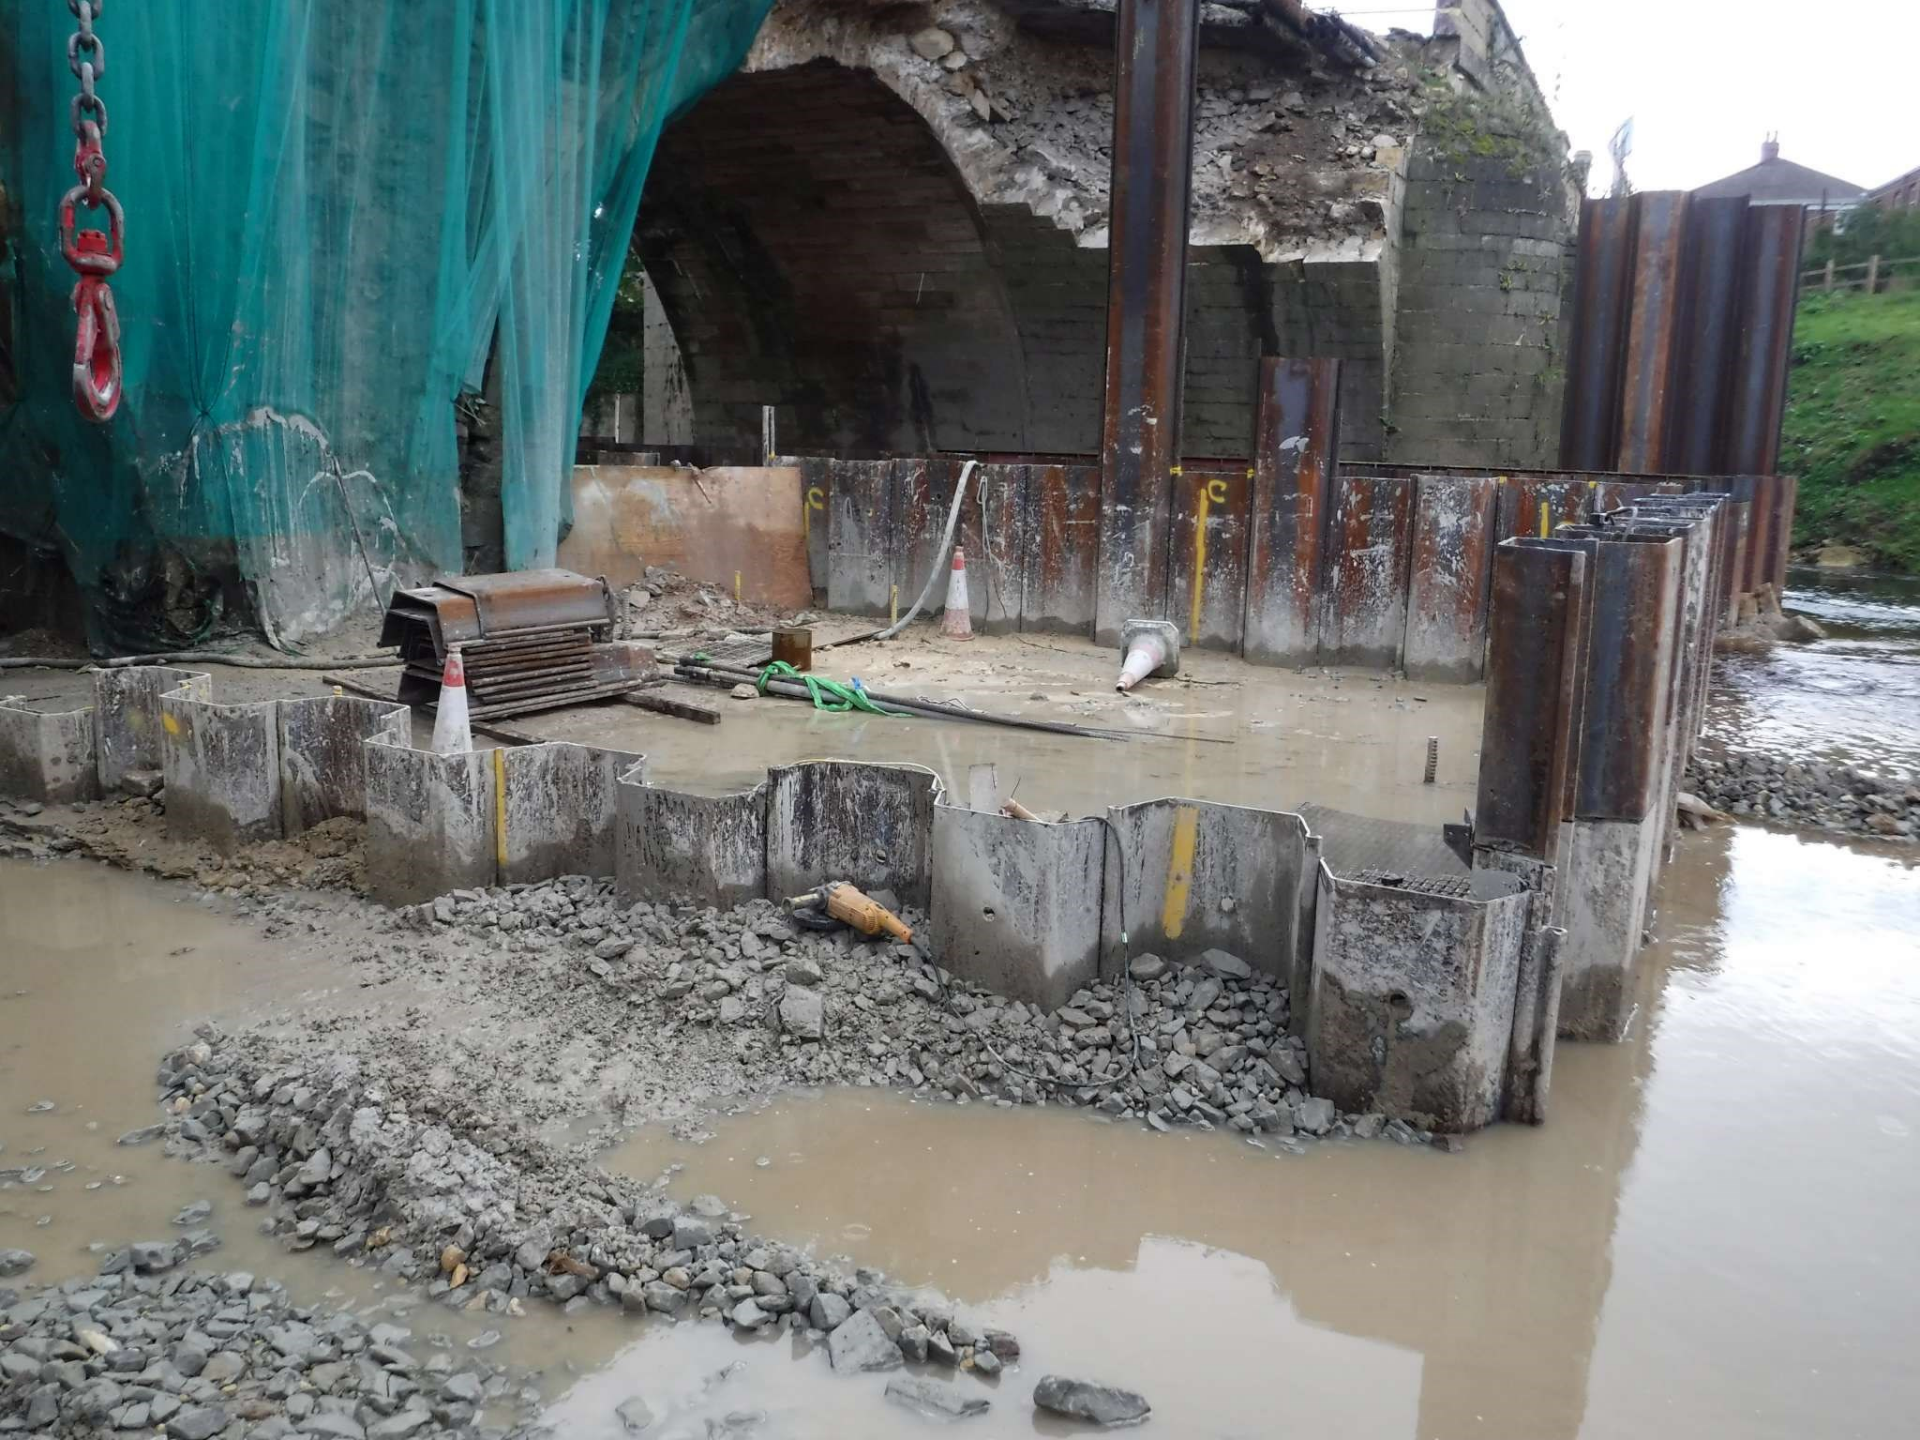
- Immediately after the flood receded we commissioned a hydrology report and a study of the river.
- We needed to confirm how the bridge had been damaged so that we could decide how to protect the bridge in future events.
- JBA Consultants produced a report and modelled the river flow around the bridge.
- Contrary to the general mood of the time the bridge was not the dam in the river.

- The river downstream was naturally backing up and forming a standing wave which was acting of a wall of water causing the water travelling down the river to crash into it and tumble.
- This is a similar action to the one you can see at the beach the surf rises because of the energy from the out going wave causing it to rise, here we have the reverse, high speed water is forced downward eating into the river bed.

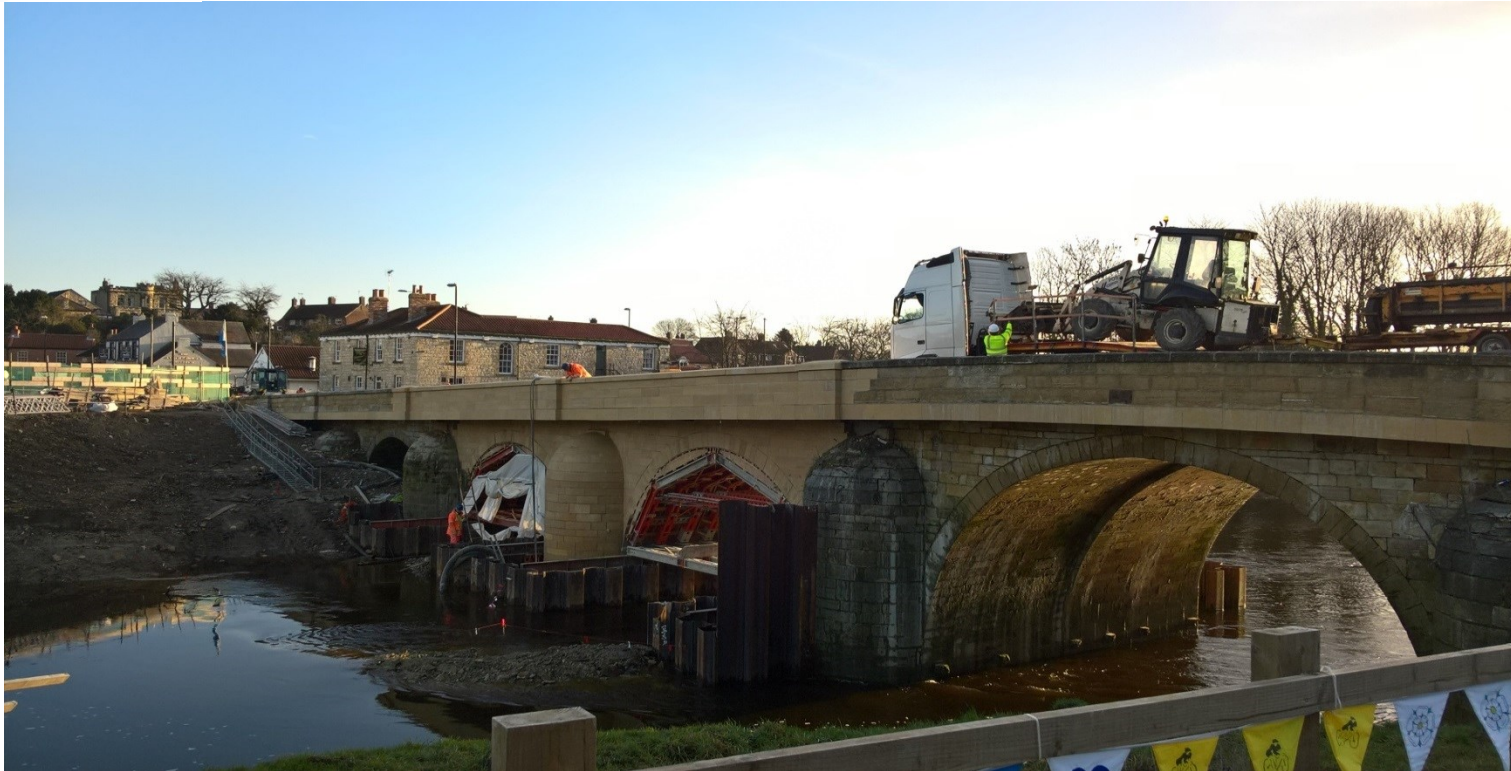
- Damage found after the flood January 2016

- Designed the widening of the structure.
- Applied for List Consent and Planning Consent.
- Project managed the rebuilding of the bridge.
- Designed precast concrete slabs to form the cantilever when delays due to river levels and masonry supply left no time for the convention slab to be used.

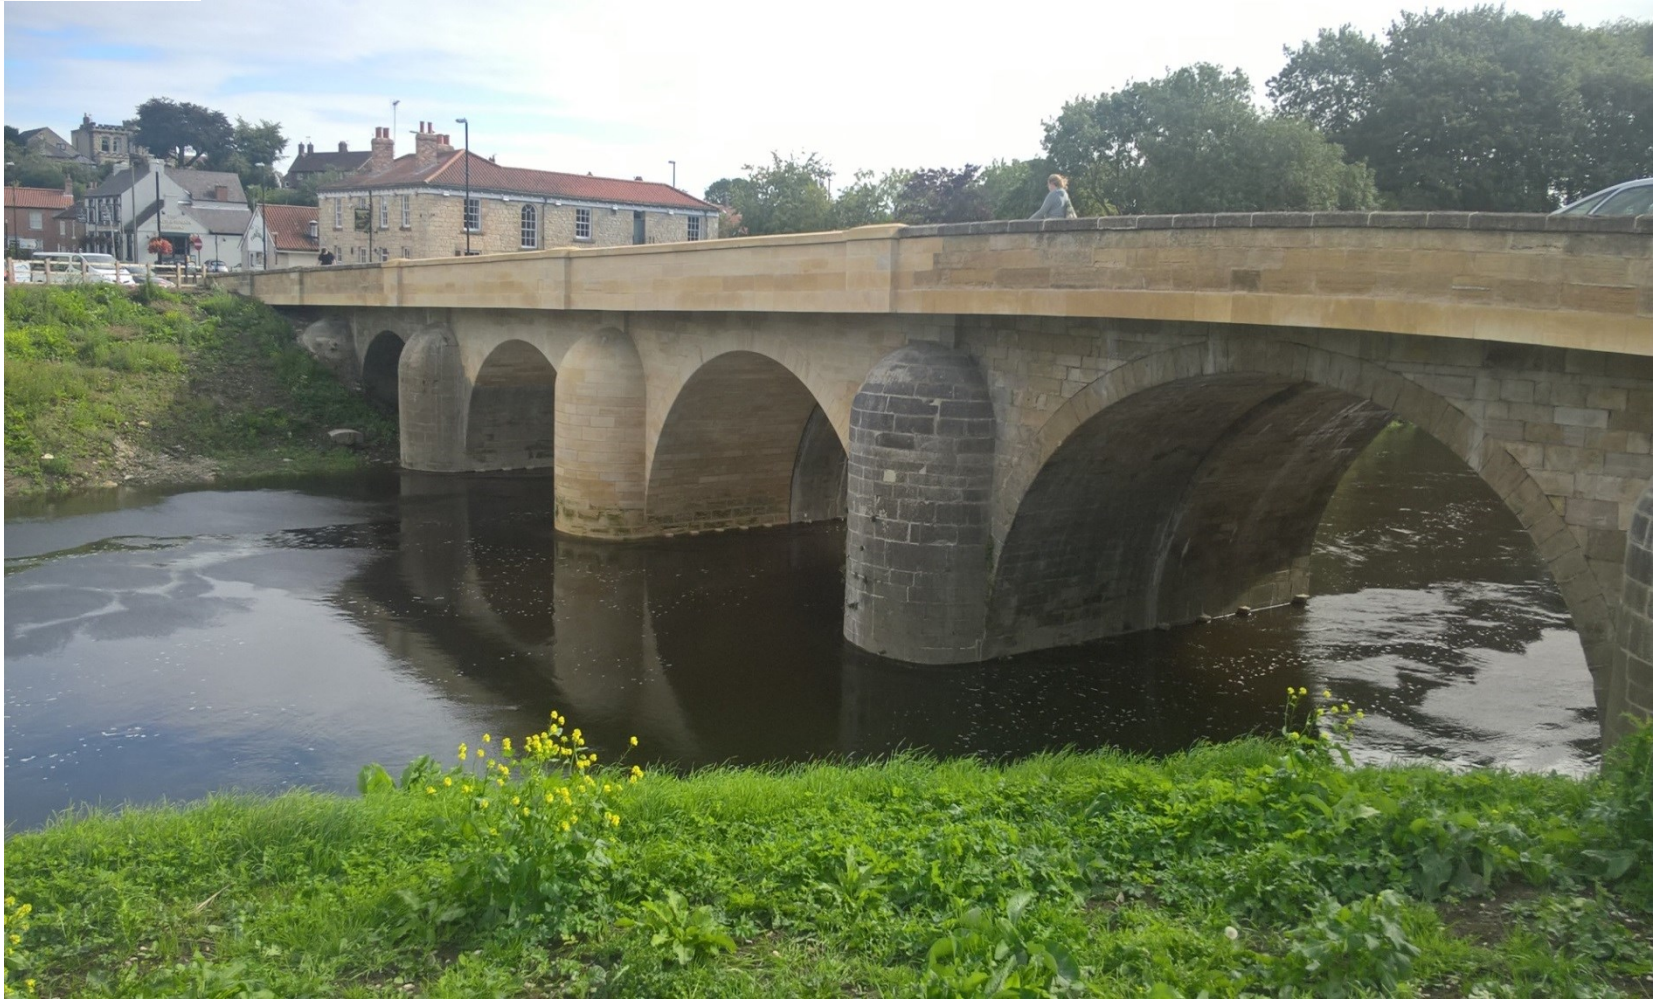
- The complete elevation.
