Rehabilitation of Willaston Bridge: Utilization of Rivet Heads as Shear Connectors

*Alistair Paul, BE MIE Aust. CPEng
Senior Design Engineer, Transport SA*

*Associate Professor Deric Oehlers and Dr Rudolf Seracino
Centre for Infrastructure Diagnosis, Assessment and Rehabilitation
School of Civil and Environmental Engineering, The University of Adelaide*

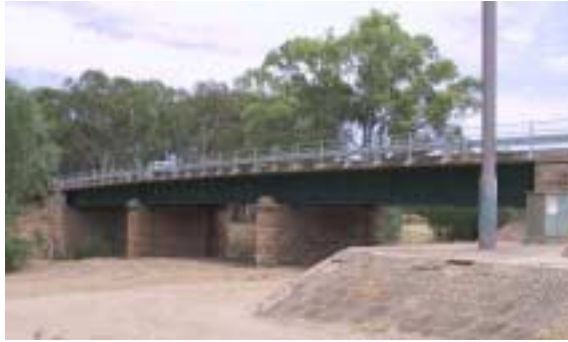
Figure 1: Elevation of Bridge

The Willaston Bridge at Willaston, S.A. crosses the North Para River and provides a Northern access to the Township of Gawler. It comprises three simply supported spans of 18.8m and was built during 1890 using five riveted wrought iron plate girders per span (Figures 1 and 2). The original timber deck was replaced with a non-composite reinforced concrete deck during 1956, which was cast on top of the girders with the top flange rivet heads embedded in the deck concrete.

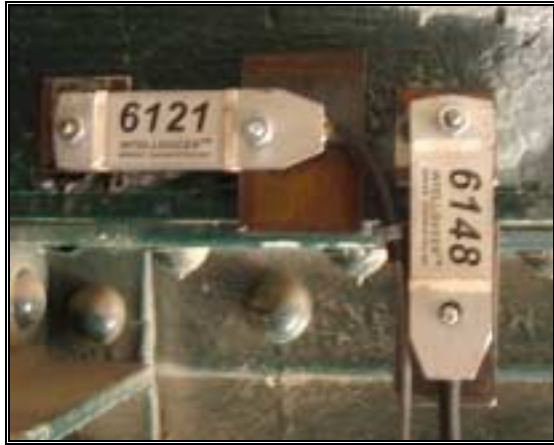
Figure 3: Transducers Measuring Slip and Separation

Slip and separation across the concrete/girder interface were measured at quarter span and near the girder ends using strain transducers across the interface (Figure 3).

Extremely low values of slip and separation were measured – the maximum slip was 0.02 mm while the maximum separation was 0.01 mm. This seems to conflict with the finding of

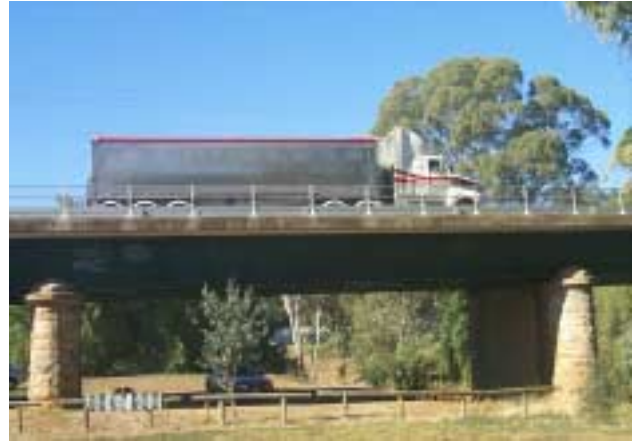
Figure 4: Test Vehicle on Bridge

A “legal” 43.5 tonne six axle semi-trailer with measured axle loads and spacings was used as a test vehicle. It was used to load the bridge without any other traffic present (Figure 4).

It crossed the bridge along three different tracks: adjacent to a kerb, adjacent to the carriageway centreline and along the centreline. The superposition of the first two tracks allowed the results for two trucks on the bridge simultaneously to be determined, enabling the live load distribution to be determined. Two speeds were used – crawl speed and “normal” driving speed for the road geometry – to enable the dynamic load allowance (DLA) of the bridge to be determined.

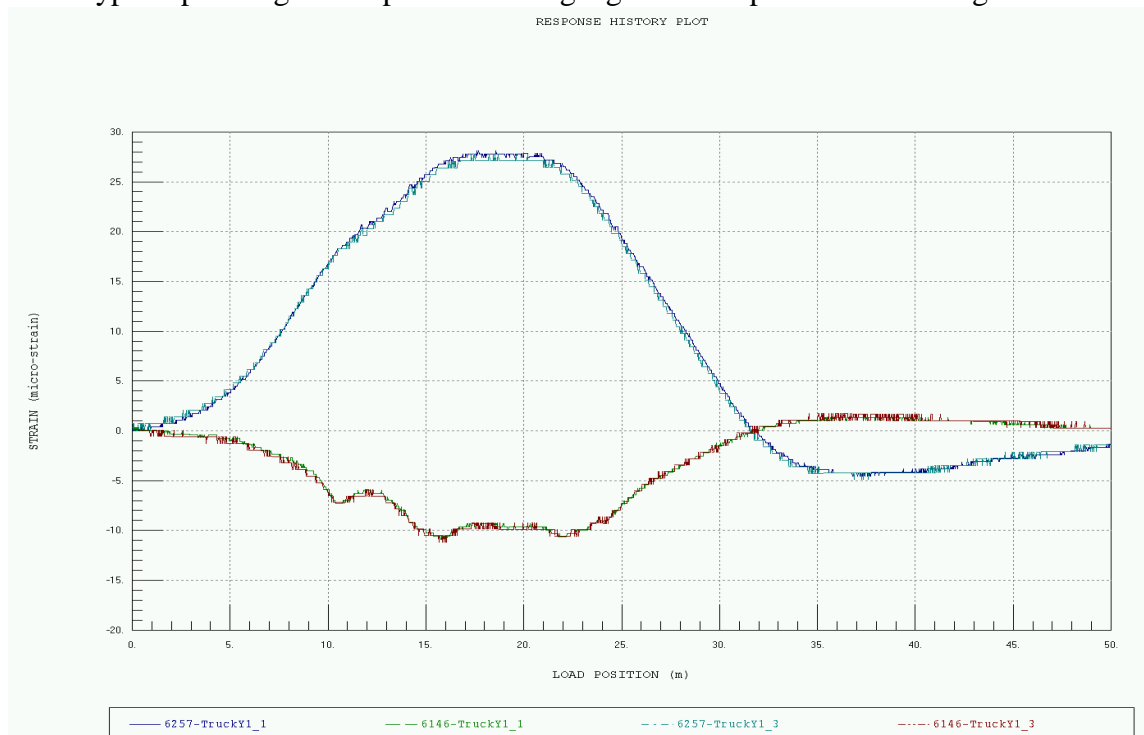
Figure 5: Typical Transducer Output Showing MidspanTop and Bottom Strains vs Truck Position

The transducer outputs were fed into a lap top computer loaded with specialist software, which was able to produce plots of strain versus truck position for all transducers. Figure 5 shows a typical plot of girder top and bottom gauges at midspan of the centre girder.

The neutral axis locations in the girders were found to be above the girder mid-depth in all cases, but generally lower than expected for full composite action, indicating that a variable degree of composite action was occurring. Girders that were directly loaded by a wheel line appeared to behave more compositely than those distant from a wheel line. Similarly, outer girders, which support more dead load than inner girders (due to kerbs, barriers and a footpath), appeared to behave more compositely than inner girders. The most plausible explanation for this is that these girders were subjected to a higher interface normal force, enabling the rivet heads to transmit higher interface shear flows. However, the fact that the degree of composite action was variable indicated that it could not be relied upon when estimating the ultimate limit state girder moment capacities.

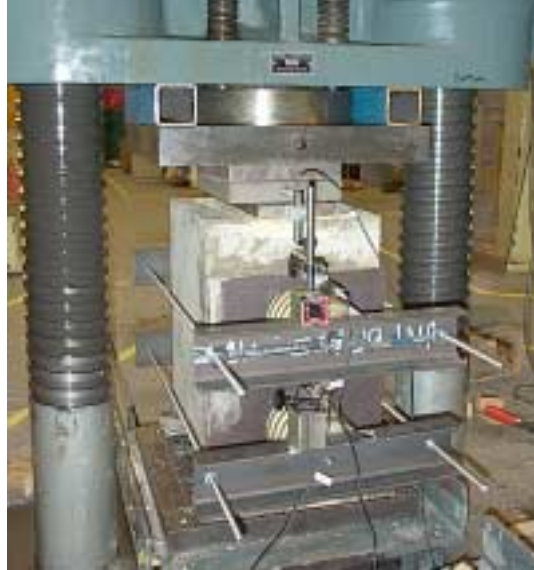
Figure 8: Spring Loaded Test Setup

Six tests were undertaken in this series where the interface normal compressive stress was induced by springs as shown in the photograph of the test set-up in Fig. 8. This test series was used to investigate the behaviour of the interface under a range of normal compressive stresses simulating the actual condition of the bridge.

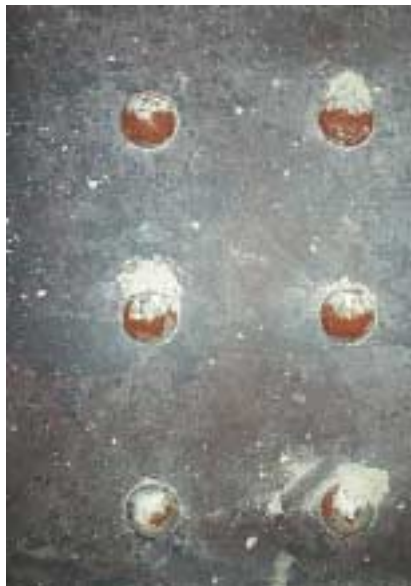
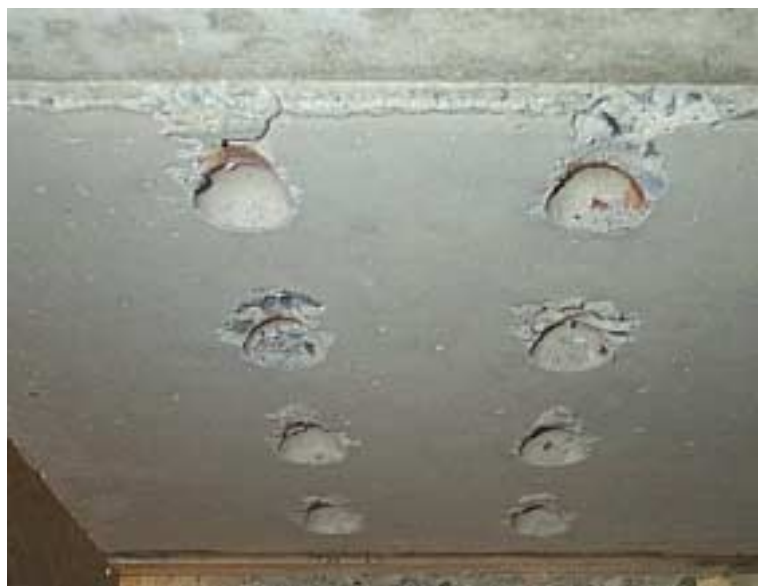
Figure 10: Typical Failure of Spring Loaded Tests

at a slip of less than 0.5 mm. As expected, the maximum longitudinal shear resistance increases as the interface normal compressive stress increases. Photographs of the plate with rivet heads and concrete after failure are shown in Fig. 10.

(a) Plate with Rivet Heads

(b) Concrete

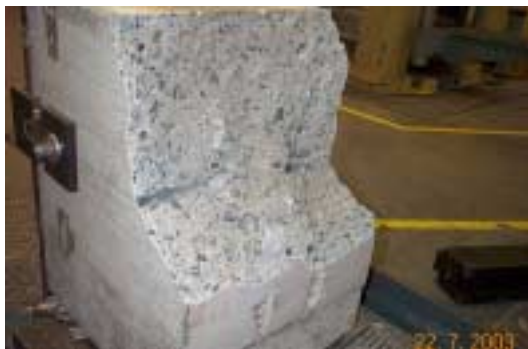
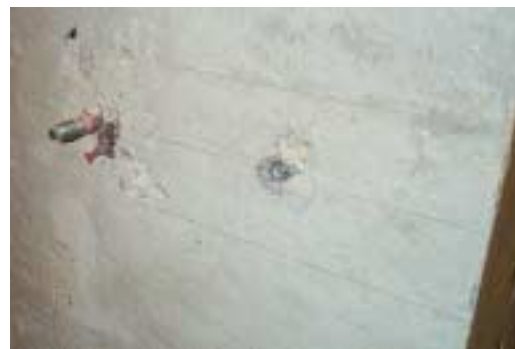
Figure 12: Failure Modes of Bracket Tests

A 10mm diameter threaded positioning bolt was used to locate the bracket on the steel flange of the girder as shown in Fig. 11. The anchor bolts used to attach the bracket to the side of the concrete haunch, also shown in Fig. 11, were 12mm diameter *Hilti HAS-E Threaded Anchor Rod* with *Hilti HVU Adhesive Capsule* and *Hilti Dynamic Set Washers*. The brackets were machined for the experimental tests to produce a “dog-bone” shape shown in Fig. 11, so that the force in the bracket could be accurately determined. The edge distance of the anchor bolt to the concrete-girder interface was found to influence the failure mode of the clamping system as illustrated in Fig. 12.

(a) concrete splitting (100 mm edge distance) (b) anchor bolt shear (125 mm edge distance)

The spring loaded tests confirmed the presence of longitudinal shear forces along the concrete-girder interface that results in the composite action observed in the load tests of the Willaston Bridge. However, the tests also demonstrated that shear resistance decreases rapidly once the peak shear force is attained at a very small slip. Hence, a second series of tests was developed to investigate strengthening alternatives to increase the longitudinal shear strength and improve the ductility of the interface so that a reliable moment capacity could be determined using standard partial interaction theory. A steel angle bracket bolted to the interface was shown to be effective in limiting the separation of the interface resulting in an increased longitudinal shear capacity in addition to improving the ductility of the interface. Since the preferred failure mode is anchor bolt shear rather than concrete splitting (Figure 12), a bolt edge clearance in excess of 125 mm was recommended for the strengthening design.
