# **Destructive Load Testing of Bridge No. 1049 – Analyses, Predictions and Testing**

*Pressley JS, Associate Director – Maunsell WA*  
*Candy CCE, Technical Director Structures – Maunsell WA*  
*Walton BL, Structural Engineer – Maunsell WA*  
*Sanjayan JG, Associate Professor - Monash University and Consultant to Maunsell*

## **SYNOPSIS**

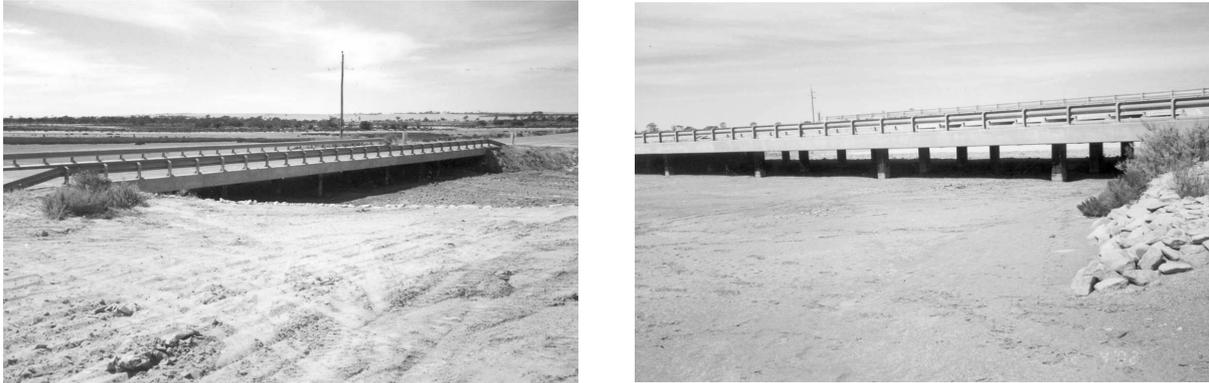
Both structures were cast in situ, five span, reinforced concrete flat slab bridges comprising 2 No. 7.39 m end spans and 3 No. 7.62 m internal spans. The bridge decks were 9.75 m wide overall, with an 8.53 m carriageway and two 610 mm wide kerbs cast integral with the 305 mm thick deck slab.

The bridge decks were supported at each abutment on 6 no. neoprene bearing pads on deep reinforced concrete sill beams, which were in turn supported on 4 no. 356 mm square

prestressed concrete driven piles. The piers had 4 no. 356 mm square piles, recessed 25 mm into the deck soffit as supports. Refer Fig 1 for general views of the bridge.

*Figure 1: General Views of Bridge No.1049*

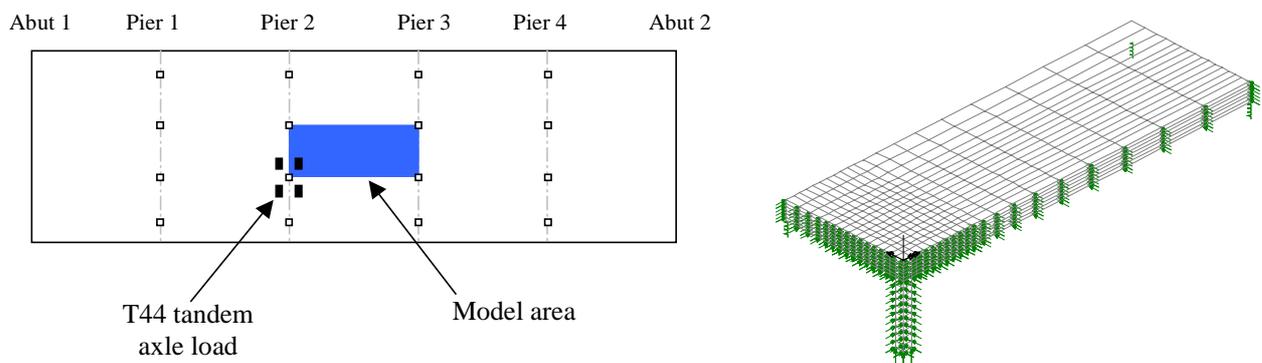
To assess the punching shear capacity at a square-section pile-head, a portion of the slab around the pile was modelled. To minimise the size of the stiffness matrix, only a quarter of the pile was modelled, and to simplify the boundary conditions the model was extended to the adjacent column and for the full length of the span, refer Fig 3. A graphical representation of the model is shown in Fig 3.

**Figure 3: Punching Shear Model Area, Discretisation and Boundary Conditions**

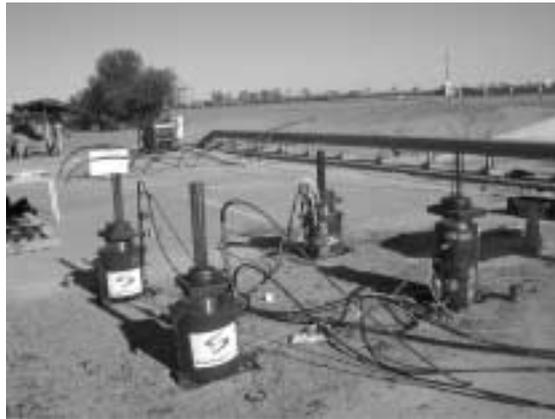
The proposed loading procedure was for the jacks to sit on chamfered steel plates representing the wheel footprints of a T44, the plates sitting on rubber bearing pads to take the unevenness out of the asphalt. This was believed to be as realistic as could be achieved. The setup is shown in Fig 4 below.

**Figure 4: Punching Shear Jack Setup**

During the first test, loading was carried out in increments of 20 t up to a total applied load of approximately 135 t and then smaller increments were adopted as the predicted failure load of 196 t was approached. At a total applied load of 192 t large rotations of the jacks occurred due to local softening of the asphalt (the shade temperature exceeded 40°C). Loading continued up to a total applied load of 325 t, after which it was decided to unload, remove the asphalt and rubber bearings and repeat the test.

In the retest, large load increments were adopted to a total applied load of 360 t. Failure occurred during the next increment at a total applied load of 369 t, with a sudden, brittle fracture of the slab, and two distinct loud bangs. There was a clearly visible failed area around the loaded pile with a step in the top surface of some 50 mm. Detailed inspection confirmed that the slab had failed with a classic punching shear “mushroom head”, both around the loaded pile and at an adjacent pile, the latter explaining the second loud bang.

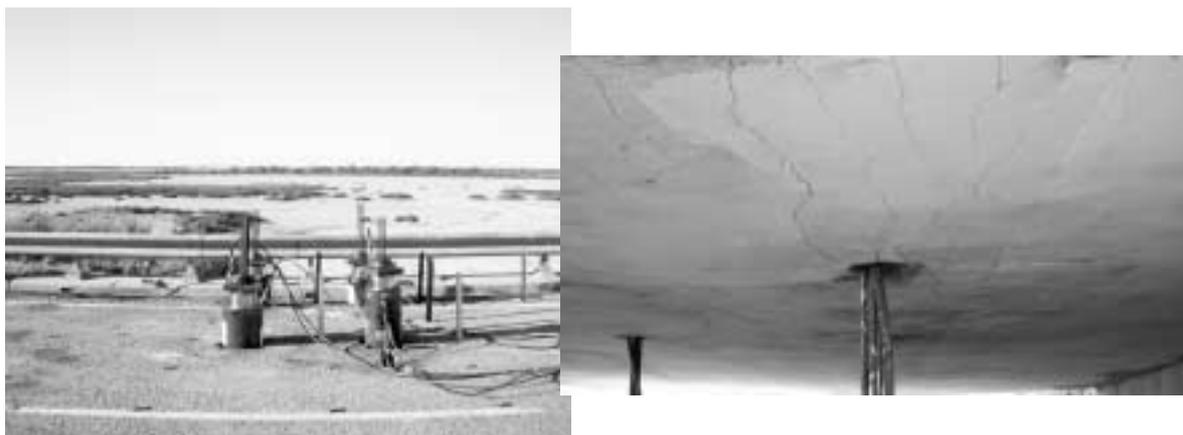
The two bending tests each had two stages, load cycling and subsequent loading to failure. Again, the bearing plates were placed directly onto the structural concrete. The jack and photogrammetry setup is shown in Fig 5 below.

***Figure 5: Single T44 Test Setup and Ultimate Flexural Cracks on the Soffit***

The first test had a single T44 tandem axle group load configuration, 1.2 m longitudinal axle spacing and 1.8 m transverse wheel spacing, in one of the end spans. During the load cycling, maximum crack widths under service loads were documented as well as the residual crack widths when the structure was unloaded. Cracks closed to approximately 0.2 mm after the structure had been subjected to a total applied load of 160 t.

Large deflections to 80 mm were noted around the loaded region as the predicted failure load was approached. At a total applied load of 249 t (62 t per jack), initial yielding occurred with a slow cracking sound from localised compressive failure of the kerb concrete. Large transverse flexural cracking in the sagging region was also evident on the soffit (see Fig 5 above). Fig 6 below shows a plot of these flexural cracks, as observed just before failure, together with the shear crack location on the soffit after failure. The flexural cracks were orthogonally orientated, with no evidence of diagonal cracking in plan, as was expected from yield line assumptions. Vertical cracking in the kerb was observed in the hogging region over the pier. After initial yield, the jacks held a total load of 223 t.

Once the structure had reached equilibrium and sounds of cracking stopped, the structure was carefully loaded back to 249 t. As the load was increased a sudden shear failure occurred at a total load of 254 t (63 t per jack). An L-shaped shear failure surface around the loaded region was observed, similar to a large scale punching shear failure of the entire loaded region downwards. A shallow angled, 50mm wide, diagonal crack extended from the soffit, through the thickness of the concrete, breaking out at the top surface near the loaded area. Fig 6 below contains plots of the L-shaped shear crack which was evident in both single and dual T44 tests.

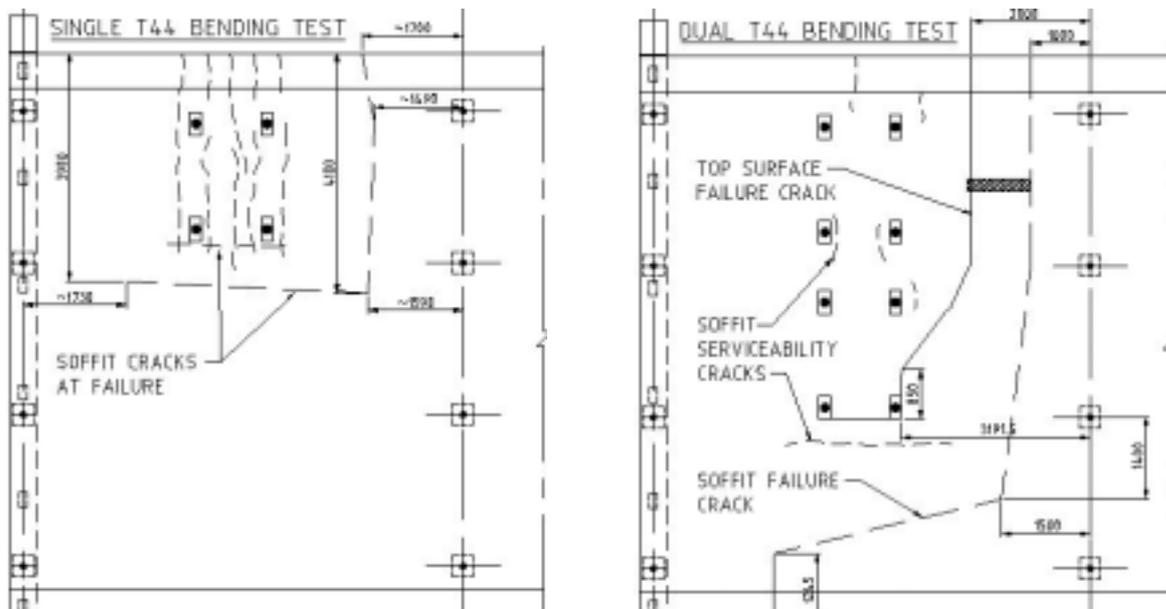
**Figure 6: Single and Dual T44 Tests – Plots of Soffit Cracking**

Elastic cycling was carried out and crack measurements taken up to a total applied load of 180 t (30 t per jack). Crack widths of up to 0.45 mm were documented at the highest load, closing to approximately 0.2 mm after unloading. The cracks that were readily visible at this serviceability load level are shown in Fig 6 above.

As before a large L-shaped shear crack was evident around the loaded area, producing a distinct step in the deck of approximately 70 mm, approximately halfway between T44 and pier. A return visit was made to the bridge a few weeks later and a section of the concrete saw-cut out to identify the through-thickness crack geometry. The location is shown by the hatched rectangle in Figure 6 and the photo is shown in Fig 8 below.

The tests did not confirm the classic assumed diagonal yield line patterns (in plan), and the flexural soffit cracks observed support a different mechanism, characterised more by dishing with very many transverse “yield lines” and one main longitudinal flexural crack.

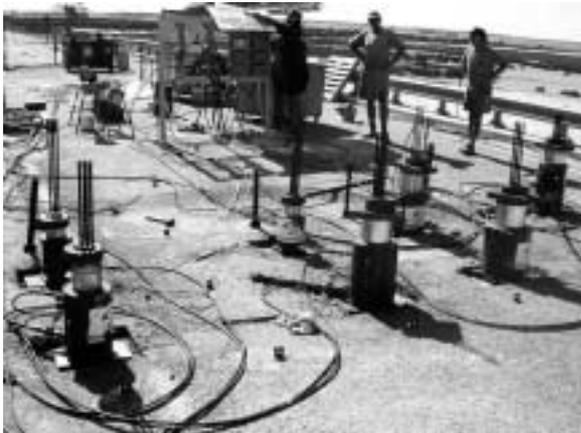
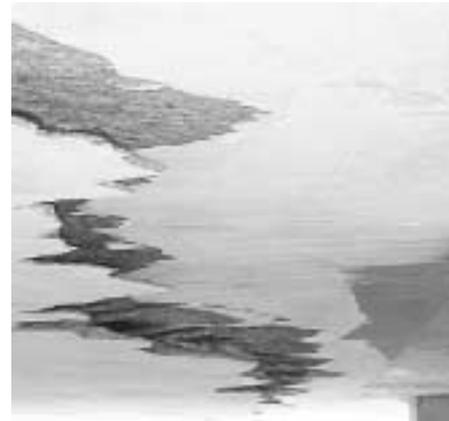
The second bending test in the other end span had a dual T44 load configuration, two tandem axle groups occupying two adjacent design lanes. 8 jacks were required. Two of the jacks could not release load and load cycling was therefore carried out using six jacks only. Loading to failure was carried out using all 8 jacks. The test setup is shown in Figure 7 below.

**Figure 7: Dual T44 Test – Setup and Soffit Shear Cracking after Failure**

A maximum deflection of 120 mm was recorded just prior to failure which was characterised by a sudden shear fracture around the loaded region, again similar to a large scale punching shear failure of the loaded zone, downwards.

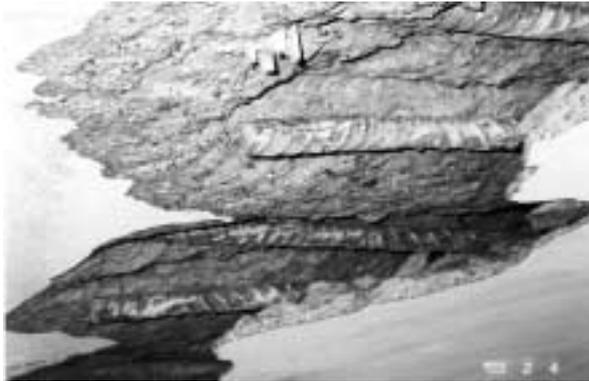
*- Thickness Shear Failure Surface*

The failure surface comprised a shallow angled, diagonal crack extending from the soffit, some distance away from the loaded area, through the thickness of concrete, breaking out at 45° to the top surface, near the loaded area.

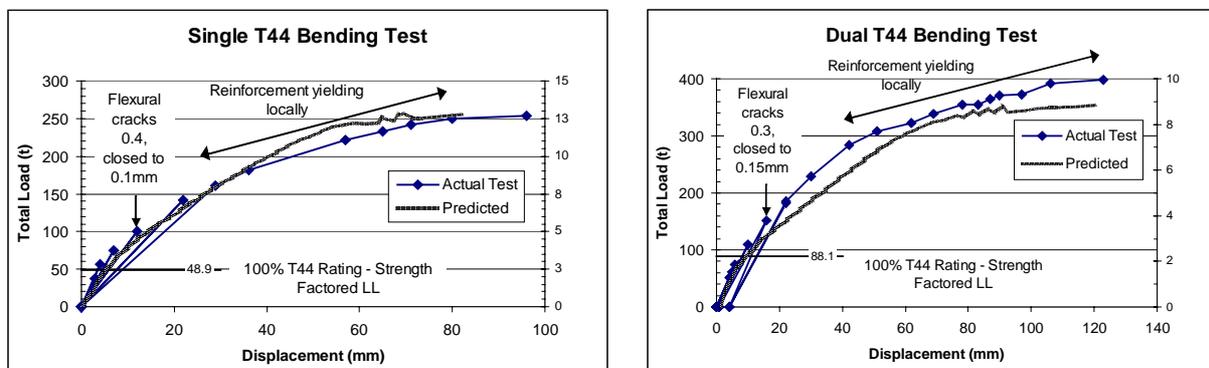
The load vs midspan displacements measured in the tests were compared to the responses predicted by LUSAS and Fig 9 below shows very good correlation.

*Figure 9: Load – Displacement Plots, Single T44 Test (left) and Dual T44 (right)*

The same T44 load patterns and positions as in the COBRAS analysis were adopted. The load magnitudes were incrementally increased and deflections at critical points plotted against load increments, to develop load-displacement plots, as shown in Fig 9 in Section 5.2.

Total station survey readings were taken whilst loading and unloading to confirm that the structure had not sustained any permanent deflections during load cycling. After load cycling, the structure was loaded from 160 t total load to 240 t in 20 t increments, after which smaller increments were adopted to approach the expected failure load of 252 t (63 t per jack). Real time plotting of load-displacement curves during the test indicated an excellent fit between the predicted and actual behaviour of the structure, refer Fig 9 in Section 5.2.

Unlike the first bending test, there was no distinct compressive failure of the kerb concrete, however the kerb upstand separated from the slab with a large longitudinal crack at the interface. The load-deflection plot is shown in Fig 9.
