Strengthening of Heritage Timber Truss Bridges

Bridge over Abercrombie River

Abercrombie, NSW

R. Oates (RTA), R. J. Taylor (R J Taylor Consulting Pty Ltd), I. Berger (RTA)

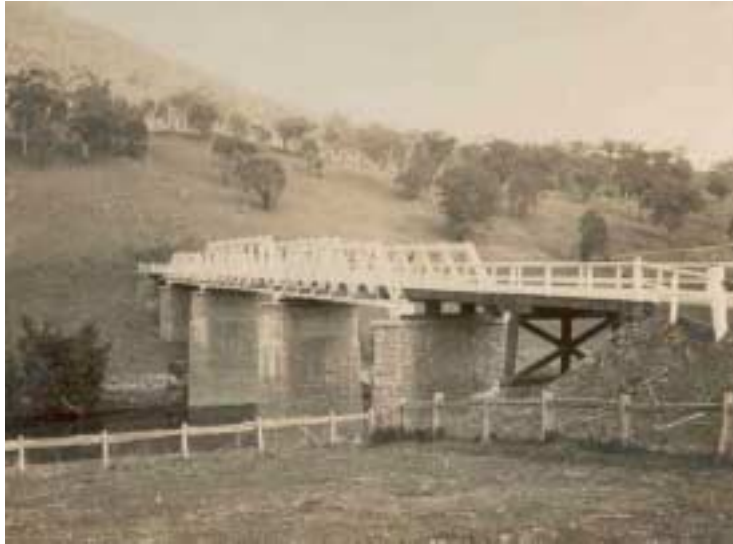
Figure 1: 1929 Photo of original bridge

In 1919 the piers were increased in height by 1.8 metres through the use of concrete and the present superstructure built. A photograph (**Figure 1**) taken in 1929 clearly illustrates the added portions of the piers, and original colour scheme. The light colour highlights the clean lines and symmetry of the Allan truss form, as well as establishing the bridge as a dominant feature in the local landscape.

The bridge consists of three Allan type timber truss spans, two of 21.6 metres (71 feet) flanking a main span of 27.4 metres (90 feet). The deck width is 4.6 metres (15 feet) between kerbs. There are two timber beam approach spans at each end giving the bridge an overall length of 106.4 metres (349 feet). An early photograph of the bridge is displayed in **Figure 1**.

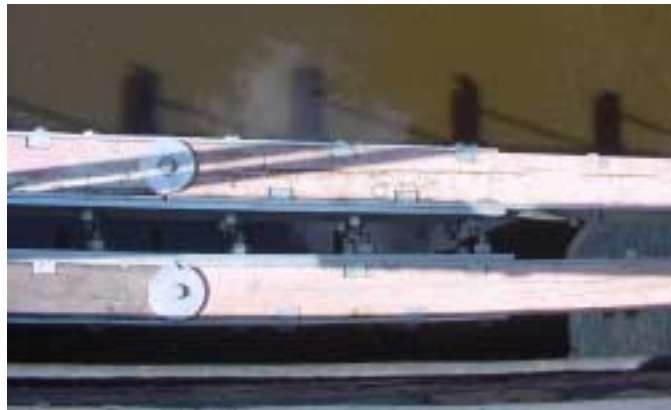
The product of the modulus of elasticity and cross sectional area (EA) of the steel strengthening plates (**Figure 2**) match the EA of the timber section and thus achieve strain compatibility. The introduction of the plates, therefore, effectively doubles the capacity of the bottom chord and if a timber flitch fails the steel alone will still be able to carry full T44 loading.

Figure 2: Steel plate reinforcement of bottom truss chords

The disadvantage of the system is the reliance on the timber to transmit loading from the shoes into the bottom chord. This means the condition of the timber under the shoes is critical and must be regularly inspected and maintained.

The advantage of the system is that the splices in the steel coincide with the splices in the timber and each segment can be shop manufactured and then lifted up into position under an existing truss without undoing any shoes.

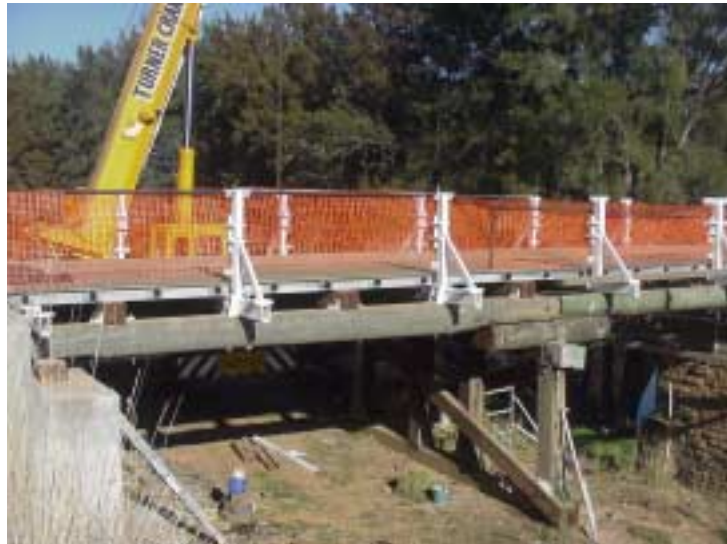
Steel cross girders were provided at barrier post location only and extend outside the deck to allow typical post backstays to be provided over the full length of the structure. Back stays are required to allow the use of posts equivalent in section to the original ordinance posts while meeting the strength required. These steel cross beams use RHS sections as shown in **Figure 3** to simulate rectangular timber members in order to support heritage requirements.

Figure 3: Typical approach span refurbishment

Transversely stressed SLT decks were installed over the full length of the structure.. The approach spans required 140 deep decks (see **Figure 3**) while the truss spans required 190 deep decks (see **Figure 5**). All decks were designed in relatively short lengths between 6 and 9 m to allow installation over numerous short duration road closures as will be discussed in the next section. Steel cover plates provide continuity between panels.

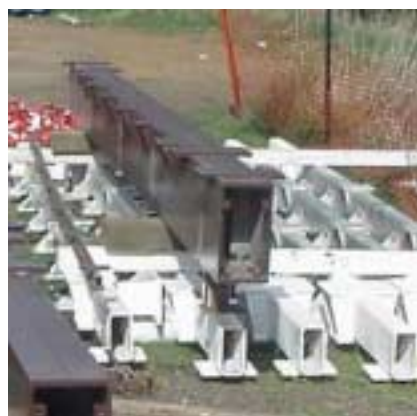
Steel cross girders were required in the truss spans due to the inherent under-capacity of the traditional timber cross girders to carry today's loadings as well as the difficulty in detailing a post connection to timber which satisfies the required traffic barrier capacity. The steel cross girders in the truss spans were made by welding two 380 PFC's together to form a 380 x 200 rectangular section as displayed in **Figure: 4**. The latter simulated rectangular timber members in order to support heritage requirements.

Figure: 4: Steel Cross Girder for Truss Spans

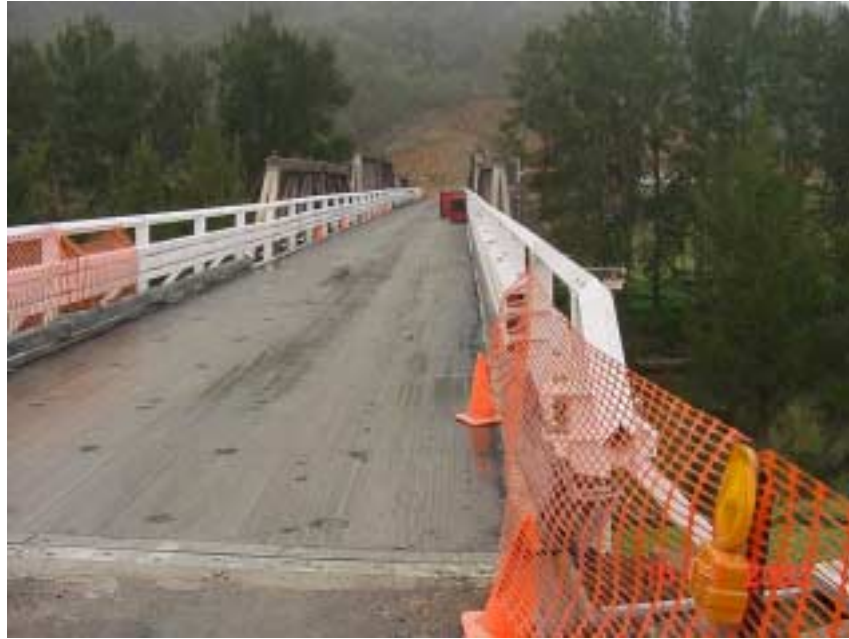
The traffic barriers were designed to satisfy Austroads Level 2. In both the approach and truss spans the posts themselves utilize 150 x 100 steel RHS sections similar to the original (6' X 4'') timber posts as shown in Figure 6. In addition, a 100 x 100 SHS handrail is mounted atop the posts similar to the traditional (4' X 4'') timber handrail. The primary differences include the need for heavy steel traffic rails between posts and the post back brace to provide adequate strength to resist impact forces. It should be noted that a more recent design for the Hinton bridge near Newcastle NSW, has been able to reduce the traffic rails to only two RHS members instead of the three used at Abercrombie. This reduces the visual obtrusive impact of the rails.

Figure 6: Completed Refurbishment Prior to Paving

The new timber and steel cross beams were then placed and secured as shown in **Figure 8**. This photograph also displays the first of the two SLT deck panels that make up the deck for the two girder spans. A view of the completed approach span was previously shown in **Figure 6**.

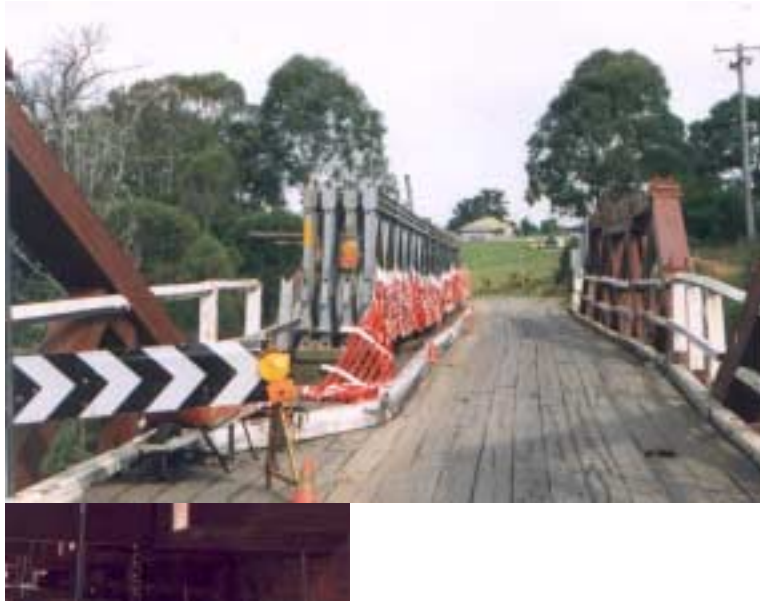
The timber trusses were rehabilitated including the bottom chord strengthening under normal traffic with some restriction on width clearances. This was accomplished by installing temporary Bailey trusses similar to that displayed in **Figure 7**. These Bailey trusses are designed to support the cross girders and carry the traffic, as well as support scaffolding and truss components to allow dismantling and rebuilding of the trusses under traffic.

Figure 7: Typical Truss Support using Bailey Trusses at Clarence Town

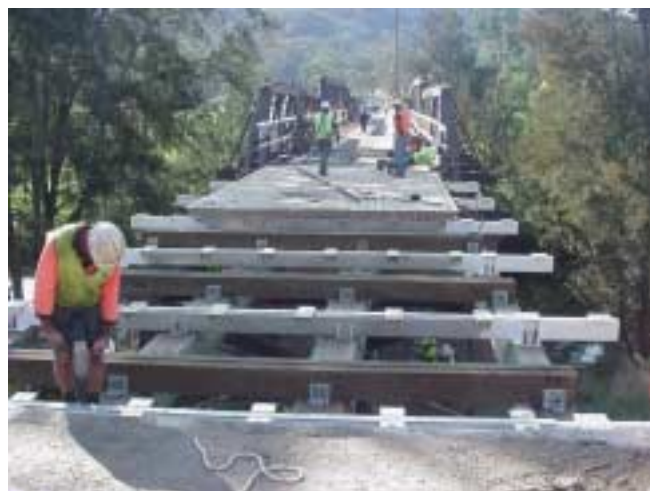
Figure 8: Abercrombie Approach Span Rehabilitation

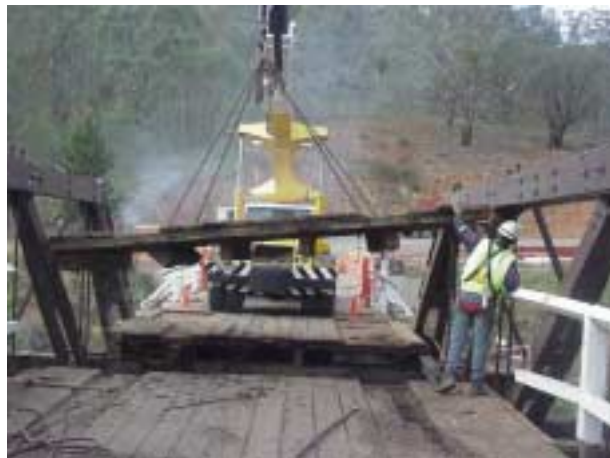
Figure 9: Removal of Old Decking on Truss Spans

- Removal of the existing deck and cross girders in large sections (**Figure 9**)
- Installation of new steel cross girders (**Figure 10**)
- Installation of new SLT deck panel (**Figure 11**)

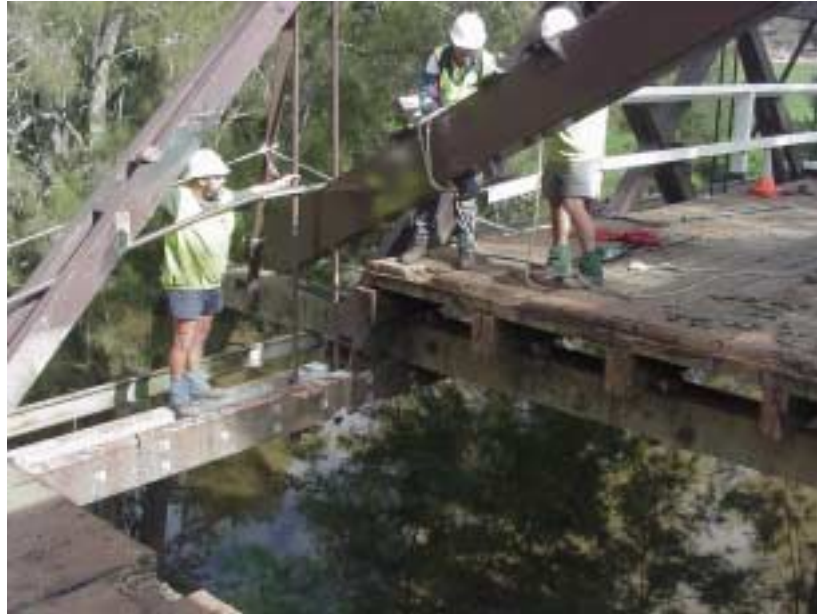
Temporary support of the existing deck, not removed during a specific closure, was supported using one of the old timber cross girders adjacent to the panel point as can be seen in **Figure 10**.

Figure 10: Installing New Steel Cross Girder on Truss Spans

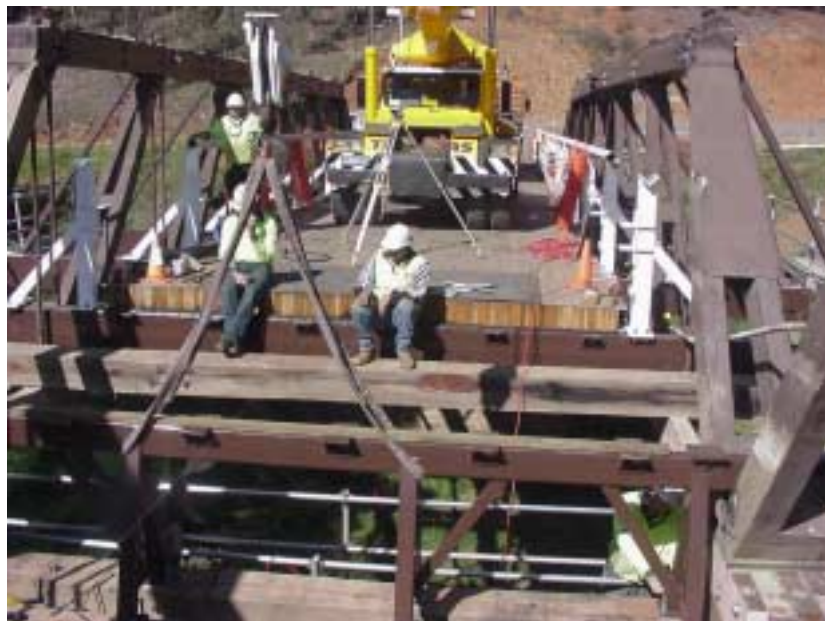
A special steel cross girder was required at the main piers between trusses which was detailed to sit directly on the piers as shown in **Figure 11**.

Figure 11: Special Cross Girder over Main Piers
