Shelly Beach Overbridge Modification, Auckland

Geoff Brown, BEng, CEng, MICE, MStructE, MIPENZ,

Opus International Consultants, Wellington

SYNOPSIS

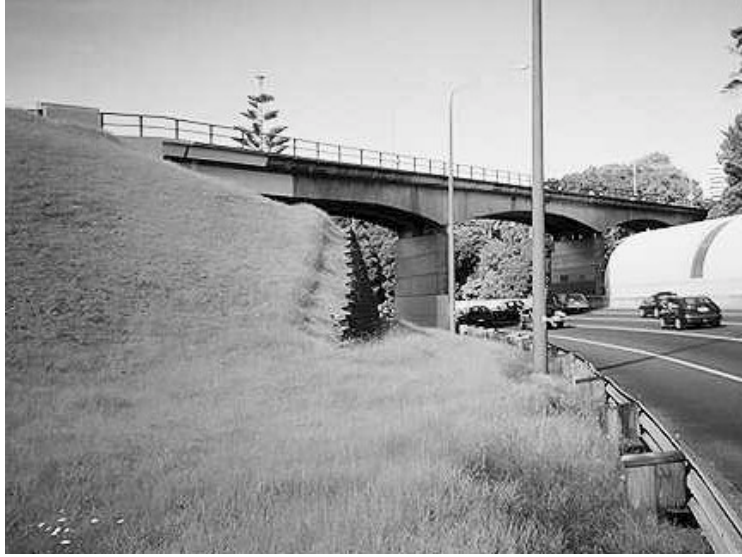
Photo 1: Existing Bridge from the North

Constructed in 1959 as part of the Auckland Harbour Bridge project, the existing bridge had four spans and a reinforced concrete ‘T’ beam superstructure. Three main longitudinal beams were provided. These were continuous, and of variable depth to a parabolic profile. The two centre spans over the carriageways were 31.4 m and the side spans 24.4 m, to give an overall length of 111.6 m. The bridge carried two traffic lanes and had a footway on the eastern side, with an overall width of 10.2 m.

Photo 1 shows a view of the existing bridge from the north, on the inside of the proposed widening.

The bridge deck was skewed at 47 degrees to the piers and abutments to suit the angle of the off-ramp as it crossed the motorway. The bridge deck had a 5% longitudinal gradient from south to north, and a 2.5% cross fall.

The main deck beams varied in depth from 2.5 m at piers to 1.1 m at midspan, and at the ends of the bridge. The beams were 520 mm wide and the deck slab was 180 mm thick. Cross diaphragms were provided to the deck at each pier and at each end of the bridge.

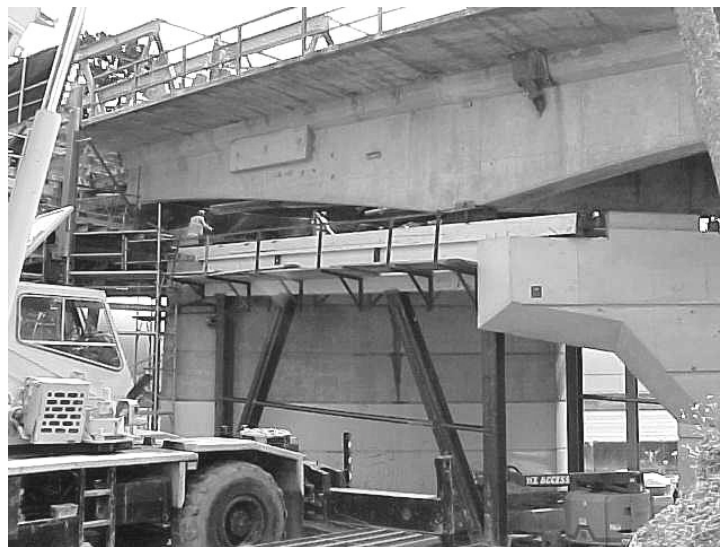
Photo 2: Bridge Sliding Showing Runway Beam

Photos 2 and 3 show the bridge during the sliding operation, and in particular the temporary decking and runway beams.

The cutting and sliding operation was undertaken after the new northern pier and abutment had been constructed. The 550 tonnes bridge section was slid on runway beams that were located between the old and new supports, and propped from ground level.

The bridge was jacked longitudinally using a "telescopic rack" system developed by Fulton Hogan, which provided a "fail-safe" restraint to prevent the bridge sliding out of control. Transverse guides were also provided to prevent the bridge sliding off the runway beams. The sliding operation was undertaken above the "live" motorway and took only about six hours to complete on a Saturday morning.

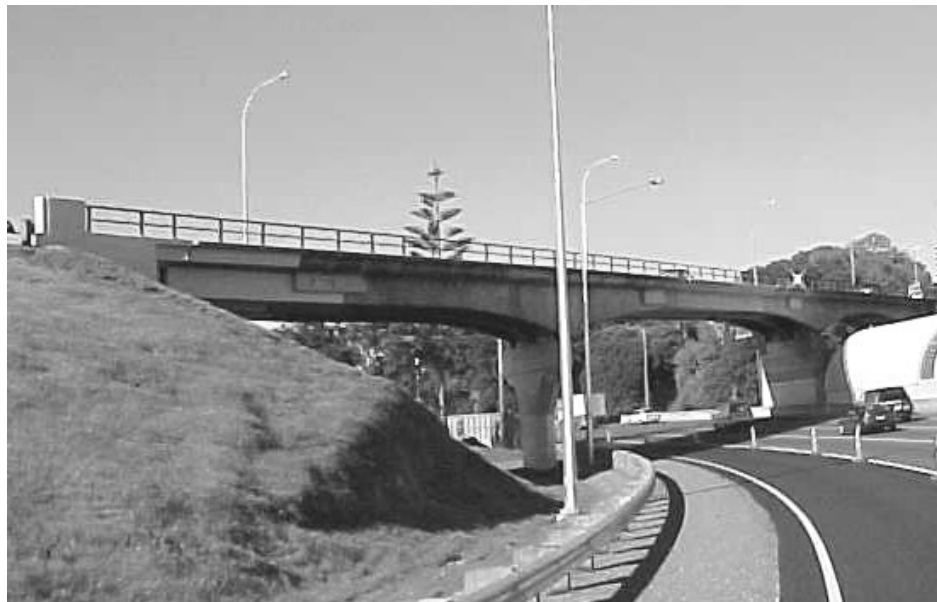
Photo 5: The Completed Bridge

Photo 5 shows the completed bridge after opening.
