# Some Outcomes from Load Testing of Bridge 631 in Western Australia

*Dr Ian Chandler, Curtin University of Technology, Perth, Western Australia*

## **SYNOPSIS**

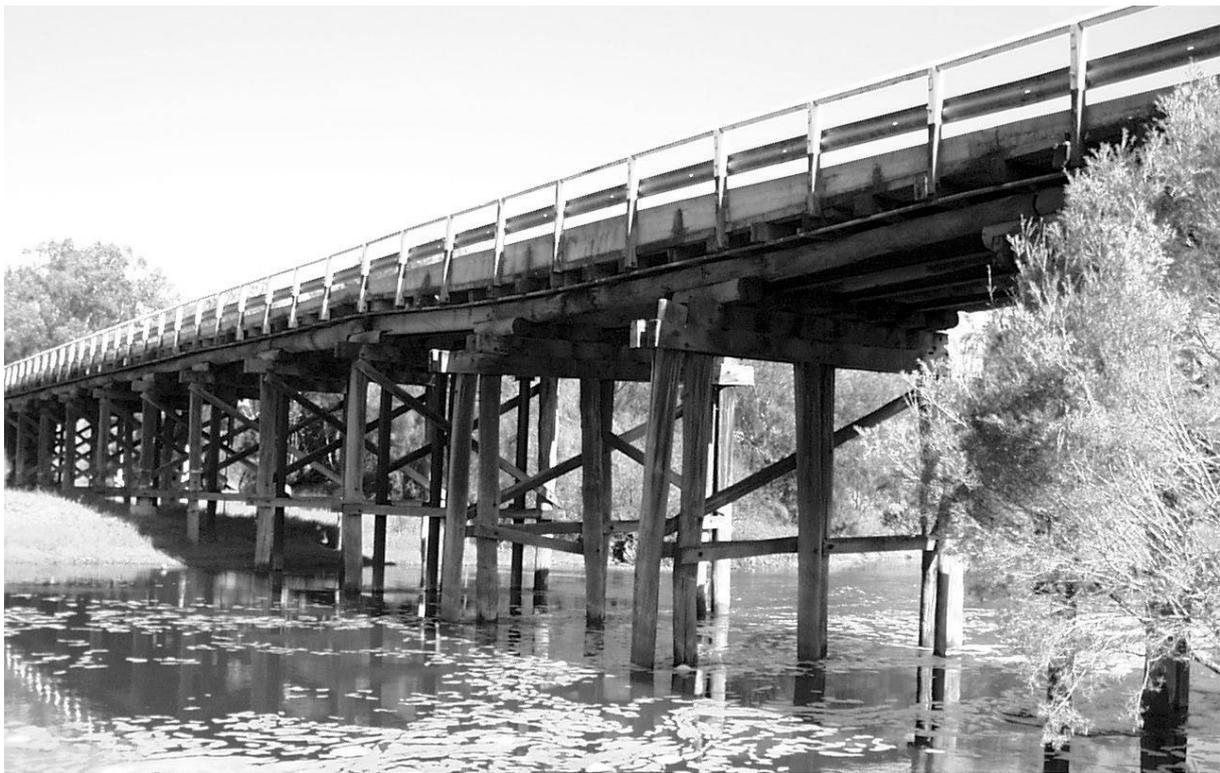
Bridge 631 was a 190m long timber bridge with 31 spans (each approximately 6 metres) over the Avon River in Toodyay (a small town approximately 100 km from Perth the capital city of Western Australia) - see Figure 1. The bridge had round log stringers supporting sawn timber bearers and a longitudinal timber deck overlain with a concrete deck approximately 100 mm thick. It was constructed from local hardwood timbers (predominantly Wandoo with some Jarrah) in 1950 and had a series of repairs in 1965, 1980, 1994 and 1998. It is the fourth bridge on the site after flooding destroyed the previous bridges. However as the width between kerbs was only 5.5 metres and it did not have a footpath it was decided to replace the bridge with a new wider concrete structure during 2001.

*Figure 1: General View of Bridge 631*

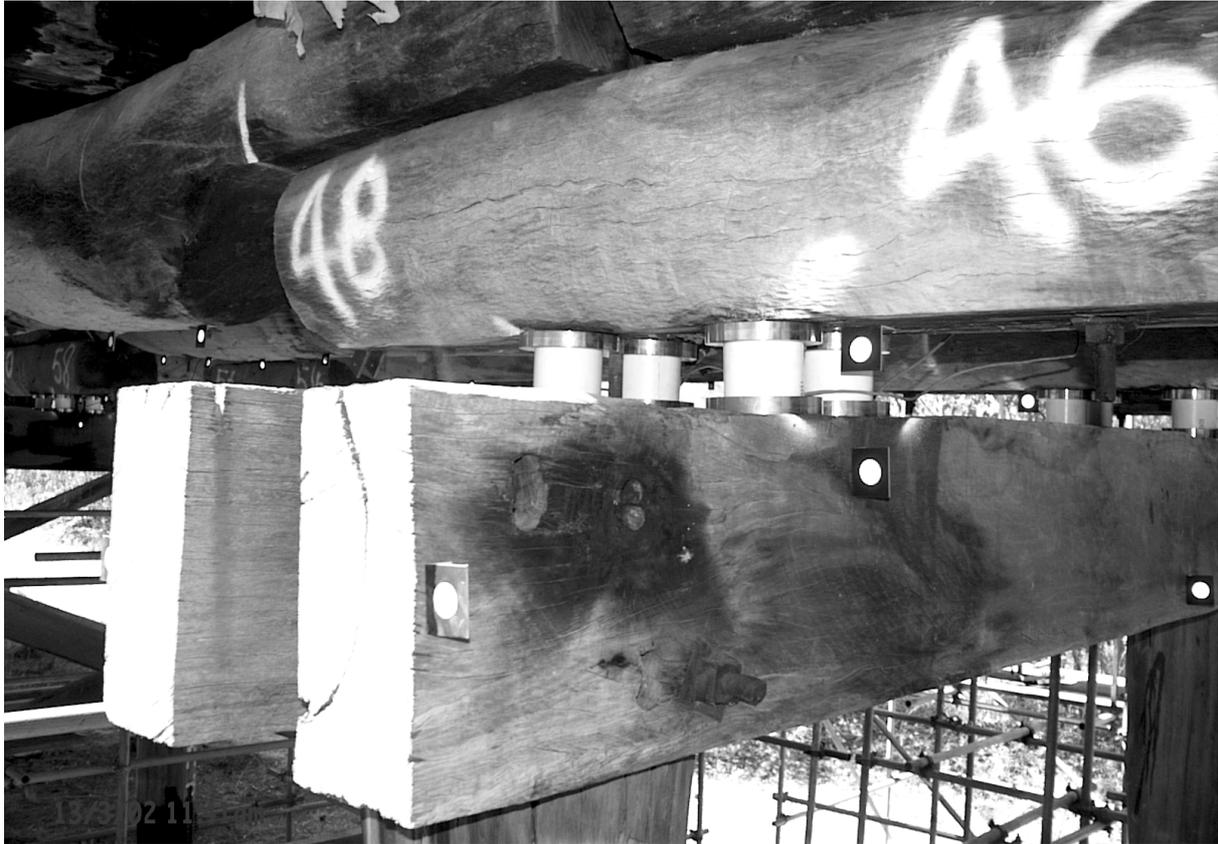
Once the superstructure was lifted, temporary packers were inserted before the load cells were placed between the half-caps and the corbels - typically four load cells under each corbel, however in a few cases only two load cells could fit under narrow corbels. The bolts connecting the corbels to the half-caps were left in place (only the lower nut was removed to allow lifting), therefore the load cells had to be positioned around the bolts, one on each side of the bolt. Figure 4 shows the load cells in position between the half-caps and the corbels. To ensure that the load was transferred axially through the load cells, care was taken to ensure that the surfaces bearing on the load cell plates were smooth and flat. After all of the load cells were inserted, the bridge superstructure was slowly lowered so the corbels rested upon the load cells. The lifting procedure was repeated for each pier in turn until all four piers associated with the test location had load cells under every corbel.

*Figure 4: Typical Arrangement of Four Loadcells Inserted between a Corbel and Halfcaps*

The load cells were intended to represent a similar contact area to the normal situation when the corbels rested directly upon the half-caps, where the width of contact ranges between 200mm and 300mm and the width of the halfcaps was 170 mm. Therefore two load cells were used on each corbel, totalling 16 load cells per pier with 64 load cells required for the four piers.
