# Design and Construction of the Otira Viaduct

*Ian Billings: Chief Bridge Engineer, Beca Infrastructure, Auckland, New Zealand*

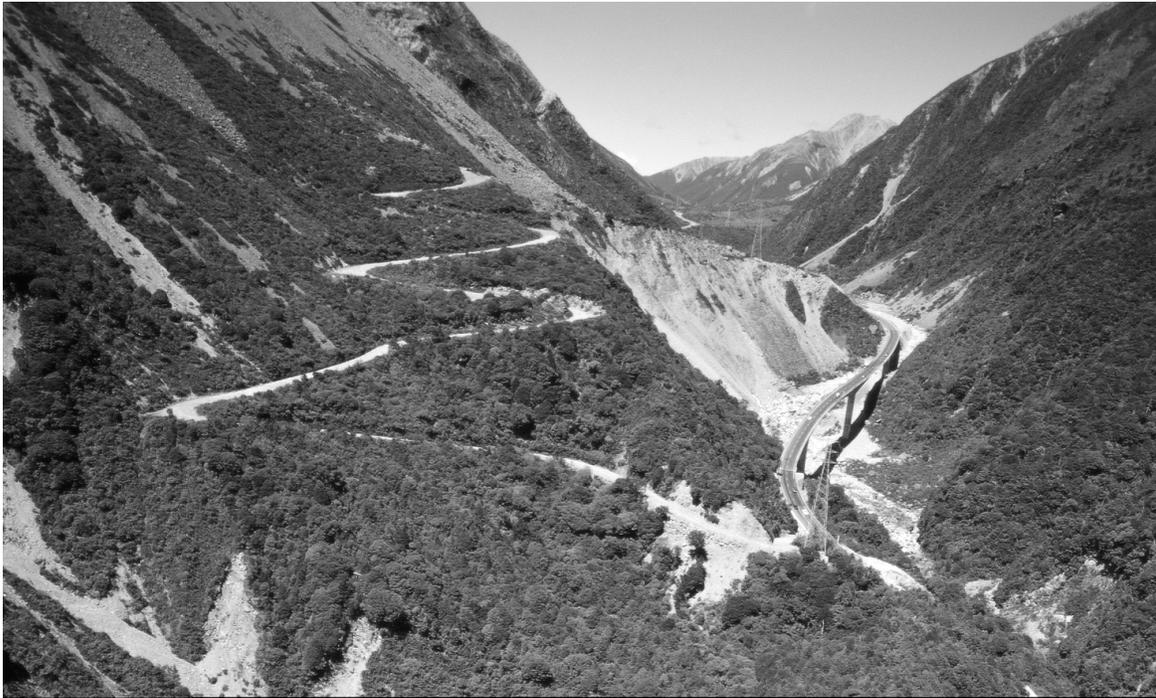
*Figure 1 - Site view showing old road (the Zig-Zag) on left*

To bypass this hazard, a major road realignment down the Otira River Valley was necessary. A range of innovative design and construction techniques were introduced to meet the challenges of what is one of the most demanding bridge sites in the world. The result – a four-span viaduct with central spans of 134m – is the longest span concrete bridge in New Zealand. The site and surroundings are shown in Figure 1.

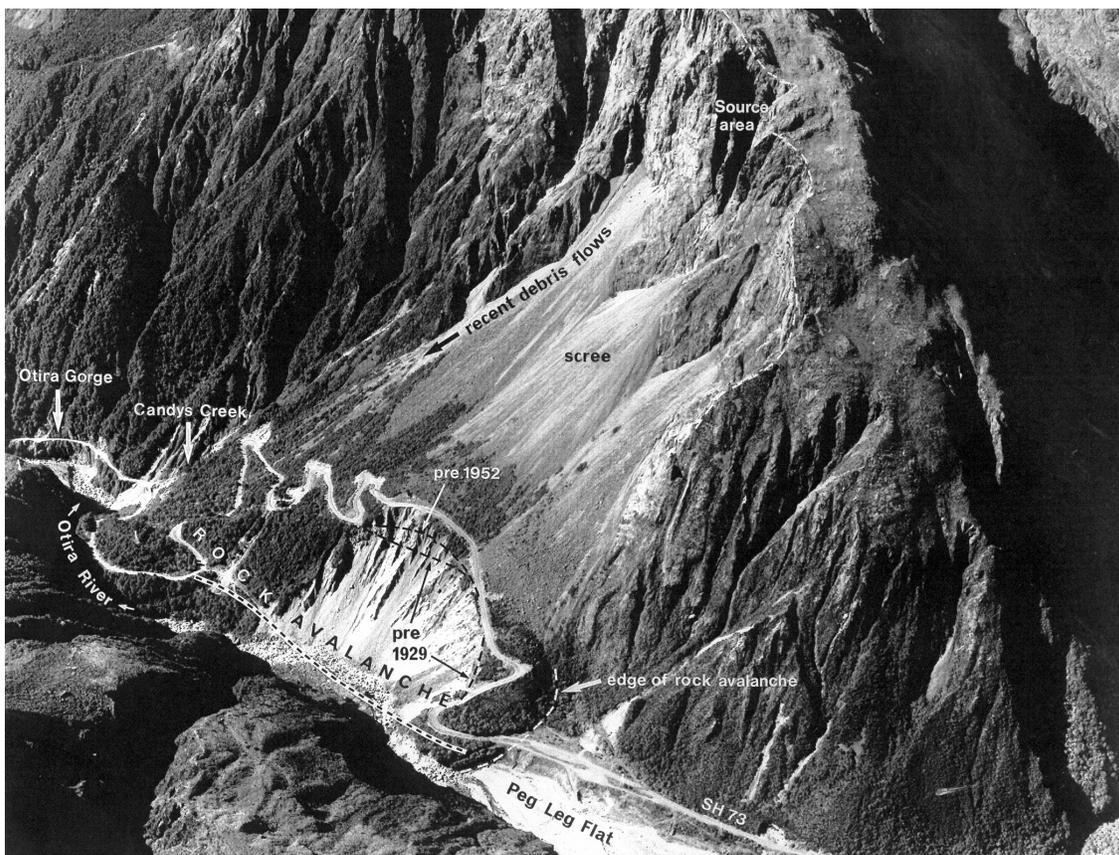
A spur at the southern end of the site (known as Deaths Corner) is the remnant of a huge rock avalanche which 2000 years ago dammed the valley, and ran well up the western bank. The avalanche, which was probably seismically induced, originated from the mountain ridge 700m above the riverbed. The river has subsequently cut a V notch in this dam. Figure 2 shows these features and indicates the avalanche source area. It also shows the road alignment prior to the 1929 Arthurs Pass Earthquake. In normal flow conditions much of the Otira River flows under the old landslide dam and underground through the rock avalanche materials in the valley. Foundations could not reach bedrock and had to be constructed in this avalanche debris.

*Figure 2 - Geological Features*

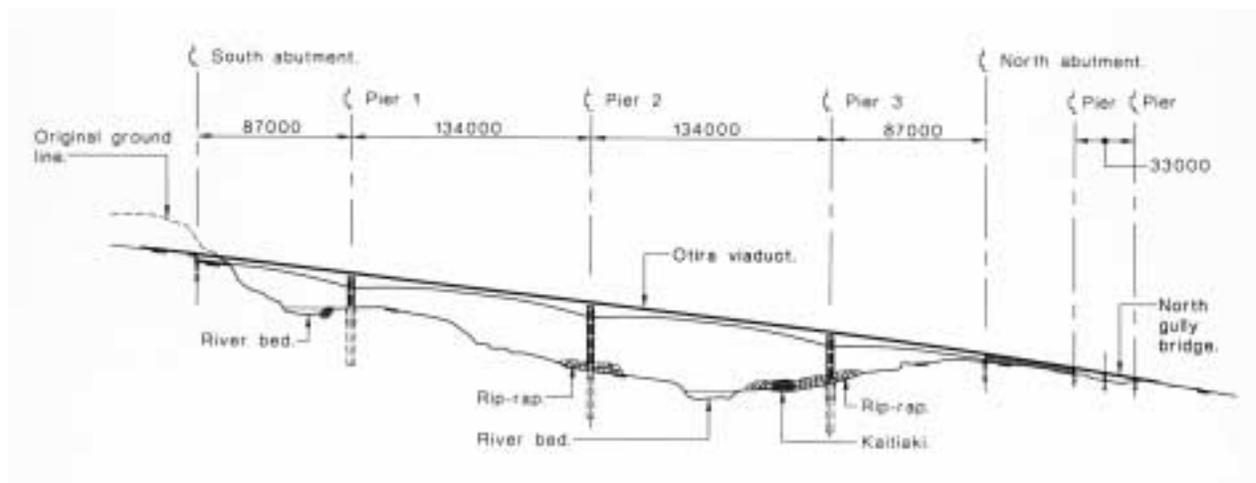
These options were taken through for further study and the four span concrete structure best fulfilled the project requirements and was also the lowest cost option. This structure has spans up to 134 m long and piers up to 45m high as is shown in Figure 3.

*Figure 3 - Bridge Elevation*

The structural form is illustrated in Figures 3 and 5.

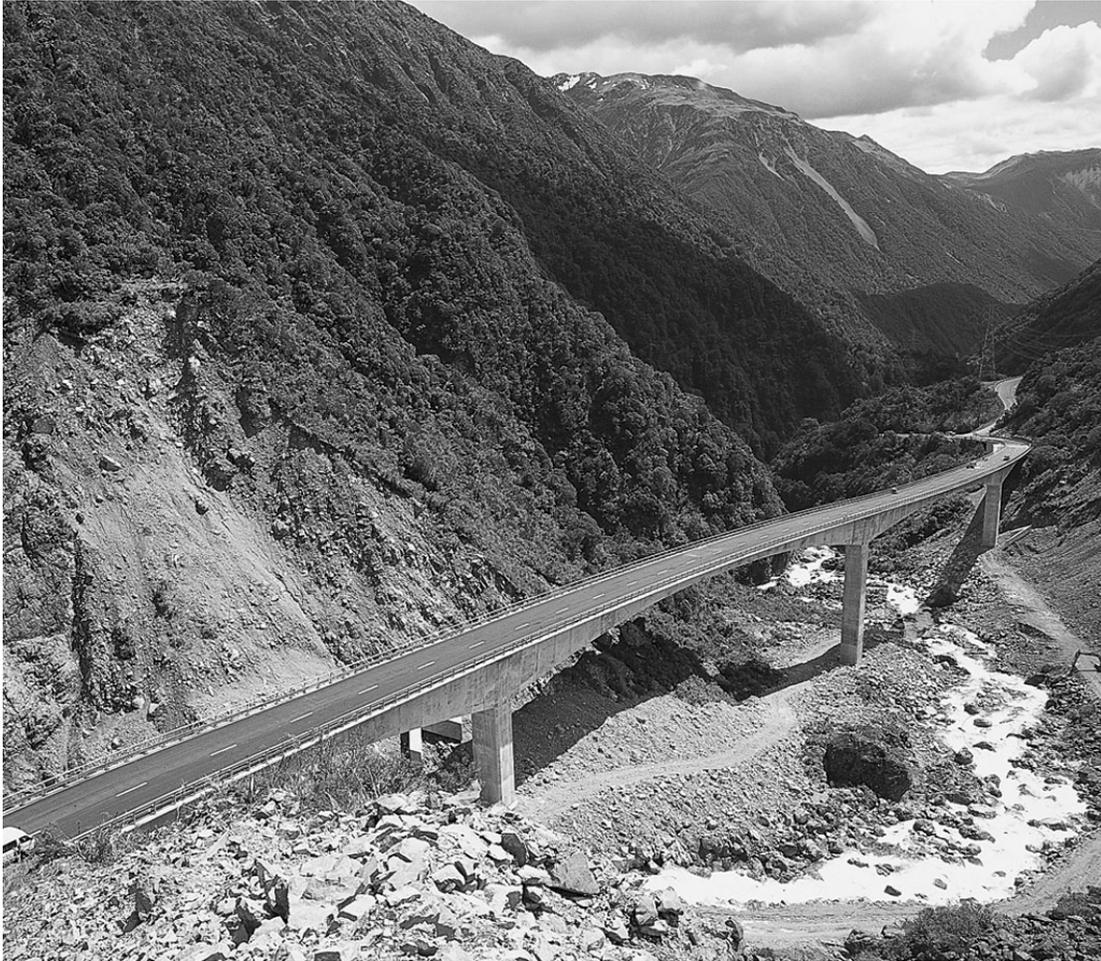
*Figure 4 - General view of site*

To compliment the gently curved alignment, the shape and geometry of the bridge were carefully crafted. Features designed to enhance its appearance included sloping the box girder webs, gently curving the web to deck soffit junction, shaping the superstructure/pier top connection and adding special finishes to the pier sides. These features are illustrated in Figures 4, 5 and 8.

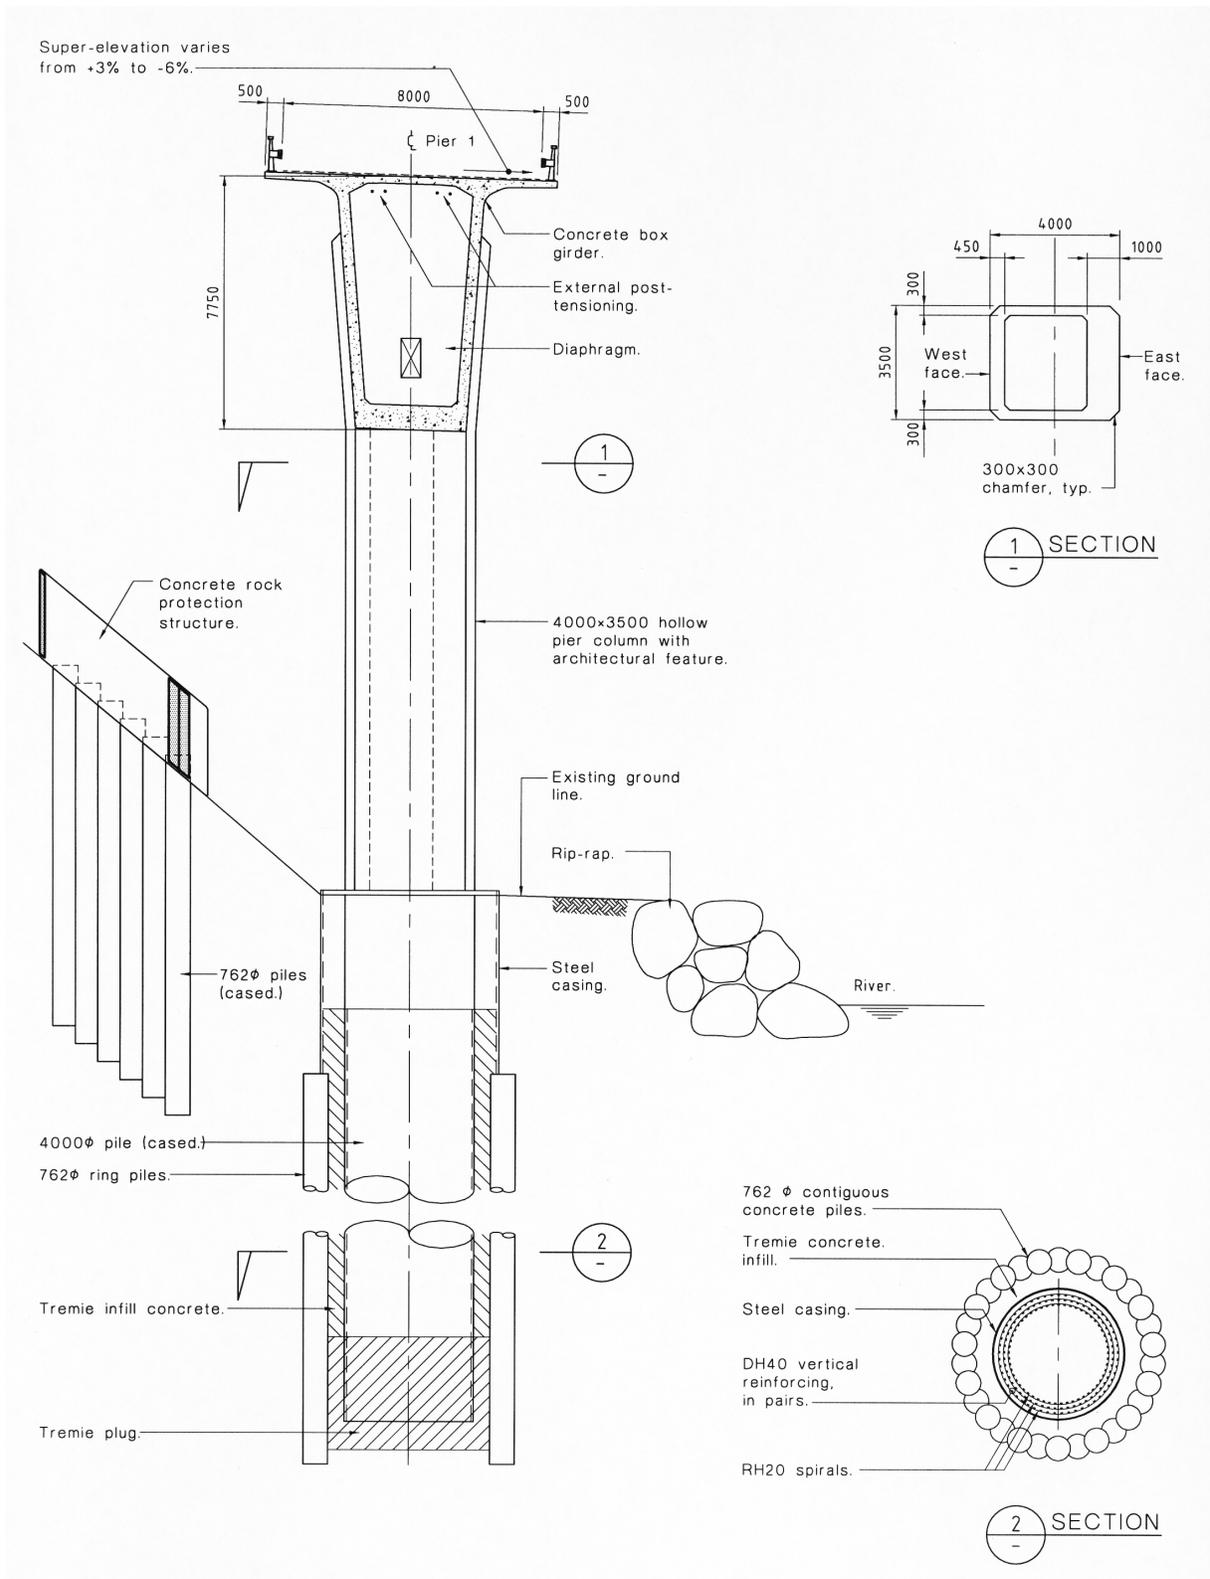
The bridge is supported on single concrete box piers up to 45m high, constructed over each foundation cylinder. The boxes at piers 1 and 3 have walls of different thickness to reduce the effect of dead load eccentricity moments which are induced because of the horizontally curved superstructure. The varying wall thicknesses shift the section centroid laterally. This was considered necessary to minimize lateral deflections during construction and to mitigate against “ratcheting” of the structure in one direction during a major seismic shaking transverse to the bridge. To reduce such effects the out-of-balance dead load effects need to be minimised.

**Figure 5 - Section at Pier 1**

These conditions dictated a relatively long span bridge, which in turn had implications for foundation design. The most appropriate solution was deep, 4m diameter, single-cylinder foundations, up to 25m long, under each pier position (refer Figure 5).

The hollow box piers are detailed for plastic hinge formation at the top and bottom, and the cylinder foundations (and superstructure) are designed for the resulting overstrength actions under seismic loadings. Thus in the event of a major seismic event damage can be inspected and repaired if required. Column overstrength moments were calculated using a reinforcement yield strength of 1.25  $f_y$  and a concrete strength of 1.5  $f'_c$ . To provide the confinement to the concrete and restraint to longitudinal reinforcement necessary to achieve the design ductility, closed Ø10mm stirrups were provided in the plastic hinge zones. Typical pier details are shown in Figures 5 and 6.

The bridge superstructure comprises a four-span, 445m long, balanced cantilever concrete box girder with a maximum span of 134m. The box cross section is shown in Figure 5 and a typical cantilever on Figure 7. The cantilever cables for the box girder comprise twenty 19/12.7mm strand cables and the continuity cables involve up to twenty two 12/12.7mm strand cables. Two external 12/12.7mm strand cables were also provided for the full length of the bridge as this was found to be a very effective method of gaining additional control of mid-span stresses in the continuous structure. To allow for dead load variations, provision was made for the installation of two additional 12/12.7mm external cables, which could be installed should traffic or dead loading increases occur in the future.

This method involved the construction of a concrete pile secant wall around the outside of the permanent pile footprint allowing later excavation inside the concrete pile coffer dam for lowering of the permanent steel liner and reinforcement. As dewatering was not possible, the work was carried out below water until the pile casing had been secured with a tremie plug and tremie in-fill concrete (refer Figure 5). The pile could then be constructed in the dry.

Following excavation the permanent 4m diameter casings were lowered into the excavation and located prior to tremie concreting the plug and later the annulus outside the steel casing. The steel casings were dewatered to allow placement of the reinforcement and pile concrete in the dry. Construction details of a typical pier are shown in Figure 5 and schematically in Figure 9

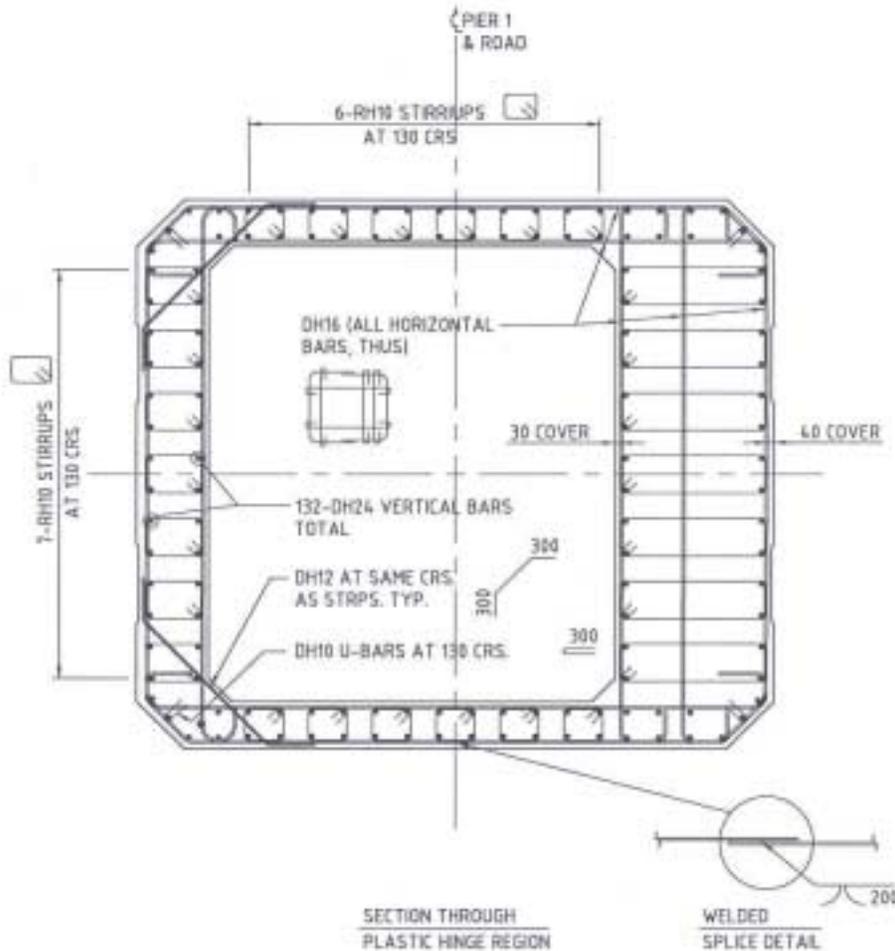
**Figure 6 - Reinforcing details for Pier 1**

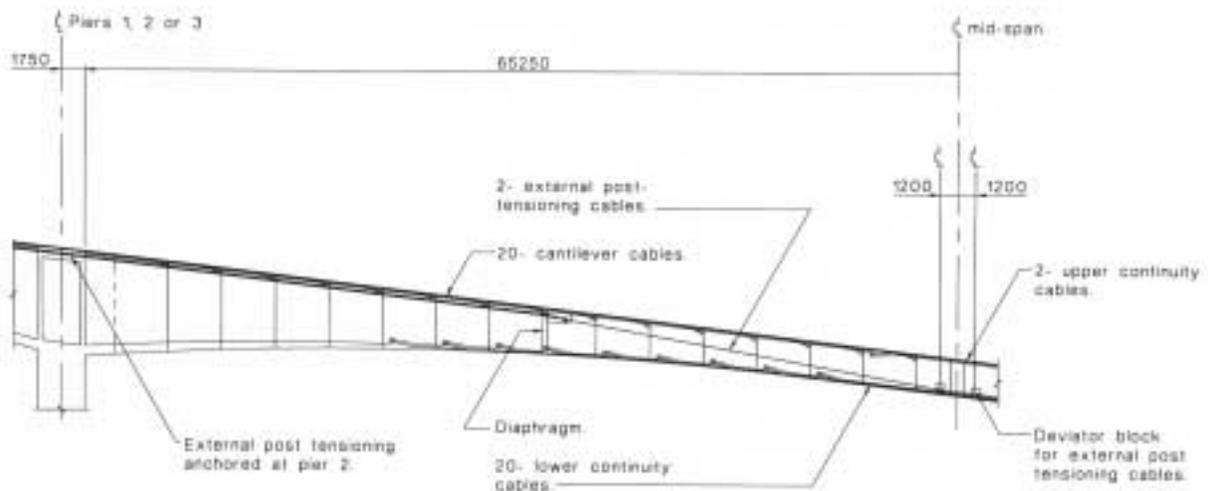
*Figure 7 Elevation of typical span*

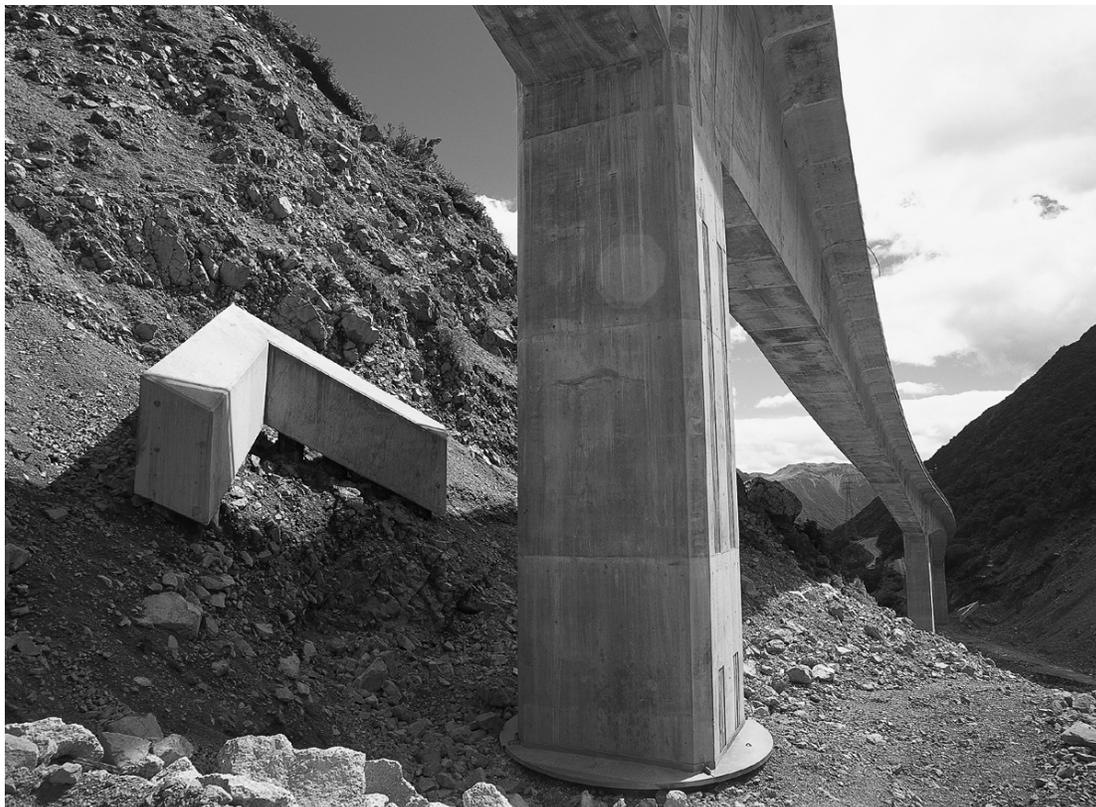
*Figure 8 - View at Pier 1*

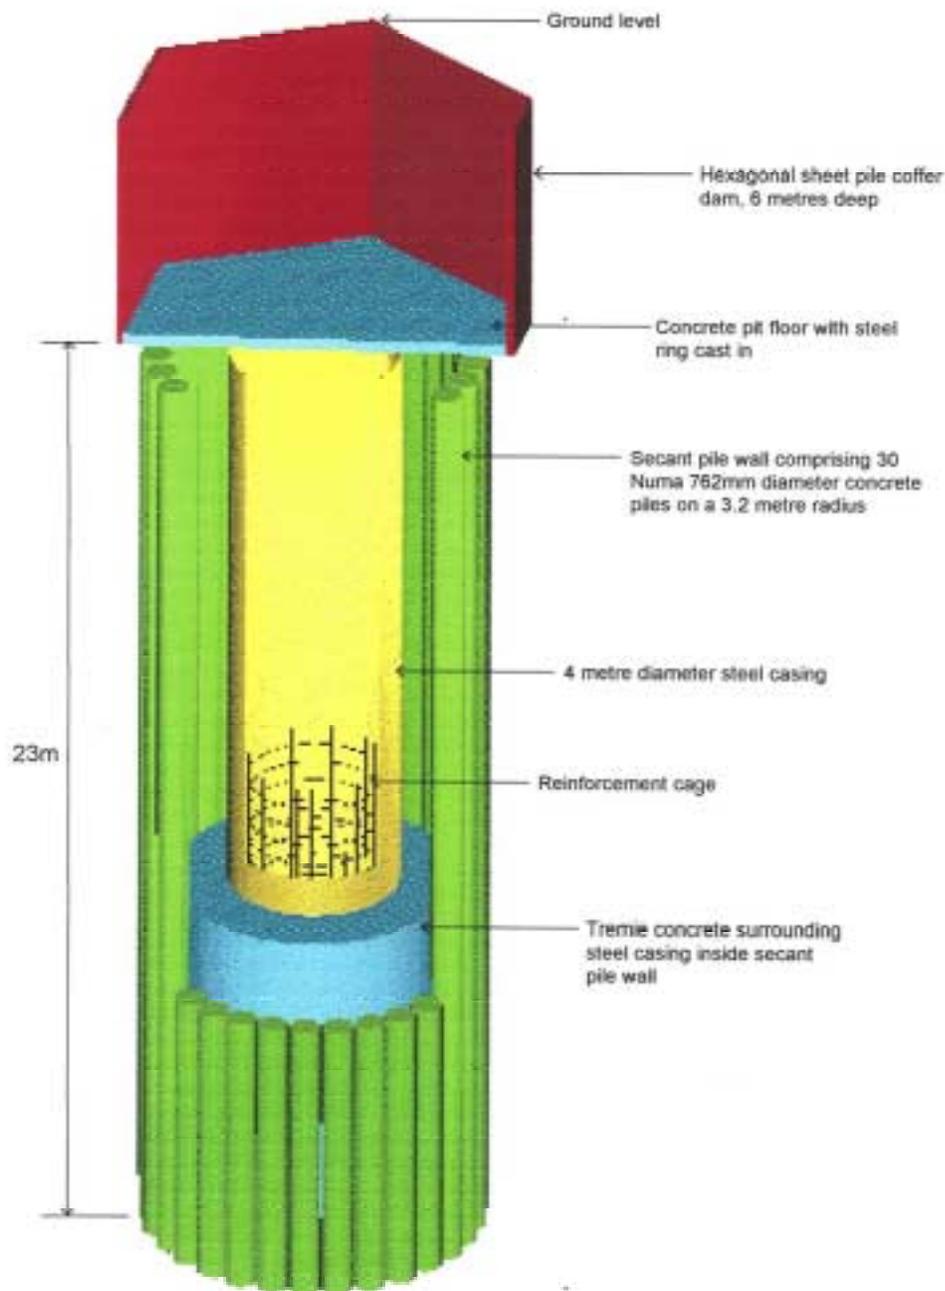
*Figure 9 - Schematic of Pier Foundation Construction*
