# CROSS UPDATE

Alastair Soane

Director: Structural-Safety

January 2021

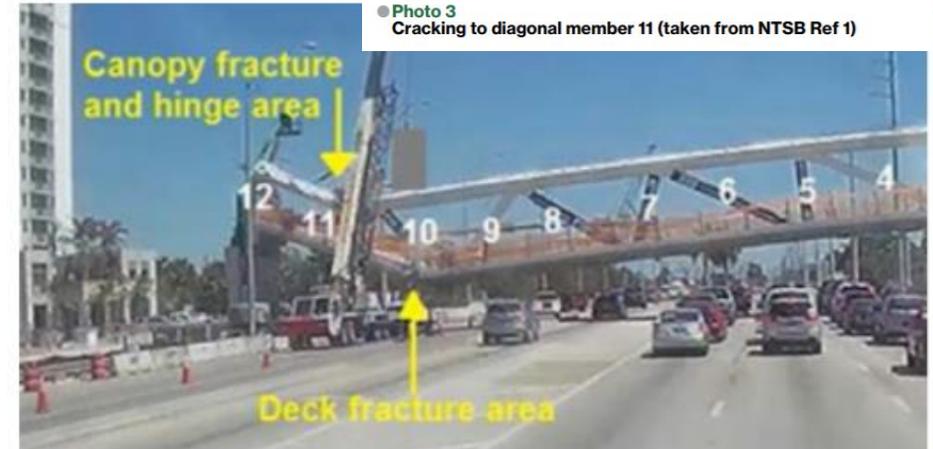
● Photo 4  
Catastrophic failure of bridge during re-tensioning activities. (taken from NTSB Ref 2)

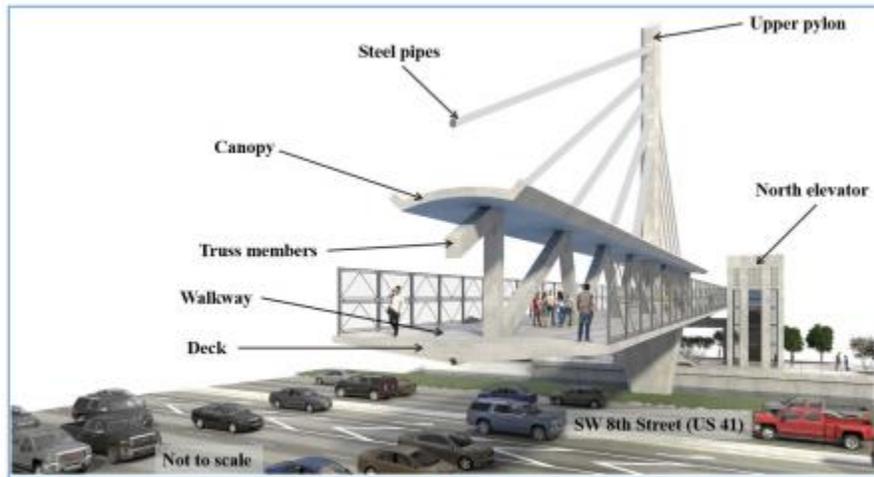
**Figure 6.** Cross-section rendering of pedestrian bridge, north view. (Source: FIU, modified by NTSB)

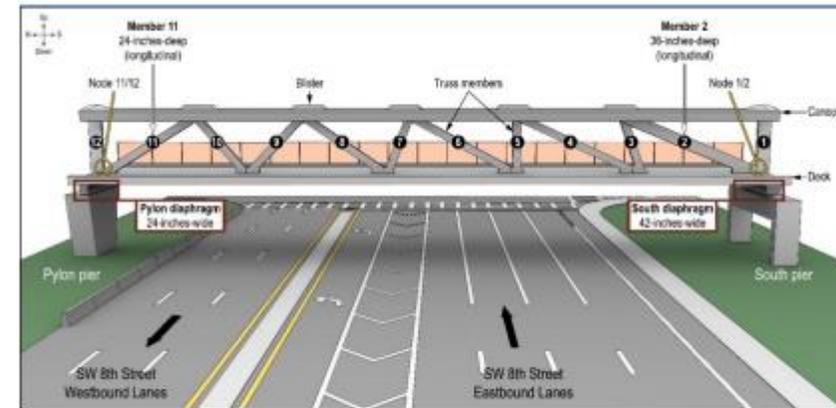
**Figure 7.** Nomenclature of bridge components and numbering of diagonal and vertical truss members on main span of pedestrian bridge, east view.

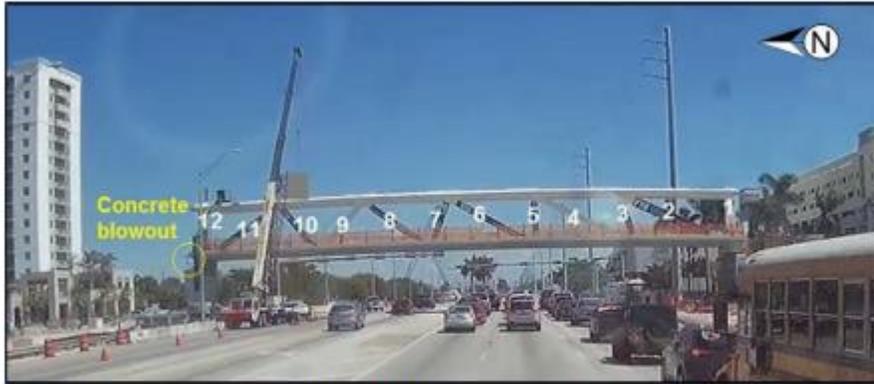
**Figure 9.** Still image (time stamp 13:46:43:881) from in-vehicle mounted video camera on pickup truck traveling east on SW 8th Street, showing concrete dust and debris blowout at north end (pylon pier), March 15, about 1:46 p.m.

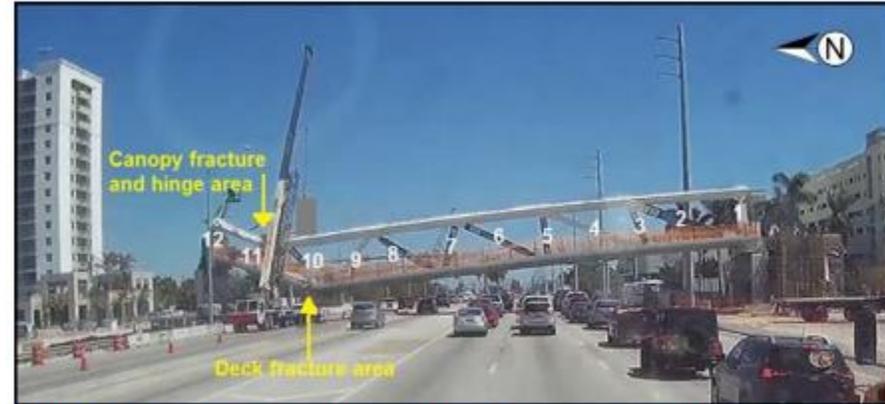
**Figure 10.** Still image (time stamp 13:46:44:046) from in-vehicle mounted video camera on pickup truck traveling east on SW 8th Street, showing full-width canopy fracture and deck fracture areas at north end (pylon pier), March 15, about 1:46 p.m.

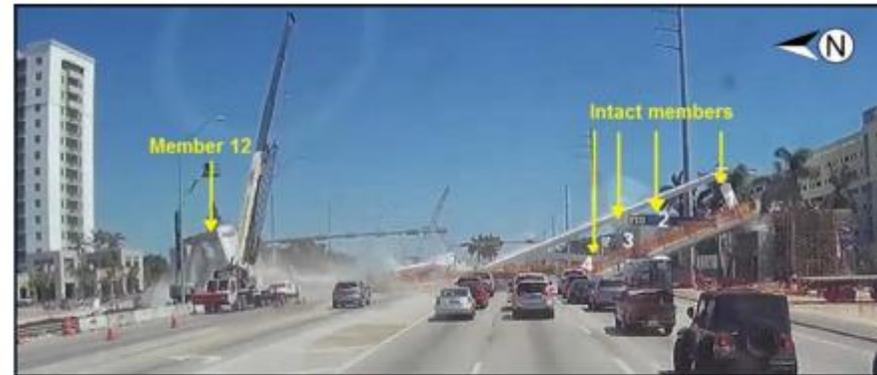
**Figure 11.** Still image (time stamp 13:46:44:310) from in-vehicle mounted video camera on pickup truck traveling east on SW 8th Street, showing main span completely collapsed, March 15, about 1:46 p.m.

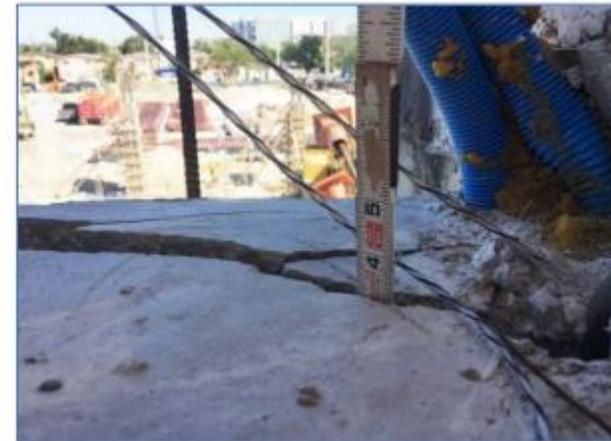
**Figure 24.** Cracks of 3–4 inch depth at northern end of precast main span, along west side of diaphragm 2 (north view), March 13, 11:17 a.m. (Source: MCM)
